SERVICE Counselor

PACKARD MOTOR CAR COMPANY

VOL. 28: NO. 6

JUNE, 1954

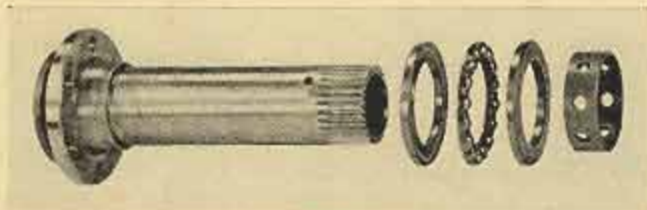
Fig. 1

1. If the converter is equipped with old original ball bearing type reactor shaft thrust bearing and spacer, (bearing assembly $\frac{5}{8}$ " wide and spacer $\frac{21}{64}$ " wide) replace it with the same type bearing and spacer using Part No. 421596 bearing and Part No. 421597 spacer. Fig. 1.

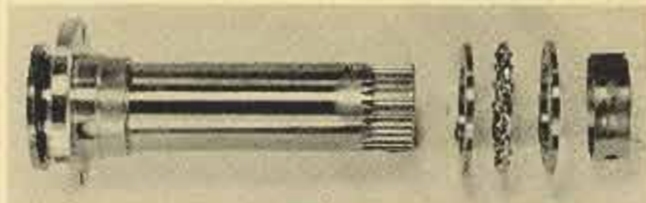
Fig. 2

2. If the converter is equipped with bronze thrust washer, two steel washers and spacer, replace these parts with the new reactor shaft thrust bearing kit Part No. 458290. This bearing assembly is $\frac{7}{16}$ " wide and the spacer is $\frac{21}{64}$ " wide. Fig. 2.

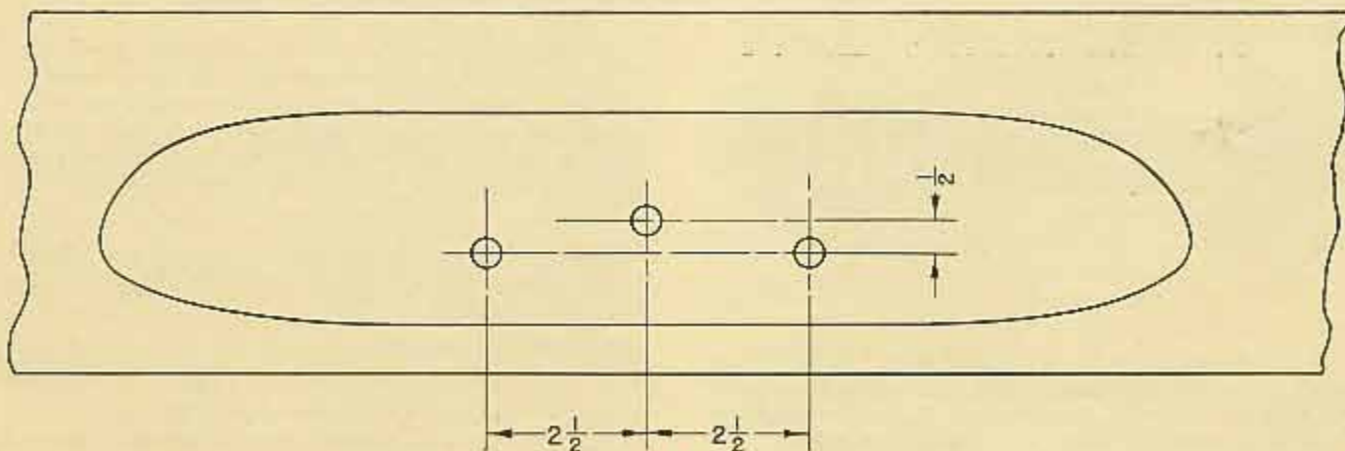
Fig. 1

Part No. 455501 Rear Bumper Impact Bar is listed in the Parts Book for the 26th Series Caribbean (Body 2678). This has been cancelled and superseded by Part No. 443339 which also fits the following models: 2602-06-26-31-5402-06-26-31.

When installing a new Rear Bumper Impact Bar Part No. 443339 on the 26th Series Caribbean, it will be necessary to drill two $3/8$ " holes through the center portion of the bar using the dimensions shown in Fig. 1.

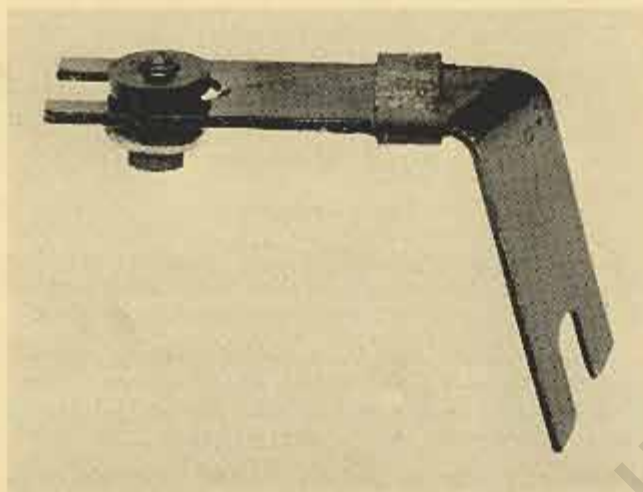
A rattle or vibration in the carburetor air cleaner may be encountered occasionally on 54th Series cars equipped with the 359 cu. in. engine.

The noise is generally caused by the air cleaner silencer striking the horizontal portion of the air cleaner support bracket near the bend where it attaches to the cylinder head.

The rubber seal, Part No. 387817, used on the front suspension upper support pivot pin can be used as an insulator by slipping it over the air cleaner support bracket as shown in the illustration.
