Service Counselor

PACKARD DIVISION
OF
STUDEBAKER-PACKARD CORPORATION

VOL. 29, NO. 12

NOVEMBER 15, 1955

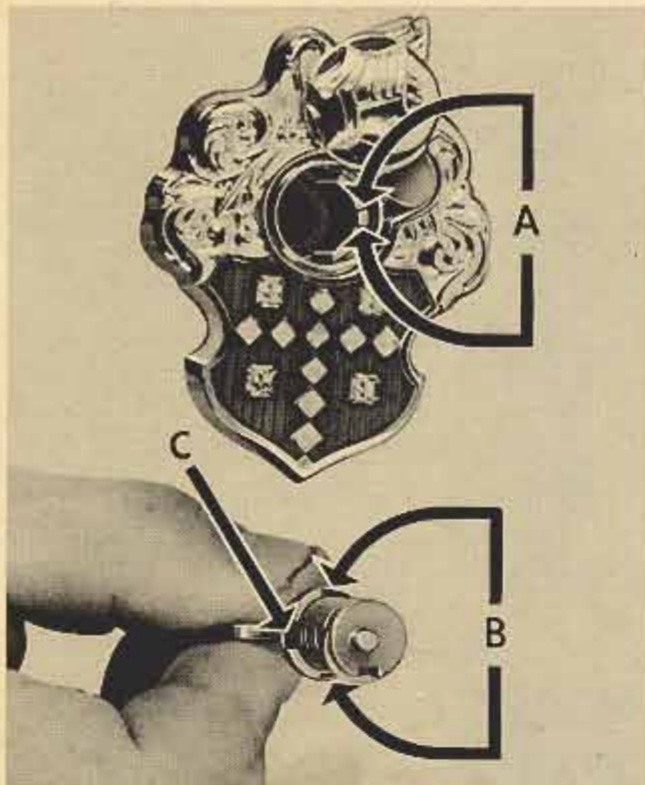
Fig. 4

CAUTION: Note the stop "A" in the lock housing and the two stops "B" on the cylinder shown in figure 4. Do not install the cylinder so that the groove "C" straddles the stop "A" in the housing.

If the cylinder is accidentally installed with the groove "C" over the stop "A," figure 4, it will be necessary to drill a hole in the housing at the location indicated by the "arrow" in figure 6, so that the yoke can be released with a stiff wire to remove the cylinder.

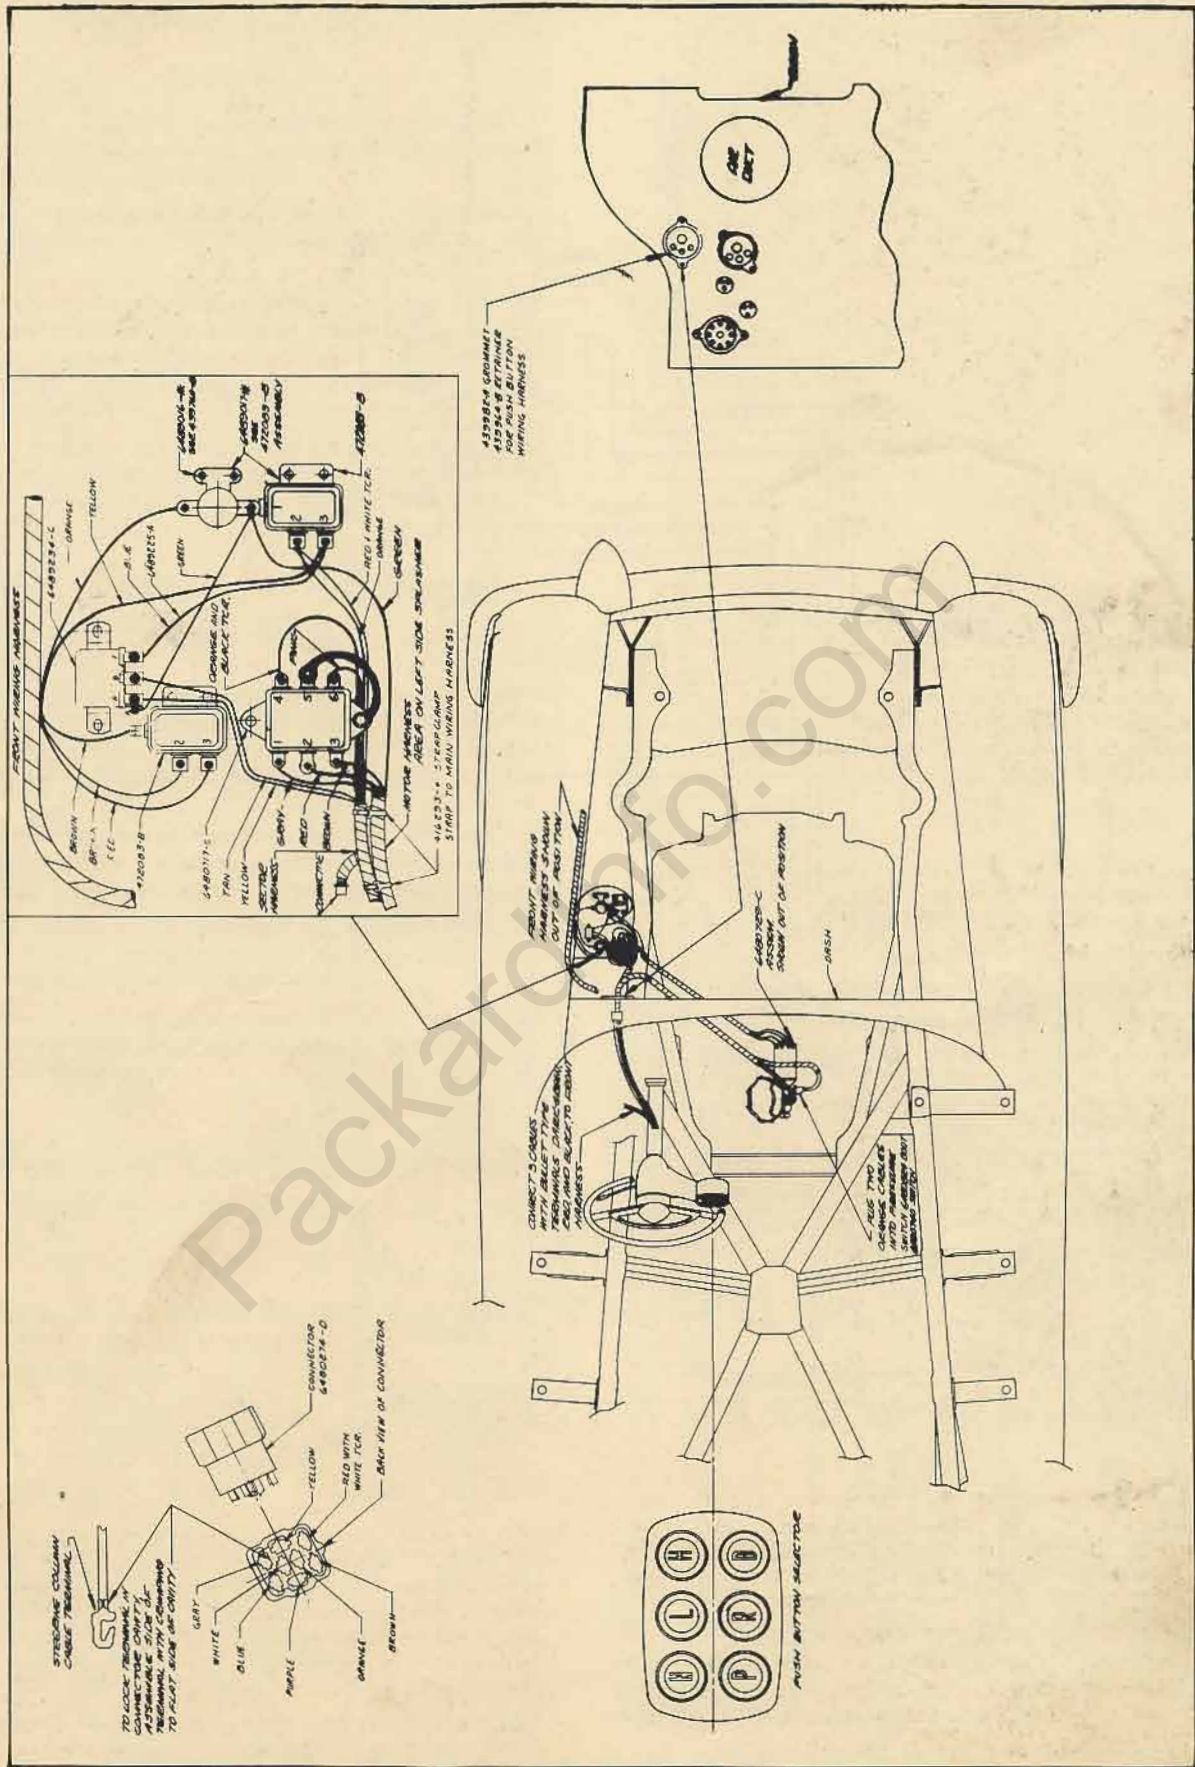
Fig. 1

By adding a relay and changing the wiring slightly, the Transmission automatically goes into "Park" when the ignition switch is turned off.

Disregard the two wiring diagrams figure 7 and 8 in the November Counselor and use the wiring diagrams in this Counselor when referring to the electrical circuit.

When removing the transmission control actuator and motor assembly, it will be necessary to disconnect two additional wires (yellow and tan) from the upper relay No. 6489234 shown in figure 1. The other wires to disconnect are described in the first paragraph on page 58 of the November Counselor.

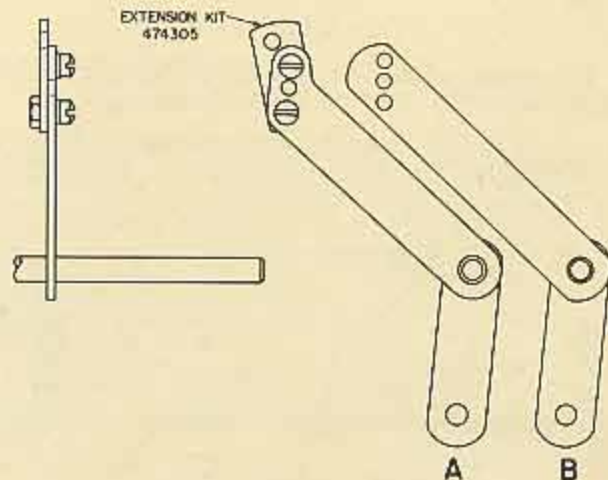
The 55th Series Ultramatic Transmission was installed on the first production 5640 models when so equipped (transmission serial numbers 5-39010 through 5-40510). The throttle lever extension shown on the lever "A" in the illustration was also used.

56th Series cars having transmission serial numbers A-1001 through A-2101 were equipped with 56th Series transmissions but still have the 55th Series throttle lever "A." Some of these cars may have the extension on the lever and some may not depending upon whether unwanted kick-down was encountered.

If unwanted kick-down is encountered on the 56th Series cars (56th Series Transmissions with the 55th Series lever), we suggest that you install the extension kit Part No. 474305 and readjust the linkage properly.

All 56th Series cars having Ultramatic Transmission Serial numbers after A-2101 will have the throttle lever as indicated by "B" in the illustration which does not require the extension. The carburetor throttle rod should be installed in the center hole of the lever unless unwanted kick-down is encountered, then install the rod in the upper hole and readjust the linkage.
