PACKARD DIVISION
OF
STUDEBAKER-PACKARD CORPORATION

Counselor

VOL. 29, NO. 4

APRIL, 1955

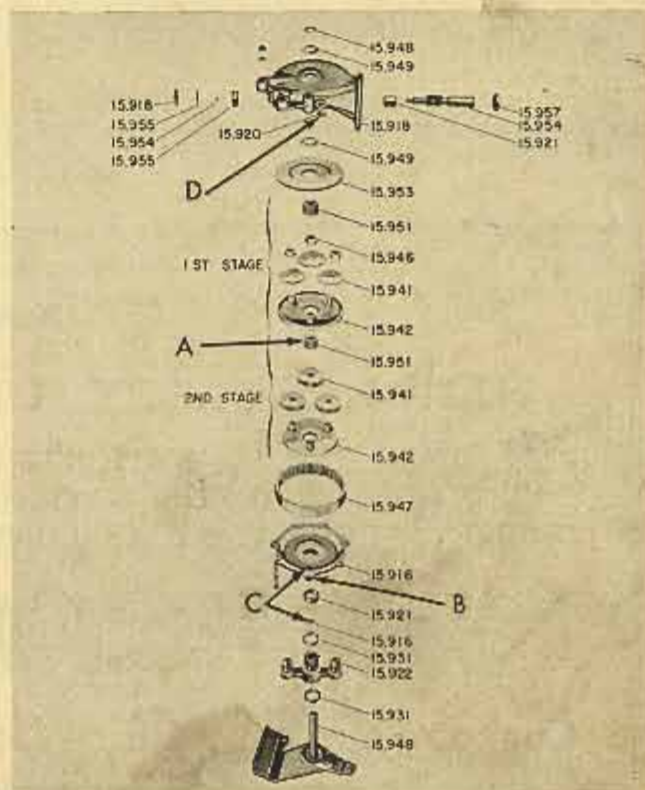
Please note the small gear indicated by the arrow "A", this gear is slightly shorter than the similar one in the 1st stage and has two oil grooves on each end of the gear. The short gear must be installed in the 2nd stage as shown.

Note the long ear on the lower housing indicated by "B," when torquing the housing bolts, torque this bolt not over 6 ft. lbs. and the balance of the housing bolts to 12 ft. lbs.

The Compensator is filled at the time of manufacture and requires no periodic changes, however, after assembly, the unit can be packed by removing the $\frac{1}{8}$ " pipe plug from the lower housing indicated by "C", install a zerk or suitable fitting in its place, fill a pressure gun with 1 lb. of special lubricant and

fill the housing until grease comes out of the upper relief valve "D."

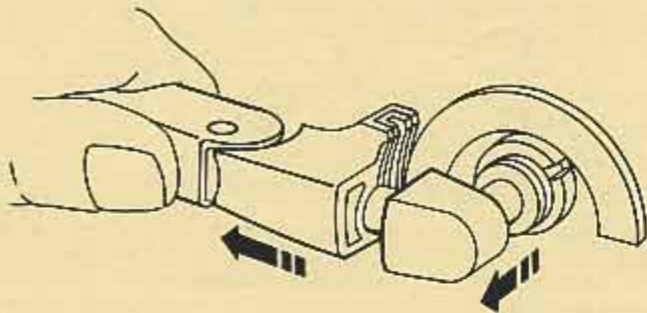
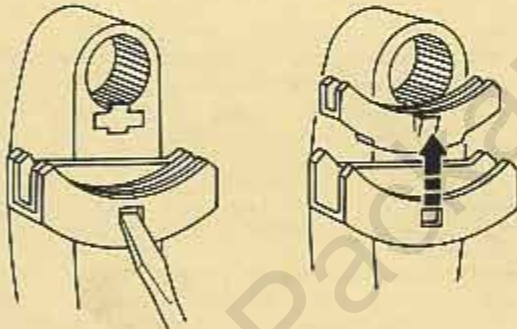
The following information covers the servicing of the windshield wiper arms used on all 55th Series cars.

Grasp arm above cam follower and elongate arm until the follower will clear the cam. "See upper illustration."

1. Push in and up on shoe locking lug with small screwdriver or punch and pry out shoe "See lower illustration."

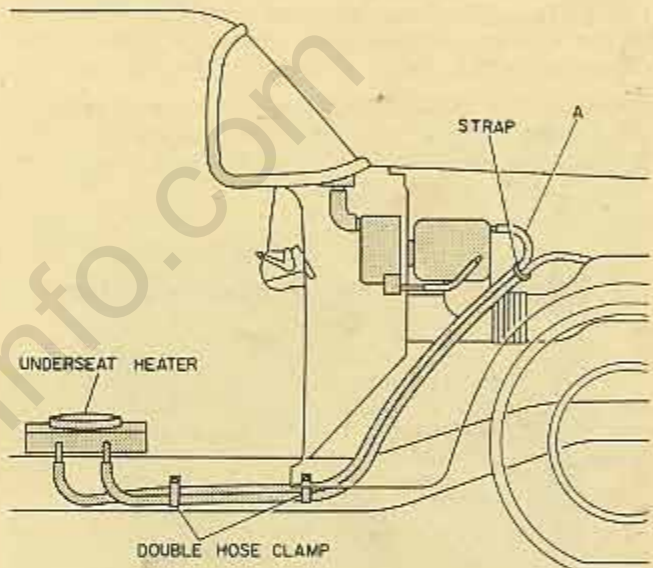
A few reports have been received of a kink in the heater hose at the location "A" shown in the illustration. A kinked hose in the heater circuit will restrict the flow of coolant, resulting in insufficient heat from both the heaters.

In most cases it has been found that the heater hose indicated by "A" has been pulled down through the double hose clamps too far, causing it to kink, at the upper end.

It is suggested that the heater hoses directly under the underseat heater be inspected for excessive length and if found so, loosen the double hose clamps and pull the hose upward to provide a larger curve at the dash heater.

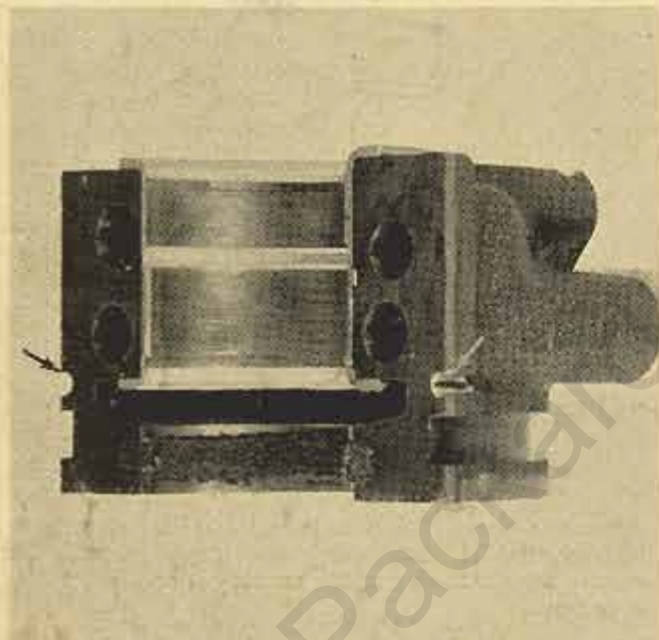
Oil leaks at the upper outer corners of the rear main bearing cap may be caused by seepage of oil between the milled surfaces of the cap and the crankcase.

This condition can be corrected by removing the rear main bearing cap and filing a notch on each side of the cap approximately $\frac{3}{32}$ " deep, $\frac{1}{8}$ " ahead of the oil seal groove to drain off the oil. "See illustration."

Use a small three cornered file to file the grooves. Be sure to remove all chips and filings by washing the bearing and cap thoroughly in cleaning solvent.

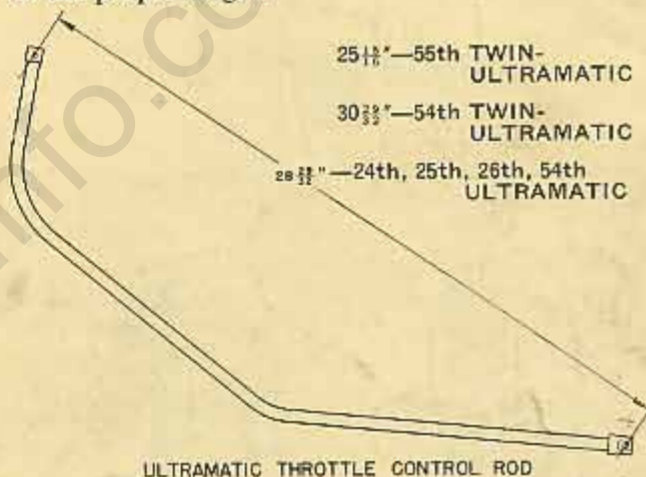
Occasionally the automatic transmission throttle control rod becomes bent due to an accident of some kind. Due to its peculiar shape, it is difficult to determine whether or not it is bent.

Because of its function in controlling throttle pressure which affects other pressures, clutch engagements and upshifts, it is very important that the rod be of the proper length.

The illustration shows the proper length of the rod used on all 24th, 25th, 26th and 54th Series Ultramatic. The 54th Series Twin Ultramatic and the 55th Series Twin Ultramatic.
