SERVICE Counselor

PACKARD DIVISION
OF
STUDEBAKER-PACKARD CORPORATION

VOL. 29, NO. 9

SEPTEMBER, 1955

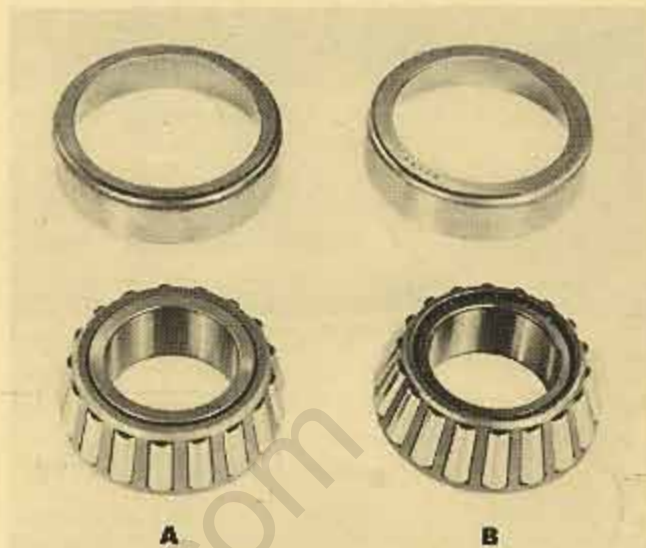
Fig. 1

Figure 1, indicated by "A", shows the 25° rear pinion bearing and cups. The 40° rear pinion bearing is indicated by "B". Note the difference in the angle of the rollers, also that the flat end section is wider on the 40° bearing cup.

It is permissible to use either the 25° or 40° rear pinion bearings provided the proper sleeve is also used. The sleeves are slightly different in length, therefore it is important that the correct sleeve be used so as to obtain the proper preload on the pinion bearings.

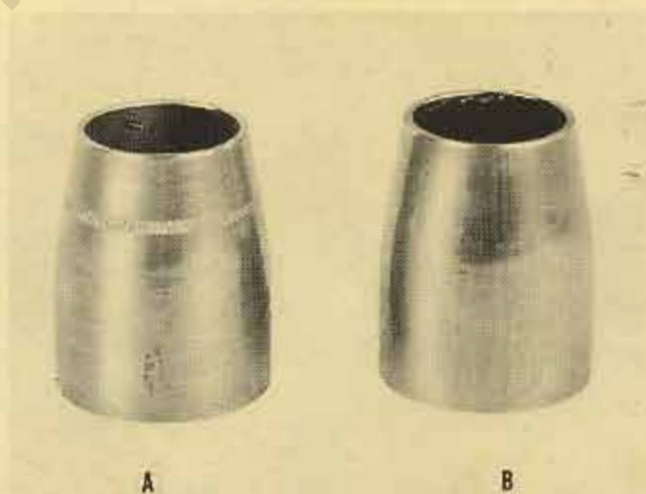
Fig. 2

Figure 2, indicated by "A" shows the pinion bearing sleeve used with the 25° bearing. The sleeve used with the 40° bearing is indicated by "B". The knurled section on the 25° bearing sleeve (A) is provided for identification purposes.
