SERVICE Counselor

PACKARD DIVISION

STUDEBAKER-PACKARD CORPORATION

JANUARY, 1956

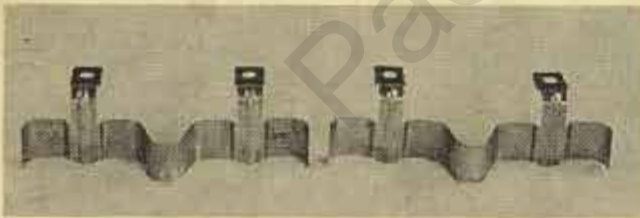
Fig. 1

In the very near future, production will use valve spring baffles that will be installed under the valve springs with a flange that extends upward on the high side of the spring to prevent excessive oil from getting on the intake valve stems.

Figure 1, illustrates the service baffles, note the square lockwashers on the attaching lugs on the baffles.

Because of the expense involved to install this type baffle, service baffles have been released that can be installed without removing the cylinder heads.

The service baffles are available as a kit and may be ordered under Part No. 6484396.

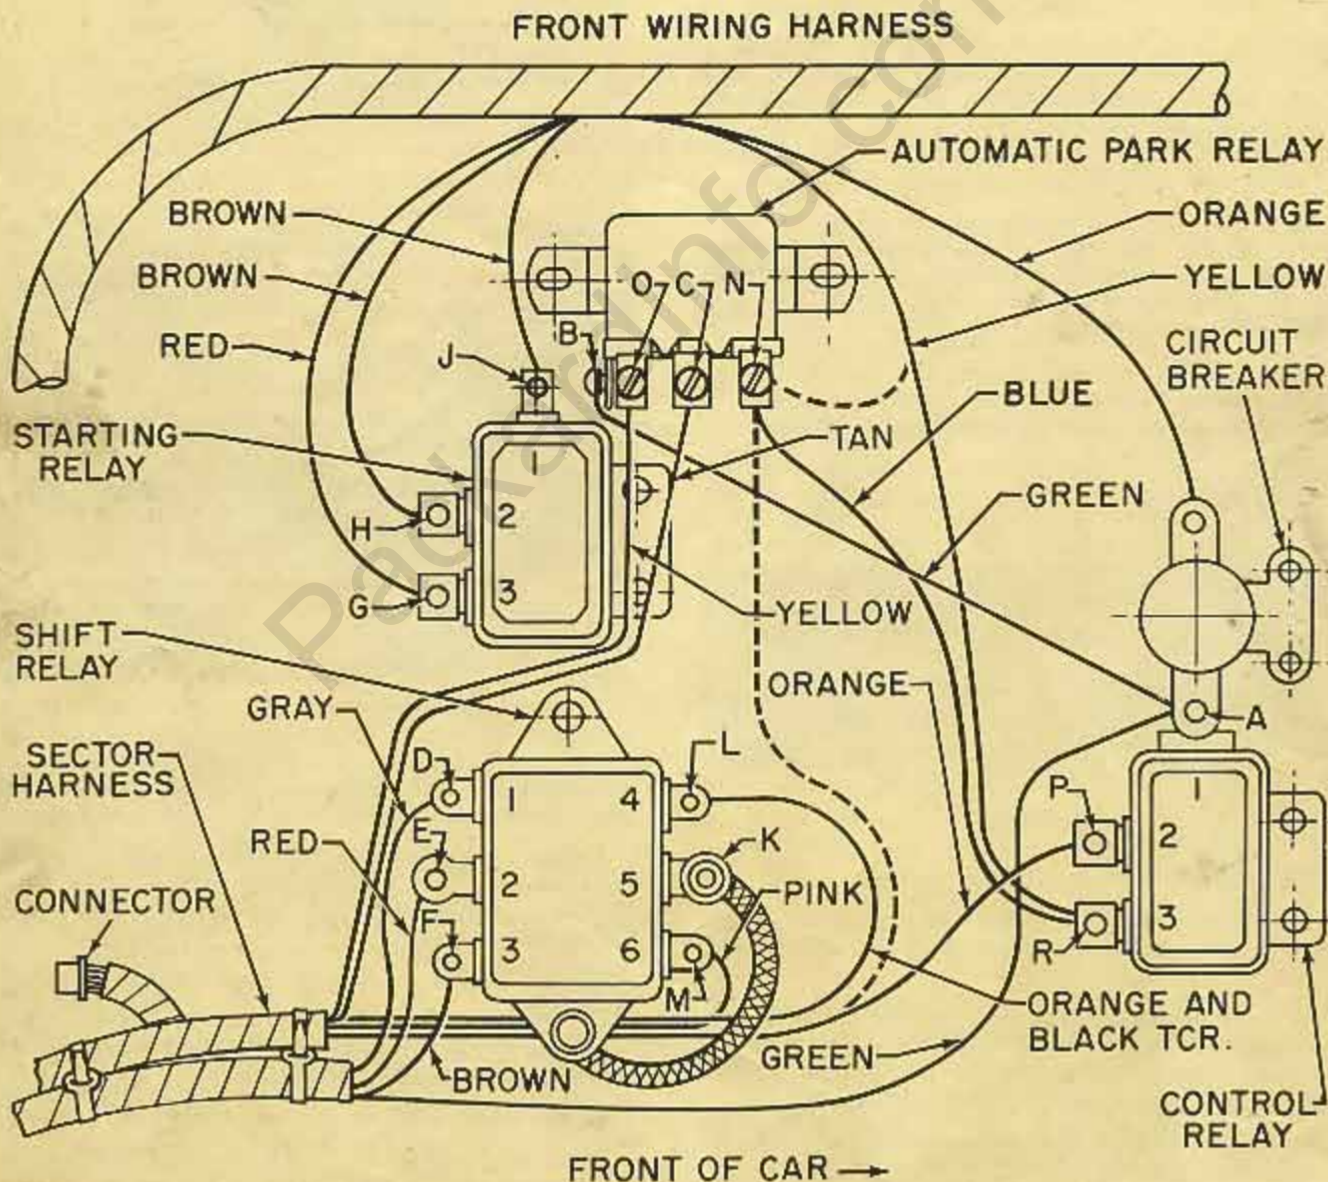
Since adding the Automatic Park Relay to the push button electrical system, it has been found that the control relay functions can be accomplished in the Automatic Park Relay.

Late production cars equipped with push button control do not have the control relay and the necessary wiring has been connected to the automatic park relay.

We suggest the control relay be removed from early production cars and the wires connected as follows:

1. Remove and discard the blue wire that leads from "R" terminal on the control relay to "N" terminal on park relay.
2. Disconnect yellow wire from "R" terminal on Control relay and connect to "N" terminal on park relay as indicated by dotted line on the illustration.
3. Disconnect orange wire from "P" terminal on

control relay and connect to "N" terminal on park relay indicated by dotted line.

4. Remove the control relay, leaving the two green wires connected to terminal "A" on the circuit breaker.

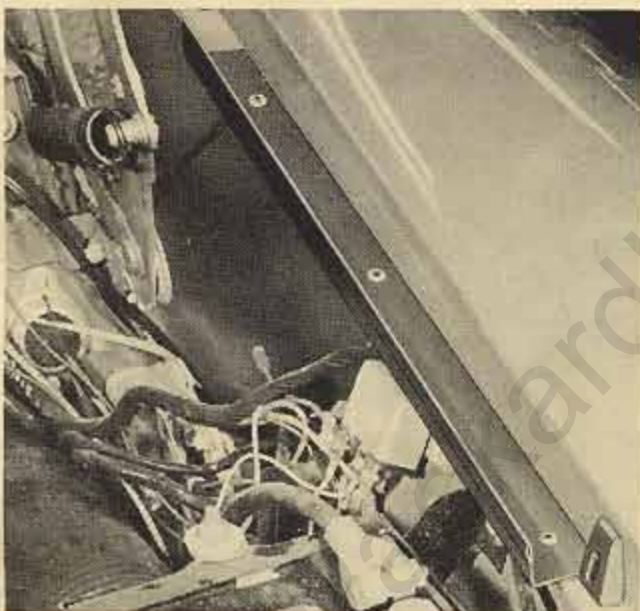
We have been informed that water is getting into a few of the push button control relays causing the relays to short.

Production is now installing a water drain trough which is attached to the flange of the left front fender just above the relays.

The water trough is available for service and should be installed on all early production cars with push button control.

Position the trough on the fender flange with its forward end against the center hood bumper.

Drill three $\frac{1}{8}$ " holes in the fender flange. Apply a coat of dum-dum on top of the fender flange and attach the trough with the three sheet metal screws as shown in the illustration.

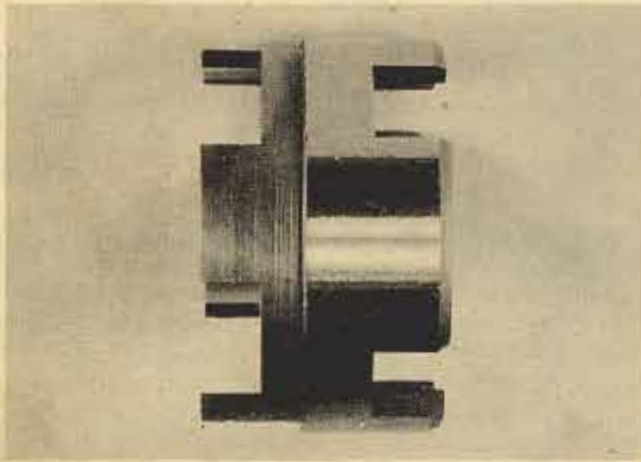
The Ultramatic Transmission Rear Oil Pump Driver has been completely redesigned, "See illustration." It is machined to fit snug into the rear oil pump rotor and also pilots on the planetary output shaft.

The new oil pump driver can be used on 54th Series "Gear Start," 55th and 56th Series Ultramatic transmissions. It can be ordered under Part No. 6489292.

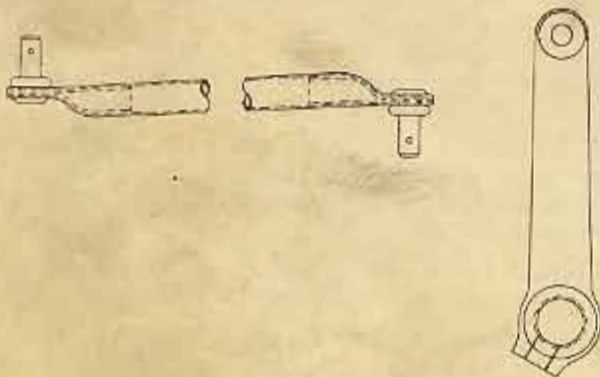
Along with the information described in the above article, it has been found in some instances that the transmission lever and rod are almost in a direct line when in the park position making it difficult to move the selector lever from the park position.

The transmission lever has been redesigned by relocating the set screw hole which permits the lever to be in a more vertical plane when in the park position. The operating rod has been shortened to accommodate the change in the lever.

The new rod and lever are available as a kit for service and can be ordered under Part No. 6484069 Transmission Control Lever and Rod Kit.

NOTE: After installing the new rod and lever, move the selector lever through its full range of travel making certain that each detent in the manual valve can be felt. If each detent cannot be felt, it may be necessary to adjust the linkage turnbuckle slightly.
