SERVICE COUNSELOR

PACKARD DIVISION

STUDEBAKER-PACKARD CORPORATION

FEBRUARY, 1956

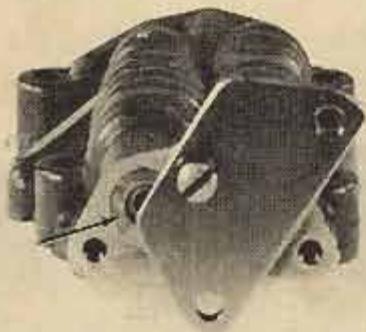
Fig. 1

A low speed disturbance, emanating from the transmission, has been reported occasionally on 54th and 55th Series Transmissions. This condition, when it exists, is most pronounced while in direct drive at a steady car speed slightly higher than the direct drive clutch disengagement speed.

The direct clutch disengagement point can be raised by placing shims or thin, flat washers behind the

direct shift valve piston spring seat as indicated by the arrow in figure 1. The shims must be installed inside the valve bore and between the spring seat and the body end plate. No clearance should exist between the body and the end plate when checked with a feeler gauge as shown in figure 2.

On Packards with a 3.54 axle ratio, use a shim pack which totals approximately .100". The car then should be road-tested and the shim pack increased or reduced, if necessary, to bring the clutch disengagement to the desired speed.

On Clippers with a 3.07 axle ratio, the shift pattern is considerably later and an initial shim pack of approximately .060" is recommended and the car road-tested.

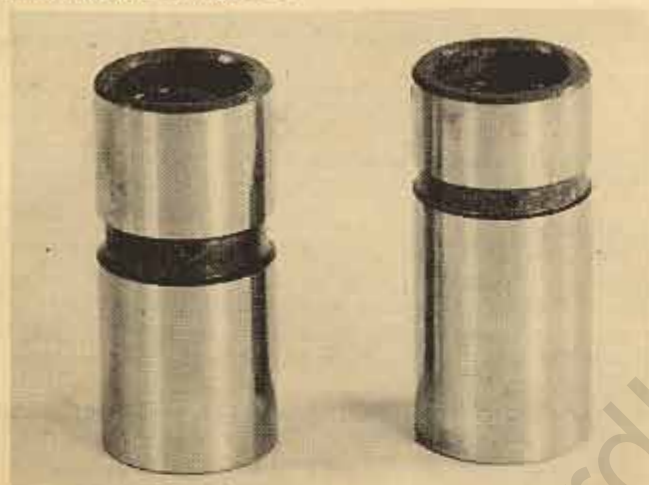
Fig. 1

The new hydraulic tappets having the greater oil reservoir have a narrower oil groove in the body and the groove is raised slightly as shown by the right hand tappet in figure 1.

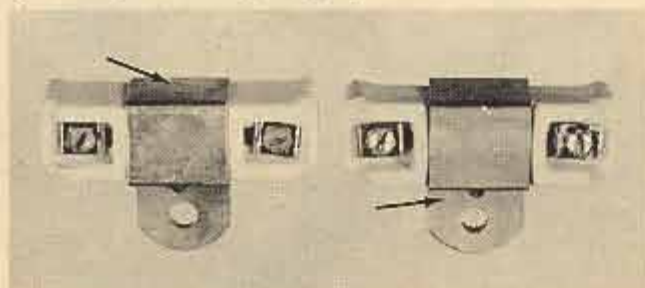
Burned or oxidized ignition points on a few 55th and 56th Series cars has been caused by incorrect ignition resistors.

The Delco-Remy Ignition Resistor has 1.52 Ohms resistance and the Auto-Lite Resistor has .665 to .735 Ohms resistance therefore, they should not be interchanged.

Should an Auto-Lite resistor be installed on a car with Delco-Remy system, a higher amperage will flow through the primary circuit than the coil is designed to carry resulting in burned or oxidized ignition points and possibly shorten spark plug life.

Illustrated are the two resistors. The one on the left is Auto-Lite and the identification mark is located at the arrow. The one on the right is Delco-Remy and the arrow indicates the location of its identification mark.

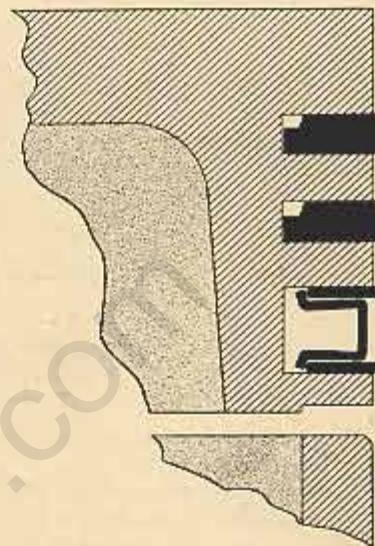
A few reports have been received of excessive oil consumption after chrome ring sets were installed in 55th and 56th Series Engines. In most all cases it was found that either the top groove compression rings or second groove compression rings or both were installed upside down.

Chrome piston rings sets should be installed as shown in the illustration. The chrome compression ring is installed in the top groove.

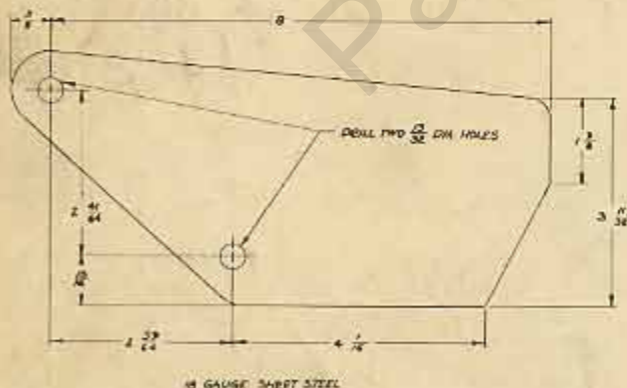
The proving ground has informed us that the compensator limit switch and wiring closest to the propeller shaft can be damaged by stones while driving over gravel roads.

Illustrated is an inexpensive guard which can be made up in your shop. The guard should be made from 18 gauge flat steel stock to the dimensions shown.

Install the guard on the rear inner side of the left front X member under the compensator bracket bolt and control switch rear bolt.
