SERVICE Counselor

PACKARD-CLIPPER DIVISION
OF
STUDEBAKER-PACKARD CORPORATION

VOL. 30, NO. 5

MAY, 1956

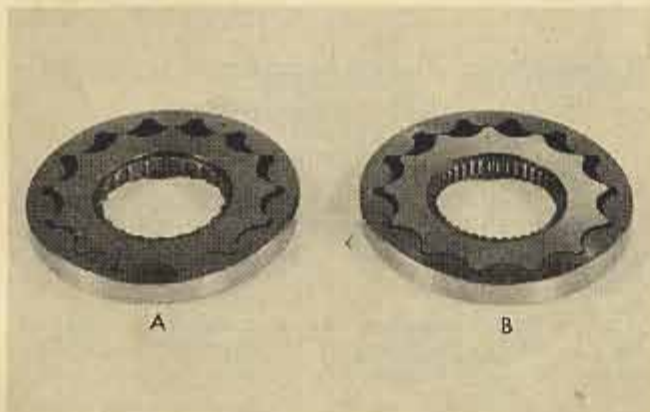
Fig. 1

Several reports have been received of worn or stripped splines on the converter pump shaft where it engages with the front oil pump rotor and in some cases, the splines in the rotor were worn or stripped. This condition may occur in 54th Series Gear-Start transmissions, 55th and early 56th Series Ultramatic transmissions.

"A" figure 1, shows the front oil pump rotor having 20 internal splines that is used in 54th Series Gear-Start, 55th and early 56th Series Ultramatic transmissions.

56th Series Production transmissions starting with serial numbers A-9681, B-6012, C-1143, D-1862 have front oil pumps with the direct clutch passage in the rear and also have the rotors with 40 tooth splines on the internal driving section, "B" figure 1.

New rotors with 40 splines and front pump assemblies with 40 spline rotors have been released for service replacement and are listed for your ready reference.

Whenever worn or stripped splines are found on one of the units, always replace both units to provide proper spline mesh.

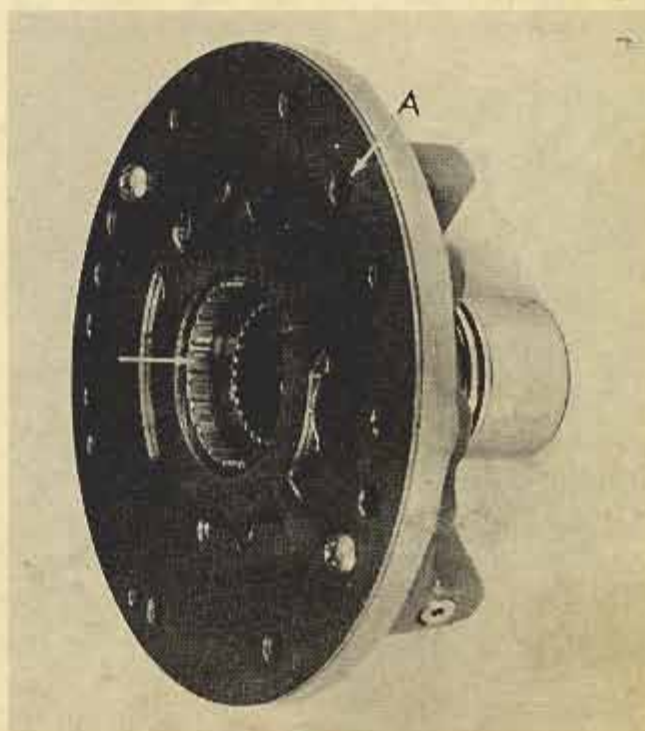
Fig. 2

On 54th Series Gear-Start, all 55th Series and 56th Series Ultramatic transmissions up to transmission

serial number 5-40469, oil pressure for the direct drive clutch came out of a passage on the front side of the pump. See "A" figure 2. The oil pressure is directed through a passage in the bell housing, then past the open splines in the rotor to the input shaft.

The pump assembly listed above has the oil passage in the front side of the body and the rotor has 40 splines, therefore it will be necessary to drill six $\frac{1}{8}$ " holes evenly spaced through the annular groove just back of the splines in the converter shaft to provide an oil passage to the direct drive clutch. "See arrows figure 4." This also applies when replacing the rotor assembly. Be sure to remove burrs from edges of $\frac{1}{8}$ " holes and internal bushing after drilling.

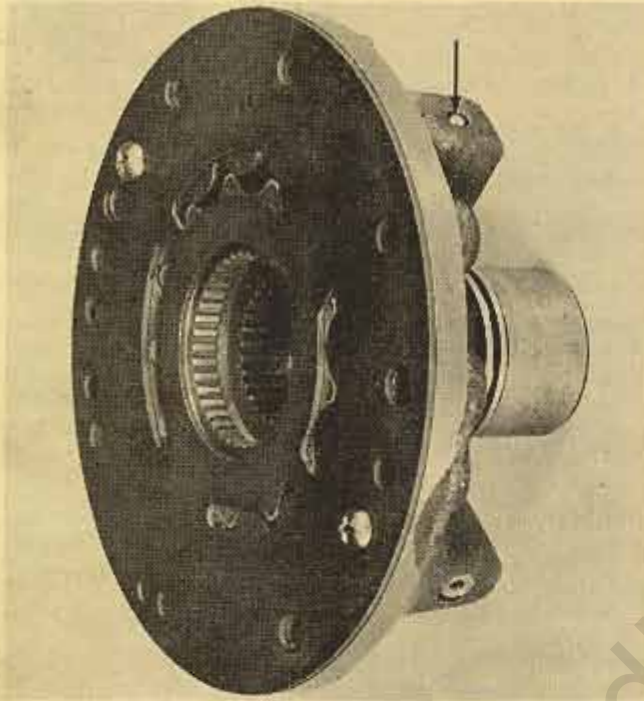
Fig. 3

56th Series transmissions after the above serial number have front oil pumps with the direct clutch oil passage in the rear side of the pump. "See arrow figure 3." The outlet for this passage is between the two bushings inside of the pump hub, also note the oil passage hole is not in the front plate. However, these pumps have the 20 tooth splined rotors. (40 tooth rotor is shown in the illustration.)

The $\frac{1}{8}$ " holes are not required in the above listed Converter Shaft because the direct clutch oil passage is in the rear side of the pump body.

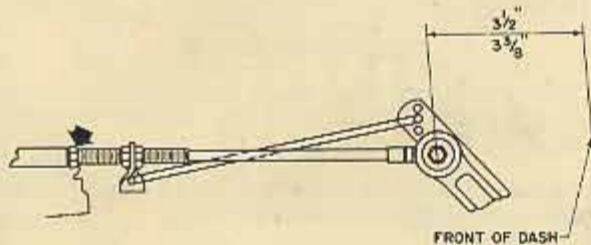
No one single item affecting proper performance and durability of the transmission is of more importance than the proper adjustment of the accelerator linkage.

This linkage matches the transmission capacity with that of the engine and can materially alter the shift point if maladjusted.

1. With engine warmed up and carburetor off fast idle, set engine idle speed at 450 RPM with selector lever in "H" position.

2. Loosen the lock nut indicated by arrow in the illustration and adjust the length of the rod to obtain $3\frac{3}{8}$ " to $3\frac{1}{2}$ " measurement from the front side of the dash in the reinforcement channel to the center of the screw in the lever.

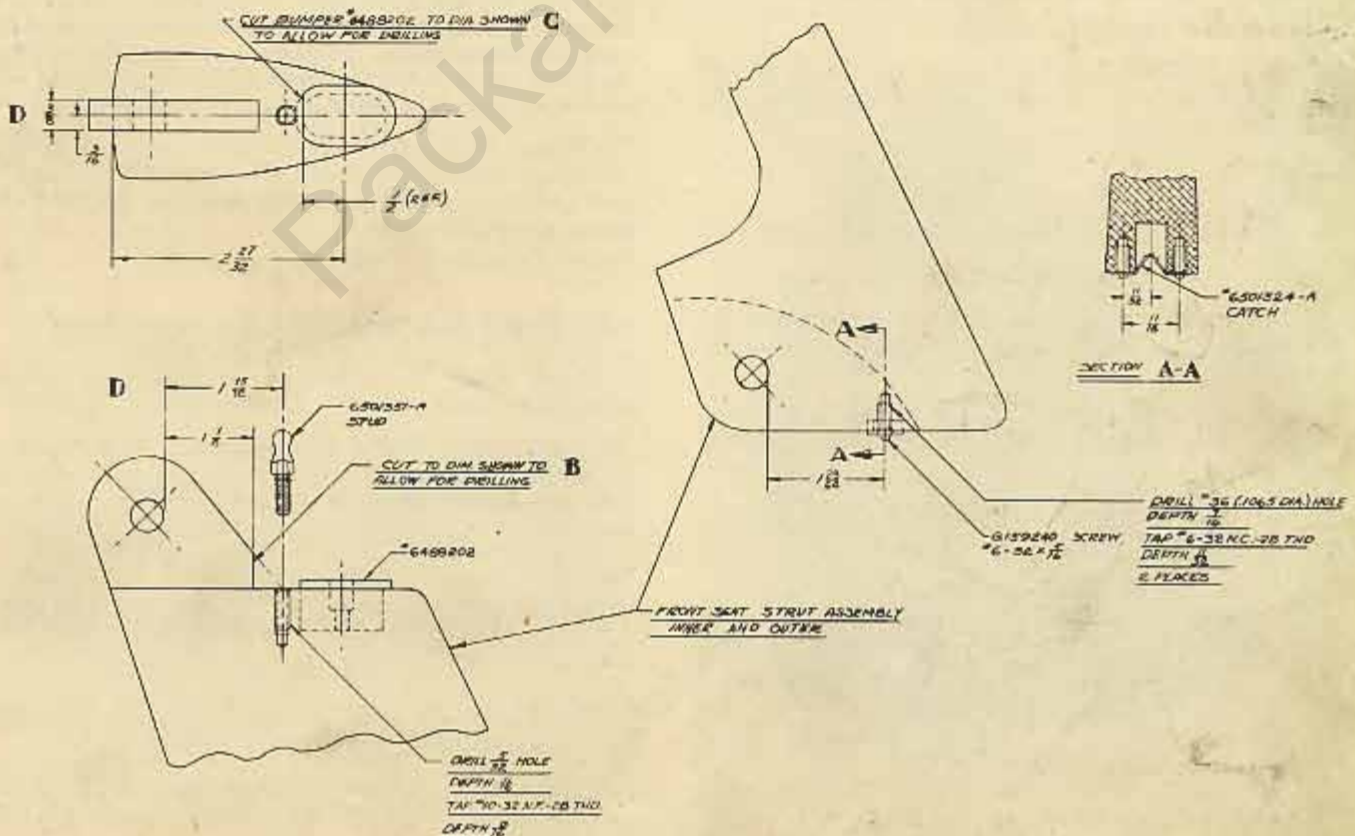
INSTRUCTIONS FOR INSTALLING BALL STUD AND SPRING CATCH IN THE FRONT SEAT STRUT ASSEMBLY TO ELIMINATE THE SEAT FROM FALLING FORWARD UPON SUDDEN APPLICATION OF BRAKES

A few reports have been received of the right front seat back falling forward upon sudden application of the brakes.

Production is now installing a ball stud and spring catch on the seat struts to prevent this condition. The ball studs and spring catches are available for service, and can be installed as follows:

2. Refer to the two sections "A-A" in the illustration.

(a) Install the two hinge pins in the seat back struts.

(b) Using a 12" scale, line up one edge of the scale with the bottom of the strut with the end of the scale resting against the hinge pin.

(c) Measure $1\frac{29}{64}$ " distance and mark this location on the bottom of the strut.

(d) Set the spring catch in the strut as shown at the $1\frac{29}{64}$ " location.

Center punch, drill and tap two holes, using a No. 36 drill and 6-32 tap.

Install the spring catch and perform the same operation on the other seat back strut.

3. Measure $\frac{1}{2}$ " forward from the hole in the rubber bumper and cut off the edge of the bumper "C" to provide space for the stud.

4. Install the two hinge pins in the seat frame struts.

(a) Using a 12" scale, line up one edge on the top flat surface of the seat frame strut with the end of the scale against the hinge pin.

(b) Mark the $1\frac{1}{8}$ " dimension and cut off portion "B" of the strut to provide space for drilling and installation of the stud.

(c) Using the 12" scale, mark the $1\frac{15}{32}$ " location as indicated by "D."

(d) Center punch, drill and tap one hole in the exact center of the strut using $\frac{5}{32}$ " drill and 10-32 tap. Perform the same operation on the other seat frame strut.

5. Reinstall seat back and insert hinge pin. Install seat cushion.

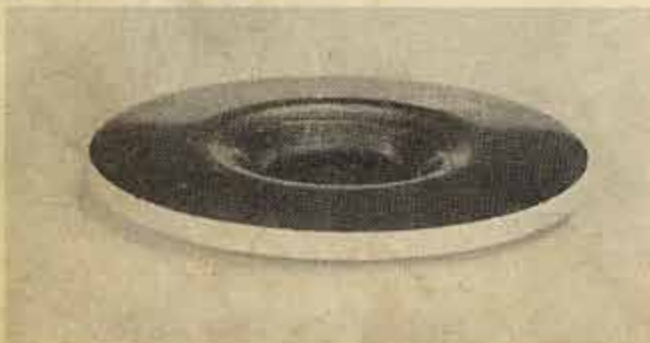
A few reports have been received stating that the low brake cap in the 56th Series transmission was distorted.

Illustrated is the 56th Series low brake cap. You will note it is "bellied" upward slightly from its outer edge which is its designed shape.

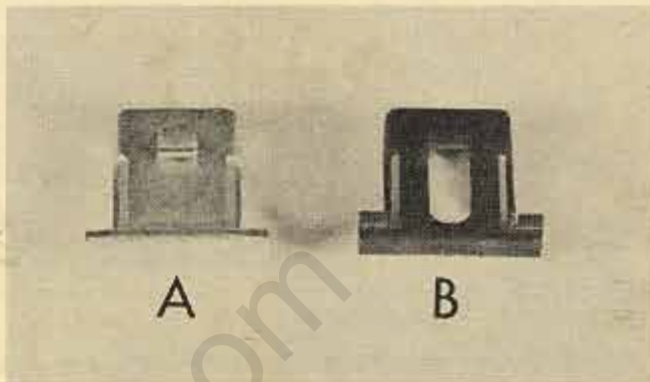
The inside window regulator and door lock remote control handle retainers have been revised to prevent the handles from falling off.

The old retainer is indicated by "A" and the new is indicated by "B" in the illustration.

The new retainer can be ordered under Part Number 6485347.
