PACKARD-CLIPPER DIVISION

## Counselor

VOL. 30, NO. 6

JUNE, 1956

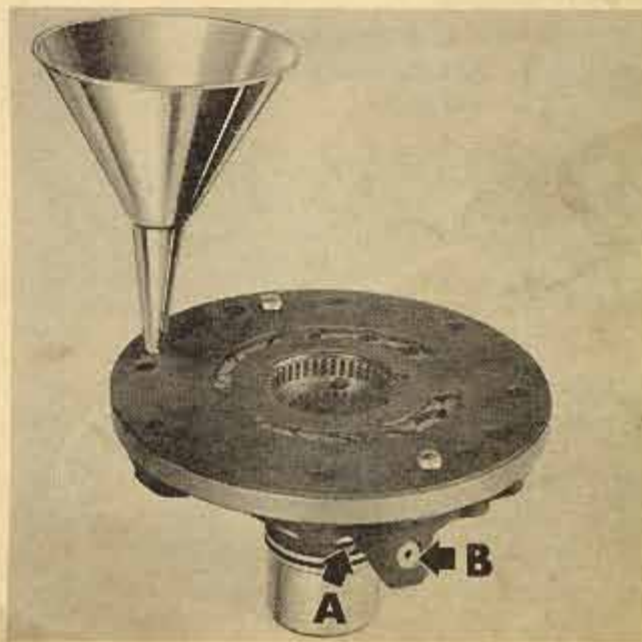
Occasionally we have found a restriction in the high range clutch oil passage in the front oil pump due to core shift when the pump housings were cast.

If the cored passage is restricted, possible engine runaway on low to high upshift may occur or the high range clutch may burn out prematurely.

If it requires more than 2 minutes and 15 seconds for passage of the  $\frac{1}{2}$  pint of fluid, it will indicate the passage is restricted and the pump is not satisfactory

NOTE: A few drops of fluid from passage "B" is permissible as this is the check valve that bleeds air from the circuit.

Place the complete oil pump assembly in a shallow pan with the pump plate up and in a horizontal position. Use a small funnel and rework the end of the funnel so it will be a close fit in the high range clutch oil circuit hole of the pump plate. "See illustration for correct location of the hole."

Pour enough transmission fluid in the funnel for fluid to start flowing from passage "A" and fill the passage in the pump, allow the fluid to drain down to a level slightly above the funnel spout. At this time pour an additional  $\frac{1}{2}$  pint of fluid in the funnel and observe time required for the fluid level to reach the predetermined level.

for the application of the high range clutch and pump should be replaced.

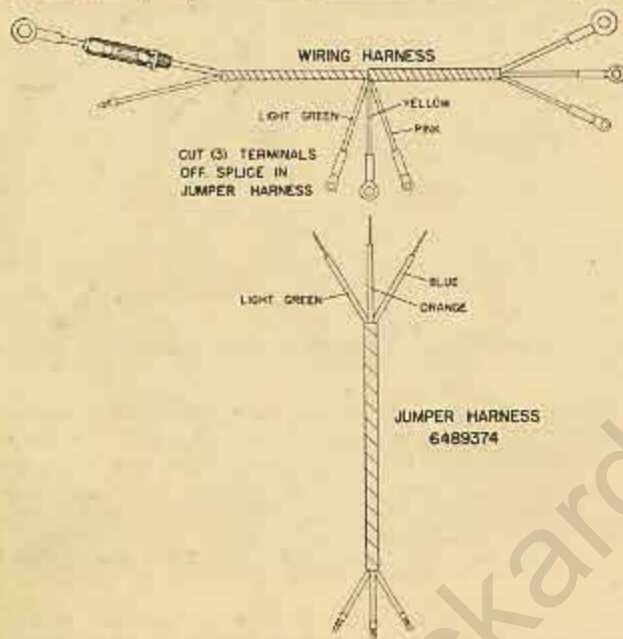
The terminals on the Torsion Level Suspension Control Assembly on 56th Series cars are enclosed in the switch case to protect the terminals from shorting due to snow, ice and salt.

When installing Part No. 472239 Control Assemblies on 55th Series cars, it will be necessary to order and install a jumper wiring harness Part No. 6489374.

Cut the three terminals off the old harness and splice the new jumper harness to the wires as shown in the illustration:

Light green to light green.

Orange to yellow.

Blue to pink.

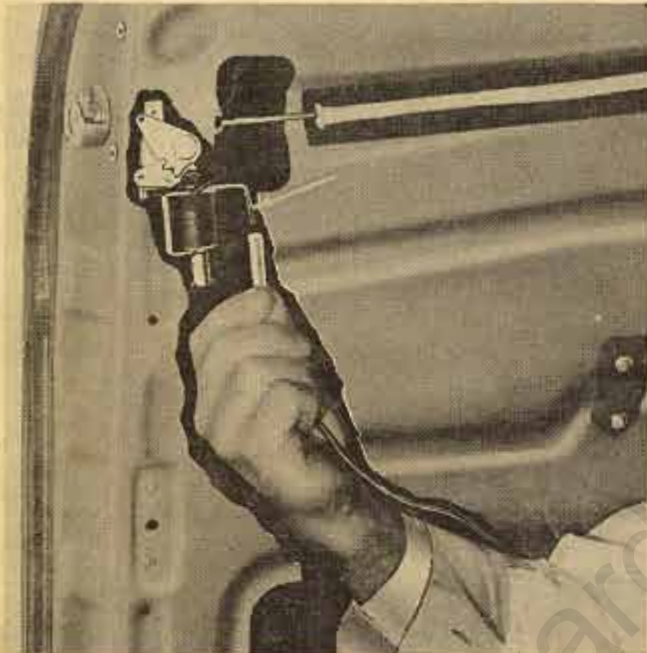
Trouble has been experienced with the wire connectors becoming disconnected from the electrical door lock units. The brass terminal on the lock unit points downward, therefore, the weight of the wire tends to pull it off of the terminal.

This condition can be corrected by bending the brass terminal on the lock unit 180 degrees upward to a vertical position or just opposite as shown in the illustration.

This is being done in production along with the installation of a wiring clip Part No. G432682 to hold the wire in position.
