PACKARD-CLIPPER DIVISION

# Counselor

VOL. 30, NO. 8

AUGUST, 1956

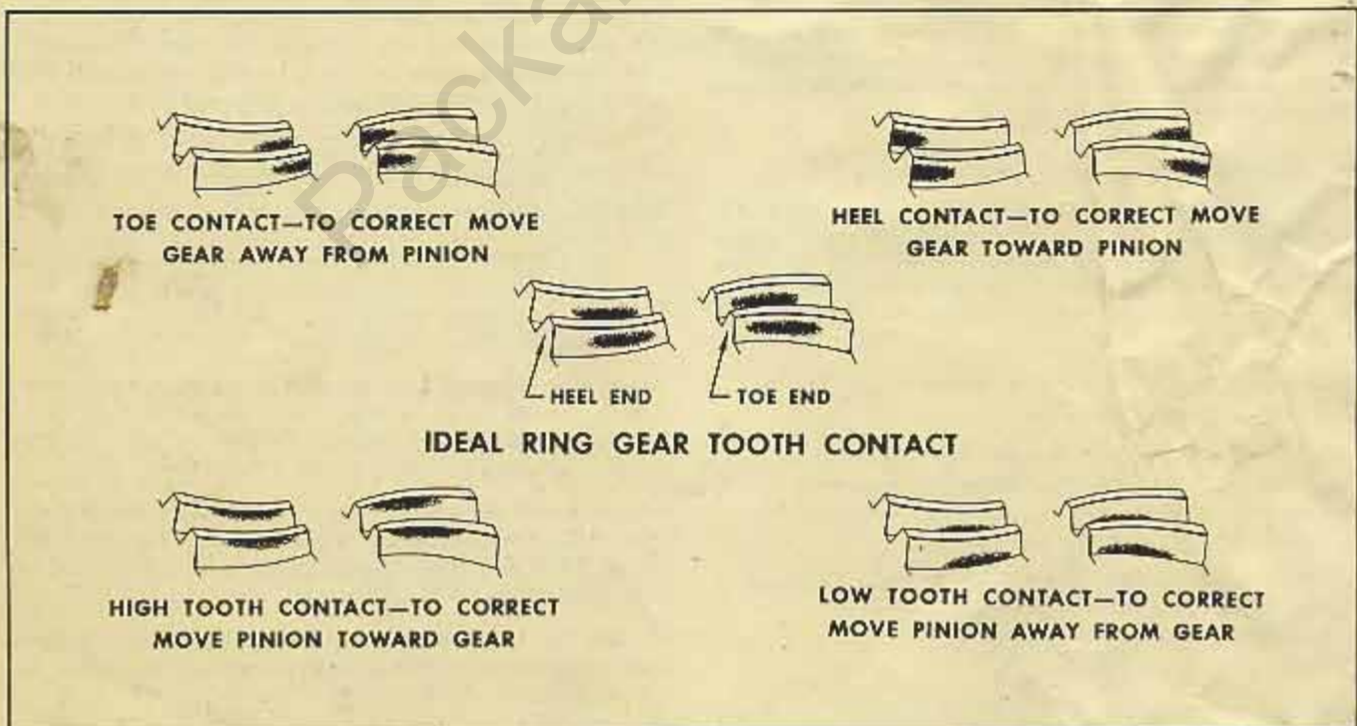
2. Wrap a rag around the U-joint flange on the pinion shaft to serve as a brake, move the painted ring gear teeth over the pinion until a good impression of the tooth contact is obtained. The impressions should be similar to the one in the center of the illustration.

rected by adjustment; examples of incorrect tooth patterns are illustrated for your ready reference:

a. To correct a short toe contact, move the ring gear away from the pinion. This will increase the lengthwise contact and move the contact area toward the heel of the tooth. This adjustment of the ring gear will also increase the backlash between the two gears; therefore, if the backlash is out of limits, move the pinion toward the gear to make the backlash correction.

b. A short heel contact can be corrected by moving the ring gear toward the pinion. Then, to make the necessary backlash adjustment, move the pinion away from the ring gear.

c. To correct a high narrow tooth contact condition, move the pinion toward the ring gear. If the backlash is out of limits, move the ring gear away from the pinion.

d. A low narrow tooth contact condition is corrected by moving the pinion away from the ring gear. If necessary to correct the backlash, move the ring gear toward the pinion.

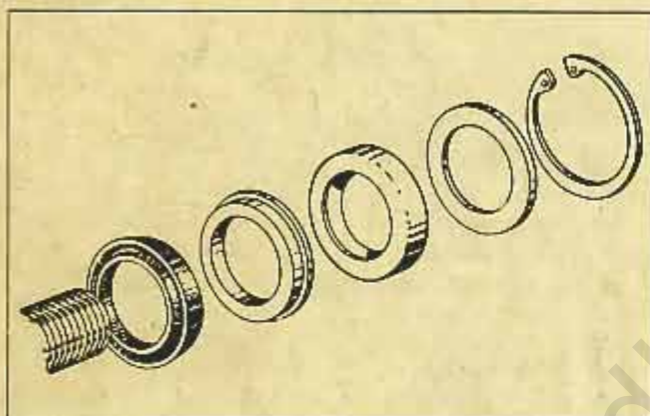
Improper installation of the Bendix Power Steering Cylinder Seal Kit Part No. 474321 will generally result in a fluid leak past the power cylinder piston rod.

The proper sequence of installation is as follows: "See illustration."

1. The Neoprene "U" cup seal is installed with the inner lip of seal toward the cylinder.
2. The seal back-up aluminum washer spacer is installed with its small flange outward from the cylinder.
3. The dust seal is installed with its inner lip outward from the cylinder.
4. The scraper washer may be installed either way.
5. The snap ring is installed with its sharpest edge outward from the cylinder, this assures positive locking of the snap ring.
