PACKARD-CLIPPER DIVISION
OF
STUDEBAKER-PACKARD CORPORATION

Counselor

VOL. 30, NO. 9

SEPTEMBER, 1956

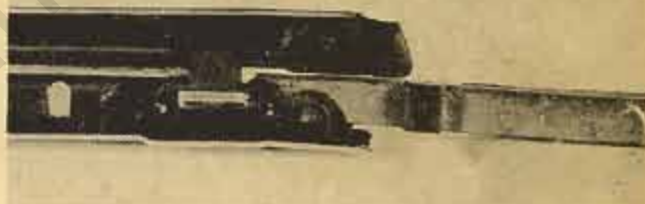
Fig. 2

2. Using a screw driver, pry up the spring at the forward end of the flipper and insert the thin end of the rubber under the spring with lip of rubber between the two halves of the flipper, see figure 2, the lip should line up with the flipper hinge pin.

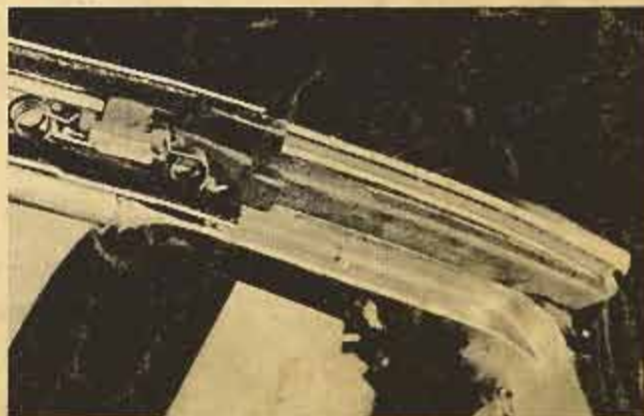
Fig. 3

5. Cut off front end and back side of rubber at the forward end so it fits properly at the windshield post weatherstrip. Figure 3.
