VOL. 10 No. 13

JULY 1, 1936

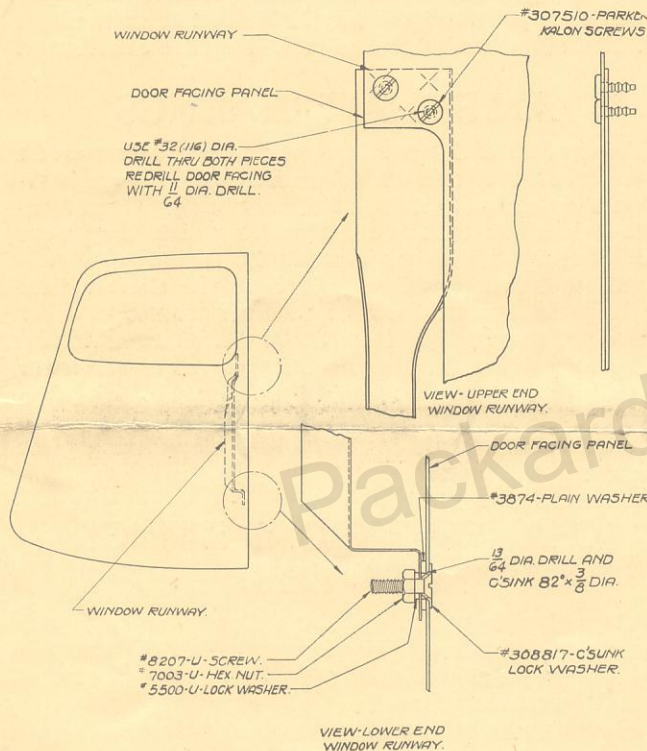
REFASTENING FRONT DOOR WINDOW RUNWAY GUIDE—120-120B

Remove garnish moulding.

Loosen lower section of door trim (not necessary to remove inside hardware).

Drill two No. 32 holes, through door facing and upper end of guide where previously spot welded, drilling from inside of window opening. Redrill door facing $\frac{11}{64}$ ". Fasten with two Parker Kalon screws, No. 307510.

In lower end drill $1\frac{13}{64}$ " hole from outside door facing through lower end of guide using countersunk bolt and nut, as shown on print. There may be some cases where it will not be necessary to fasten the lower end. If this is the case simply use the two Parker-Kalon screws in the upper end. This can be done by merely removing the garnish moulding.

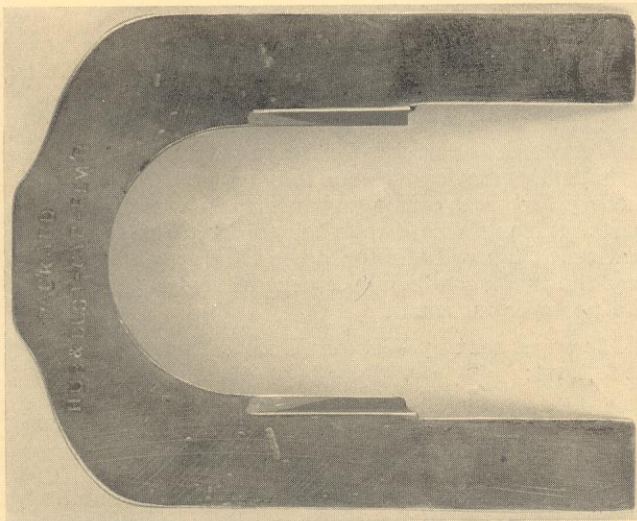
Hub Cover and Cap Remover

Awards were made to Mr. Glenn Phillips of Earle C. Anthony, Inc., Los Angeles, California, for a tool which he designed to remove the front hub caps from Models 120 and 120-B. From Mr. Phillips' idea a tool has been developed that will remove the hub cover as well as the cap.

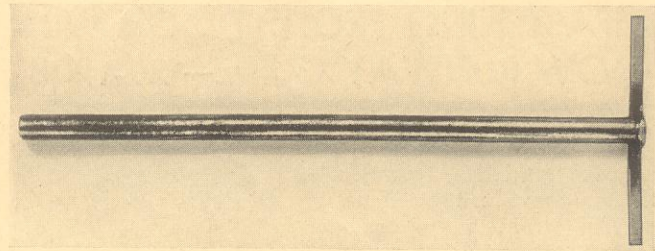
Distributor and Oil Pump Pilot

An award was also made to Mr. P. F. Laird, Shop Superintendent, Earle C. Anthony, Incorporated, Oakland, California, who comes across with an inexpensive tool for installing the 120 and 120-B oil pump. The tool consists of a long tee handled pilot having slots at either end formed to engage the slots in the drive ends of the oil pump and distributor.

When the oil pump is to be removed, turn motor to No. 1 firing position and note position of distributor rotor arm.

When replacing oil pump: 1. Turn motor to No. 1 firing position. 2. Insert tool through distributor and oil pump drive passage in motor. 3. Engage distribu-

tor drive slot with upper end of tool and oil pump drive slot with lower end of tool. 4. Turn distributor rotor to No. 1 firing position as previously noted. 5. Slip oil pump up into place engaging drive gears. 6. Check distributor to see that rotor arm is in No. 1 firing position as previously noted. If not, disengage oil pump and rotate one tooth right or left until, with oil pump gears in mesh, distributor rotor is in proper position as previously noted. 7. Bolt oil pump in place. 8. Remove distributor and tool. Replace distributor.
