## WINDOW DRAFT ELIMINATION 120 - 120B

## DISTRIBUTOR—PACKARD TWELVE

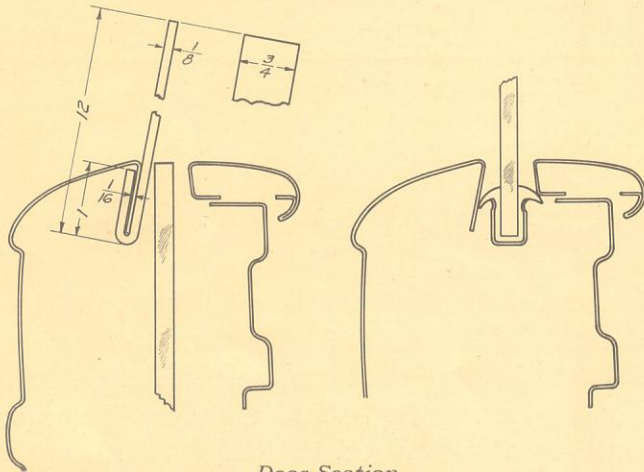
Door Section

The run-up-and-down window channels are equipped with a rubber weatherstrip on the outside edge. This weatherstrip should contact the metal weatherstrip fastened to the door when the window is in fully raised position. If a correction is necessary, it should be made by bending the metal weatherstrip.

To do this it is not necessary to disturb the door trim or glass. Make a 12-inch bending tool from a piece of strap iron  $\frac{3}{4}$ " wide,  $\frac{1}{8}$ " thick. Put a 1" lap bend on one end, leaving an opening about the thickness of the body metal. With the window in the lowest position, the tool can be inserted between the glass and the door and slipped over the ledge of the metal weatherstrip which then can be bent and shaped as required. In a few cases you may find that the channel rubber weatherstrip is short, leaving an opening at the ends. To close the opening, cut a piece of sponge rubber of suitable thickness and length and cement it to the door metal in a position which will seal the opening.

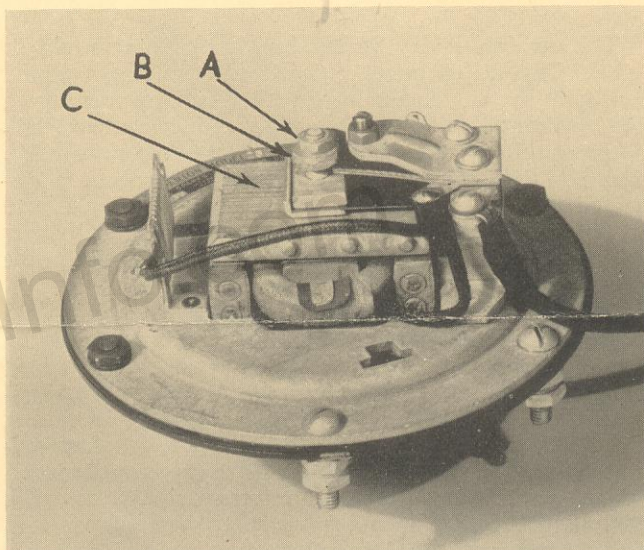
If the horn is rough and metallic in its tone, loosen lock nut "A" and turn adjusting nut "B" clockwise one-sixth of a turn or one flat on adjusting nut and lock in place with nut "A". Continue in this manner until tone is smooth and clear.

If the horn lacks volume, turn adjusting nut "B" in counter-clockwise direction. One should bear in mind when adjusting horns singly that there will not be as much sound output as when operated in pairs. This applies especially to the high-pitched horn.

Caution:—Before replacing motor cover, be sure lock nut "A" and Adjusting nut "B" are securely locked together and that resistor or coil lead wires do not rest against armature "C".
