VOL. 11 No. 4

FEBRUARY 15, 1937

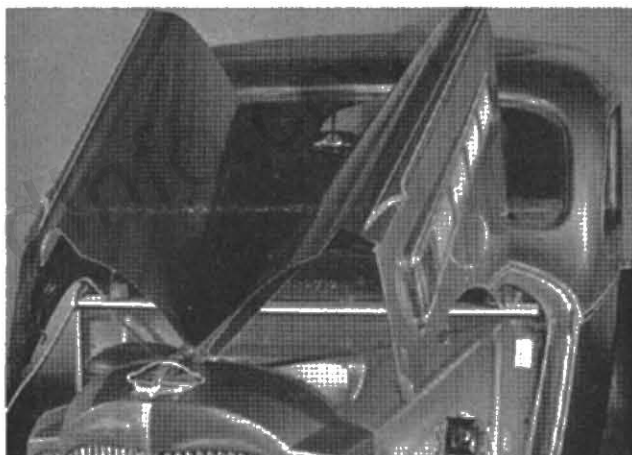
Out of a piece of box board they cut a strip 40½" long and 3" wide with an approximate thickness of ¾". When the hood is raised the board is placed crosswise on the radiator tie rods at the rear next to the body. Placing between the body edges eliminates the possibility of the board slipping endwise.

You will find that both sides of the hood can be raised and kept securely in the raised position. This gives plenty of clearance to work and is particularly handy when installing accessories such as heaters, radios, and in other service work.

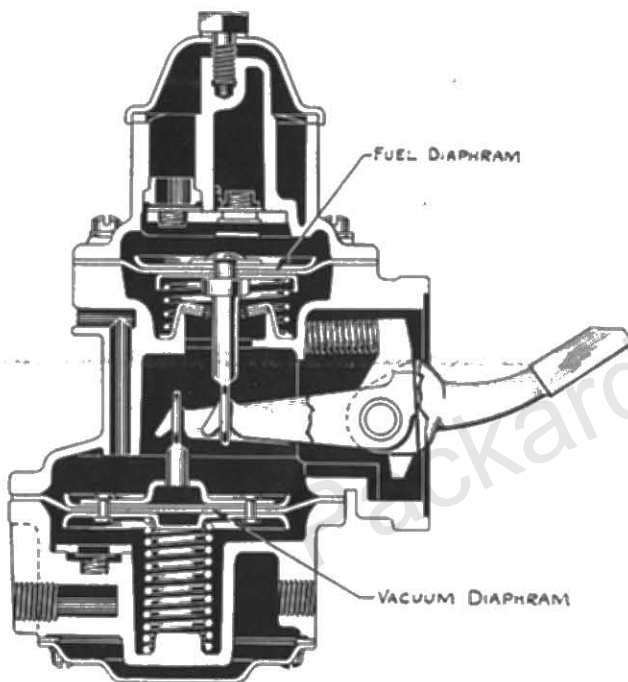
As you know, one side of the vacuum booster pump diaphragm is open to the crankcase. With one side of the diaphragm open to the crankcase and the other side exposed to the manifold vacuum, even a minute opening in the diaphragm will allow crankcase vapor and oil spray to be drawn through into the intake manifold and so on into the combustion chamber.

This source of oil loss may be difficult to locate as it is particularly heavy at high engine speeds when the crankcase vapor is heavy, and may be negligible or non-existent at low speeds. The vaporized oil being thoroughly mixed with the incoming charge to the cylinders burns completely and is not indicated by dirty or fouled plugs or smoking exhaust (except in particular and extreme cases).

In cases of excessive oil consumption the vacuum booster pump should be removed, disassembled and the diaphragm inspected for leaks before any other work is done on the engine.

Vacuum booster diaphragm failure is more prevalent on the 120 and 120-B since hot oil from the crankcase lies on the diaphragm because of its position at the bottom of the pump. You may however have diaphragm failure on the 120-C and Six. It is recommended that the diaphragm be renewed every 25,000 miles, and when doing this it is also recommended that the fuel pump diaphragm be renewed.

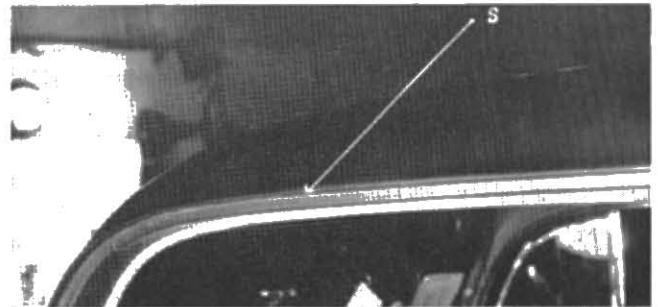
The roof rail is covered with a two-piece metal cover with an overlapping joint under the drip moulding. Water entering here at "S" will fill the header and run down the front door pillar and out at the lower corners of the windshield or it may run back toward the rear where it soaks through the trim near the top.

To seal a leak at "S" it is not necessary to remove the section. Seal the opening with a good top sealer all along both sides and a permanent cure will be effected.

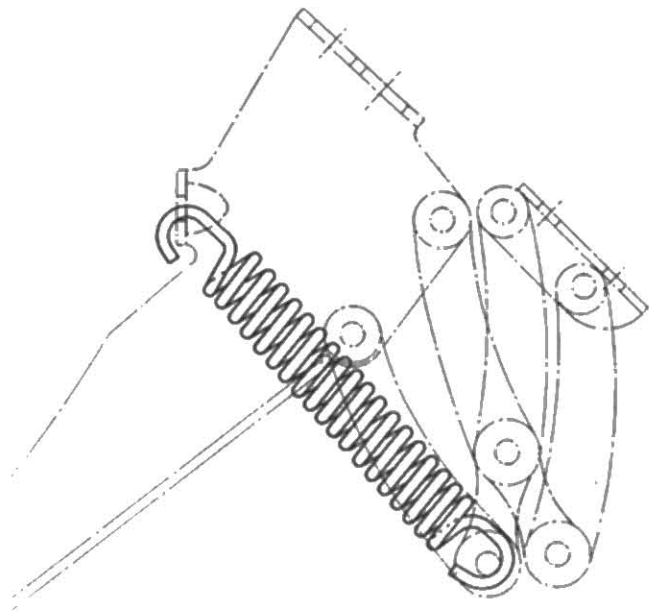
These springs must be installed correctly or failure will result. If the springs are installed with the opening in the eye up, opening the lid will throw the contact on the outer end of the eye greatly increasing the load. Repeated opening of the lid will cause the spring to break at the eye.

When the springs are installed with the opening facing down, as illustrated, the contact is kept in close to the shank of the eye, the load is much reduced and no trouble will be experienced.

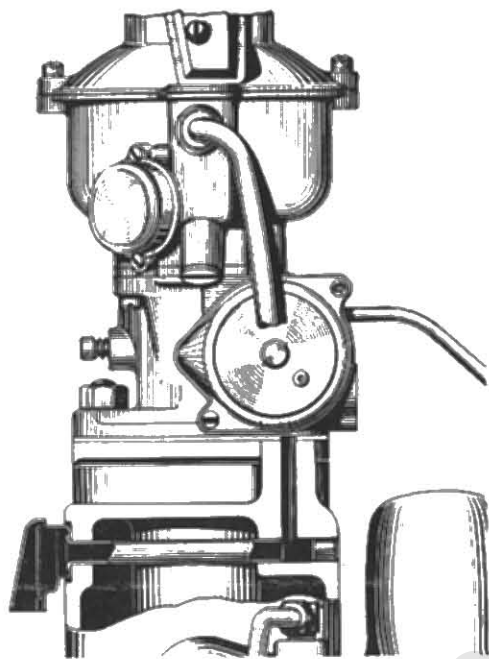
Failure of the automatic choke on the Six to come off the fast idle cam, or a slow action of the choke causing overchoking during the warm-up period may be caused by rust in the automatic choke chamber.

Rust formed by condensation accumulates on the fast idle cam cross shaft and binds it so that the light return spring cannot turn it off the fast idle position. Rust forming on the floating lever retards its free action and interferes with the free action of the choke.

This condensation may be caused by exhaust gases leaking into the automatic choke heater tube in the manifold hot spot.

When moisture and rust are found in the automatic choke chamber, examine the heat hole in the carburetor body. Moisture or carbon deposits on the walls will indicate an exhaust leak and the tube must be made tight in the manifold. In some localities, due to conditions of temperature and humidity, condensation forms in the automatic choke chamber even though there is no exhaust leak.

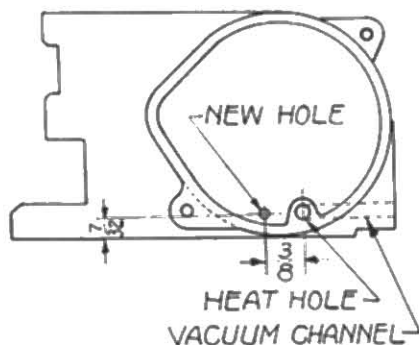
This condition is not general, but in localities where it is found it can be corrected by providing a drain hole as shown in the illustration.

Drill a No. 60 drill size hole $\frac{1}{8}$ " to the left of the heat hole and $\frac{1}{8}$ " up from the flange. Drill through from the automatic choke chamber to the vacuum channel. This will permit moisture and condensation to be drawn off, and thus prevent rusting.
