VOL. 12 No. 20

OCTOBER 15, 1938

ECONO-DRIVE CONTROL

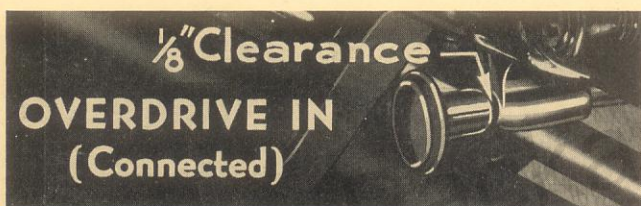
On some early production cars the cable to the Econo-Drive control knob on the instrument board was adjusted too short. All cars should be checked and adjusted when necessary before being delivered to owners or for demonstrations.

The Econo-Drive control linkage must be properly adjusted to insure full travel of the disengaging lever. If the operating cable is too short, the instrument board control knob may come up against the stop before the overdrive engaging unit is released with the result that the free wheeling unit only is engaged. Under this condition the car will be in free wheeling at all speeds and the Econo-Drive cannot be engaged.

When making the adjustment, disconnect the cable from the control lever on the right side of the Econo-Drive unit. Move the lever all the way to the rear into the engaged position. Lengthen or shorten the cable at the yoke so that when connected with the lever in the extreme rear position the instrument board control knob is $\frac{1}{8}$ " out from the stop.

Leaving clearance between the control knob and the stop, provides an extra margin of travel that will insure positive engagement.

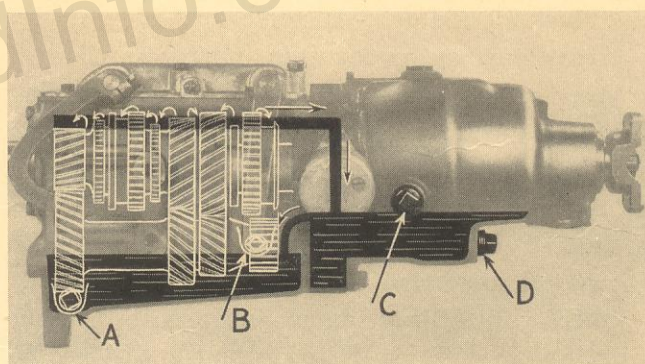
The transmission and Econo-Drive units have different oil levels, that in the Econo-Drive being higher than in the transmission. Each unit is provided with its own drain and filler plug.

The construction is such that the lubricant circulates from the transmission to the Econo-Drive and back to the transmission. In operation the transmission gears carry the lubricant up and into a trough cast inside the transmission case near the top on the left side. From the trough it drains to the rear, flowing into and across the planetary overdrive gears and down into the Econo-Drive case. The Econo-Drive case is provided with a drain hole in the right side of the front face at the lower level of the filler plug through which the lubricant drains back into the transmission to maintain the proper level in both units.

After a car has been standing, some of the oil in the Econo-Drive may work down into the transmission so the Econo-Drive level may be low and the transmission level high. This does no harm, because as soon as the motor is started the circulation of the oil will establish the proper levels. It is necessary, however, to run the motor just before checking the units in order to get the true levels.

Always check the lubricant level in both units. When filling, remove both transmission filler plug "B" on the right side and Econo-Drive filler plug "C" on the left side. Fill the Econo-Drive to the lower level of the filler plug "C" first. Allow any excess to drain into the transmission unit and then fill it to the lower level of the transmission filler plug "B".

The transmission unit is drained at plug "A", the Econo-Drive at plug "D". Both units must be drained separately as removing plug "A" will not drain the Econo-Drive unit.
