VOL. 13 No. 1

JANUARY 1, 1939

CLUTCH CHATTER

LOOSE MOTOR SNUBBER LINKS

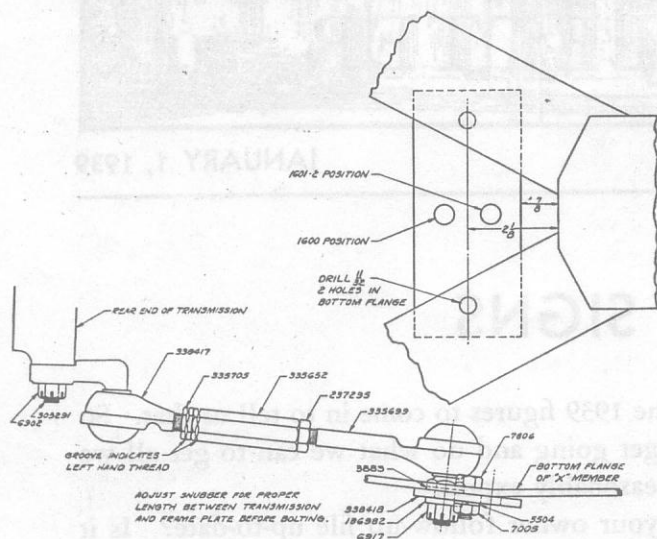
338431—Motor Snubber Equipment

A method of correcting clutch chatter in these cars was given in the July 1, 1938, Service Letter.

A new motor snubber equipment has been developed for use on these cars using the new 17th Series parts which supersede previous equipment.

In particularly bad cases or those of long standing the clutch plates may have developed radial ridges. When this has occurred, the operations just described will not overcome the chatter. A new clutch plate will be required to complete the correction.

When installing the link, attach the front end first. Then lengthen or shorten the link so that the rear connection enters the frame plate hole freely and seats squarely. It is very important that the hardened washers 3883 and 136982 be installed and the self-locking nut pulled up securely.

Putting the engine mountings under a slight tension, by lengthening the turnbuckle, may help to further dampen particularly bad cases of clutch chatter. It may be found advisable to do this under certain conditions, but it must be remembered that doing so will increase the amount of engine sensation in the driving compartment. The length of the link should not be changed from the neutral position more than $\frac{1}{8}$ inch, three turns of the turnbuckle.

As a further corrective, Silenite inserts, piece number 333746 may be used to replace the rubber inserts in the rear springs. This change of inserts will increase the static friction of the springs and help reduce the tendency to chatter.

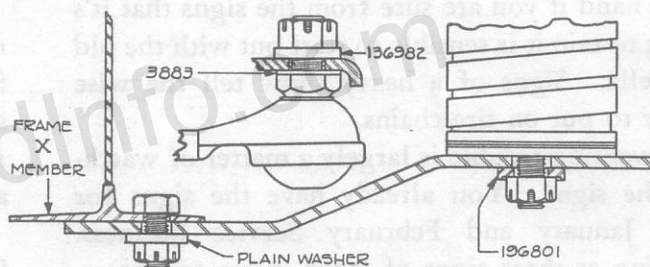
Some difficulty has been experienced with keeping the motor snubber links tight on these cars.

In some cases, on the early cars, washers may be found to have been omitted or the wrong washers used. If the proper washers are installed and the link tightened securely no further difficulty should be experienced.

A lock washer 5508 (not illustrated) should be used under the cap screw attaching the forward end of the link to the transmission. At the rear where the link attaches to the cross channel, a thin hardened washer 3883 is used on the snubber side, and a thick hardened washer 136982 is used under the Marsden self-locking nut. In some cases the washers were omitted at the rear connection, and the edges of the hex on the stud and nut cut into the cross channel, loosening the connection. Hardened washers that cannot be cut by the hex must be used and the nut tightened securely.

3883 —Washer, hardened (thin) —1 required
136982—Washer, hardened (thick)—1 required

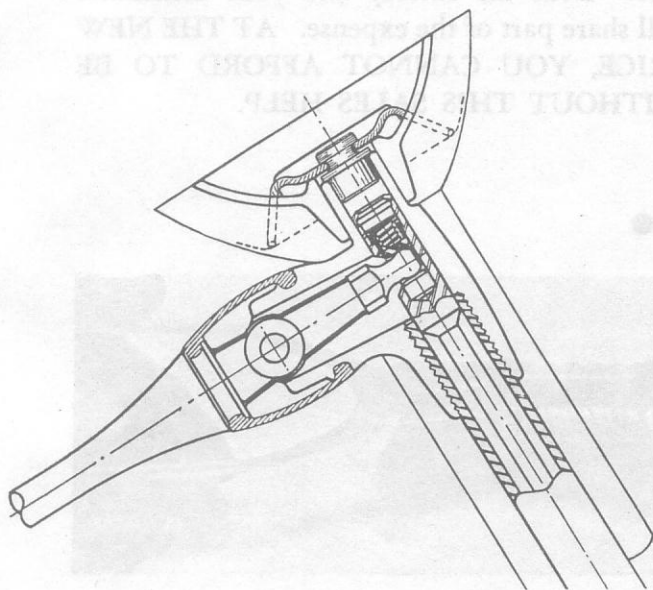
338043—Steering Column Anti-rattle Spring Plug
338044—Steering Column Anti-rattle Spring

These new parts may be installed in the earlier cars where a rattle has developed due to excessive clearance at the upper end of the gear shifter tube.

Even a slight misalignment or a close fit of the gear shifter tube in the steering wheel cup may make the shift objectionably stiff. When this condition is encountered the tube should be freed up and given about .003 inch clearance in the cup. The anti-rattle plug and spring should then be installed to prevent a rattle developing.

We have made a change in production to increase the clearance of the upper end of the gear shifter tube in the steering wheel hub cup and have added a plug and anti-rattle spring.

Remove the steering wheel and press the anti-rattle plug into the upper end of the shifter tube. Engage the spring with the groove in the plug and snap the ends in against the reinforcing wall of the steering wheel hub cup to put a tension on the tube.
