VOL. 13 No. 19

OCTOBER 1, 1939

PACKARD OWNERS ARE BEST SERVED BY PACKARD

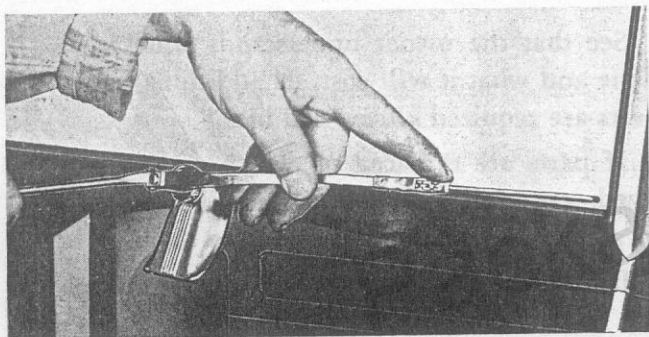
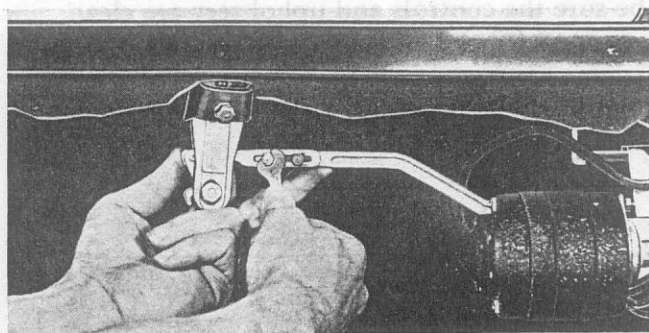
## WINDSHIELD WIPER ADJUSTMENT—1800-1-3-6

Some owners may ask to have the arc cleaned by the windshield wipers increased to provide a greater range of vision at the side. The arc of travel cannot be increased but the area cleaned may be rotated to clean farther on the outside by changing the position of the wiper arms so that they park in approximately a horizontal position rather than against the lower edge of the windshield frame.

With the blades adjusted to park in the horizontal position the arc cleaned will be extended about 21½" farther down at the sides. In this position a small portion in the center of the windshield will not be cleaned. If the parked position

of the blades is not raised much above the horizontal they will remain within the area of the windshield blocked out by the radiator and will not interfere with forward vision.

This may be done by removing the wiper arm and reinstalling in the higher position. If the location of the serrations is such that the blades cannot be made to park opposite each other the transmission link on one side may be adjusted to bring the blade into the correct position relative to the other one.

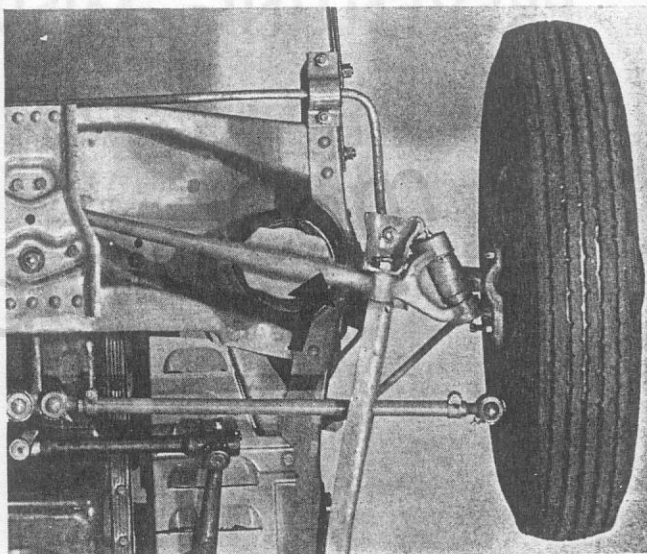
End of coil at arrow—

Squeaks and clicks in the front suspension coil springs may develop in these cars, which do not have a full circular spring pad on the lower support arm.

In this position the tapered end is held against the coil above it and cannot click against it as it may if unsupported.

This condition can usually be remedied by rotating the spring so that the tapered end of the coil is at approximately the center of the pad, directly over the support arm.

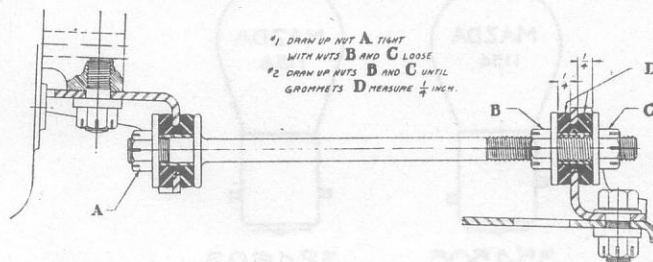
## ENGINE ROUGHNESS—18th Series

Some instances of roughness in Eighteenth series cars not equipped with Econo-Drive have been found due to improper adjustment of the engine snubber, or fore and aft stabilizer, between the rear of the transmission and the frame.

Your first step, upon a complaint of engine roughness, should be to neutralize the snubber link as follows:

1. Loosen nuts "A," "B," and "C" until snubber link and rubber grommets are entirely free.
2. Draw up "A" tight, leaving "B" and "C" loose.
3. Draw up nuts "B" and "C" until both grommets "D" are compressed to  $\frac{1}{4}$ " thickness.

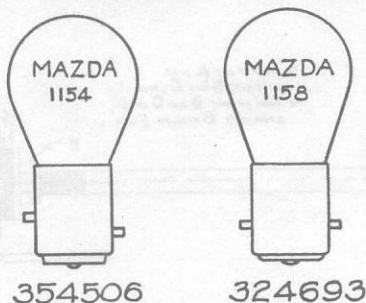
## FENDER AND TAIL LAMPS

Both the Preliminary Service Parts List and Preliminary Shop Manuals are in error in calling for Mazda 1158 bulbs in the fender lamps of 18th Series cars. These lamps require Mazda 1154 bulbs.

Both bulbs are double filament 21-3 candlepower and are the same except for the base. Mazda 1158 has common bayonet base, with the prongs directly opposite each other. Mazda 1154 has the new standard polarized base in which the prongs are offset. Needless to say, the two are not interchangeable in the same socket.

We are continuing the use of Mazda 1158 bulbs in the combination tail and stop lights for the present. This is the same bulb used in both 16th and 17th Series. In the near future, however, the socket will be changed to take the Mazda 1154 bulb.

It will, of course, be necessary for you to stock both Mazda 1158 and 1154 bulbs in order to service Sixteenth, Seventeenth and Eighteenth Series.
