VOL. 13 No. 20

OCTOBER 15, 1939

GENERATORS AND REGULATORS

18th Series

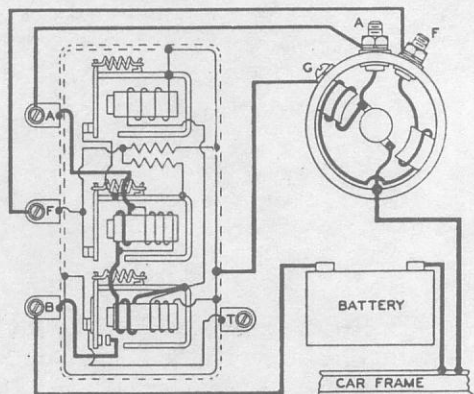
Internal Wiring VRP-4003A Generator Regulator

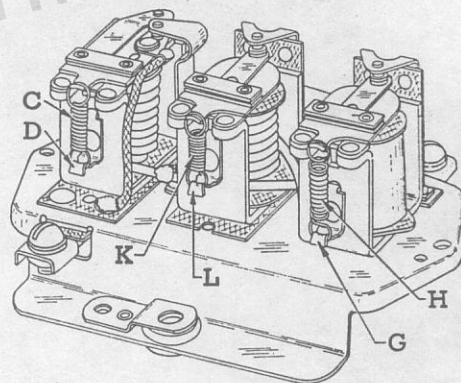
Spring Hanger "D" Controls Cut-Out Voltage
Hanger "L" Controls Generator Amperage
and Hanger "G" Charging Voltage

Adjustment of the VRP 4002A and VRP 4003A regulator used on the Eighteenth Series cars is the same as shown for the 1939 Super Eight unit VRB 4012A on page 95 of the 1938-39 Shop Manual except that the specifications shown below should be followed.

Voltage unit armature air gap .048" to .052".

Operating voltage 7.36 to 7.66 volts.

Current unit armature air gap .034" to .038".

Operating amperage 34 to 36.

Cut-out points open at 6 amps. max. discharge.

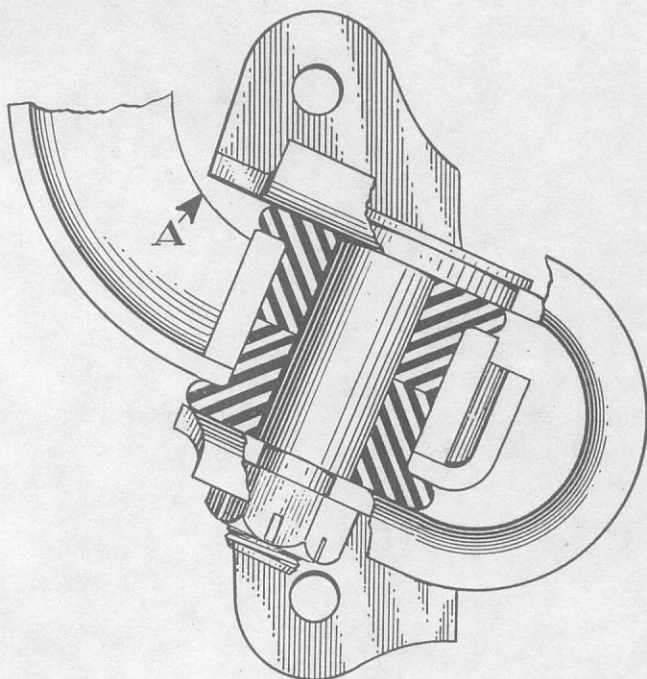
If you have cars with a squeak or rattle in the front suspension, check to see that there is clearance at "A" between the rear of the torque arm and the bracket throughout the full arc of torque arm travel and that the nut is drawn up tight.

The sides of the bracket must be parallel. If they are not, straighten them before assembling the torque arm. Nonparallel bracket sides put an uneven compression on the rubber bushings and cause them to wear rapidly.

If the torque arm should be found to interfere with the bracket, it should be filed or ground until $\frac{1}{8}$ " clearance is provided.

When reinstalling the torque arm pull the nut up until the bracket bottoms on the shoulder of

the bolt, and tighten the nut securely to be sure that it is locked.

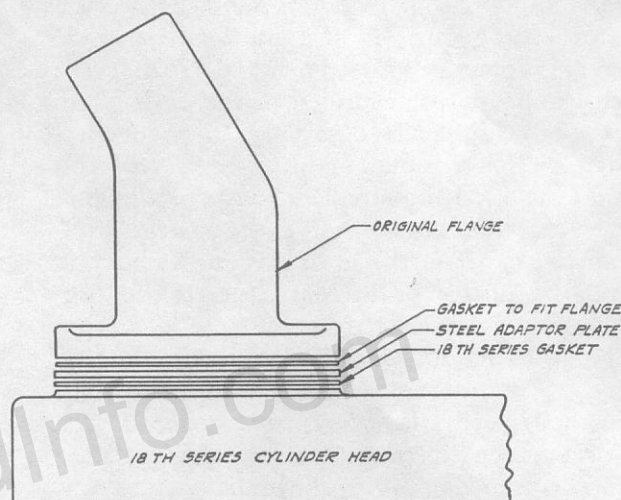
At present, we are shipping 18th series heads for all Junior model cars. Heads shipped on order for 120-120B are tapped for 14 mm. spark plugs. All others are tapped for 10 mm.

These heads are shipped without water outlet flanges. An adapter plate and two gaskets are

shipped with each head to permit the use of the original outlet flange when the head is used on engines previous to the 18th series.
