## DO YOU KNOW THE ANSWERS?

## REAR BEARING OIL SEAL

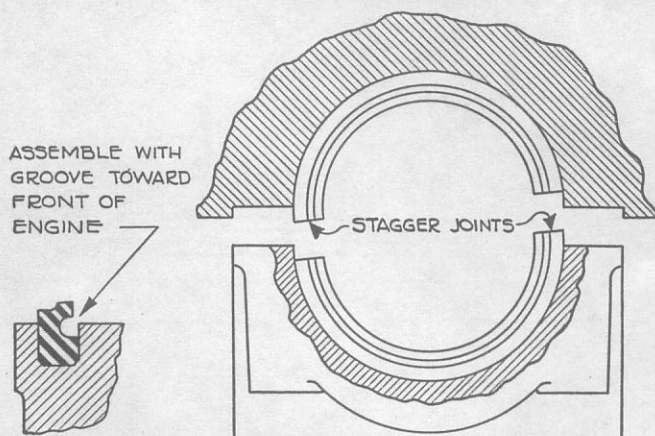
An improved all composition crankshaft rear main bearing oil seal went into production, replacing the metal and composition oil seal, starting with engine 501484-A.

An oil leak at the rear main bearing will let oil get into the clutch housing and will be indicated by oil dripping from the clutch housing drain. If the oil gets on the clutch-driven plate it will be indicated by a transmission jazz due to loss of friction in the clutch damper friction washers or clutch grab due to oil on the lining. In either case a new clutch plate should be installed and all the oil washed out of the clutch housing.

When the seal is seated the groove in the forward face is partially covered as shown in the illustration at the top. The upper half seal may be seated by placing a jack under the crankshaft and forcing it up into place.

The new seal is interchangeable with the old and should be installed in engines previous to this number when trouble is experienced with oil leakage at the rear main bearing. Only the new oil seal piece 354629 will be supplied by the Service Stores Division. This piece number covers only one half of the seal and two will be required to make an installation.

When the clutch and transmission have been removed for the installation of a clutch plate the new seals may be installed without removing the crankshaft, using the following procedure:

Remove the oil pan and all connecting rod caps. Then take off the center main bearing cap and push out the upper half of the bearing so that the thrust sides of the bearing will not bind and prevent lowering the shaft.

Now remove the other main bearing caps and lower the crankshaft to the point where it is supported by the timing chain at the front and by the flywheel cocking in the flywheel housing at the rear. In this position the oil seal may be pried out.

When installing the new oil seal place the grooved face toward the front of the engine and let one end of the upper half extend into the bearing cap about one-quarter inch so as to stagger the joints in the seal in relation to the joints in the bearing and cap. Be very careful to see that the stagger of the seal is exactly the same in the upper and lower half. If it is not it will cause the seal to bulge and bind the crankshaft.

Before finally putting the crankshaft up in place the inner surfaces of the seal that contact the crankshaft should be thoroughly coated with Lubriplate.

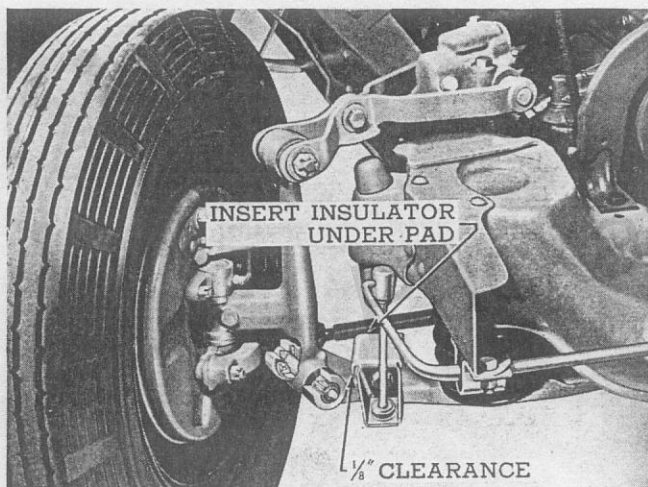
You may find cars upon which the front springs strike through with what may best be described as a crash. In most such cases it will be found that the compression bumper pad, which is formed as part of the roll control bar attaching bracket, gives under the impact of the bumper enough so that it strikes against the torque arm. The procedure in such cases is to place a pad of woven brake lining  $\frac{3}{16}$  inch thick by 2 inches square under the pad to support it and act as an insulator.

This may be done by disconnecting the roll control bar, loosening the bolts holding the bracket and inserting the insulator under the pad. The bolt holes in the bracket are elongated so it will not be necessary to remove the bolts to raise the bracket. The bolts should then be tightened just enough to hold the bracket and prevent its bouncing back while the bracket is being tapped down to compress and hold the pad.

Before finally tightening the bolts check to see that there is at least  $\frac{1}{8}$  inch clearance between the outer side of the bracket and the wheel support arm. Grind off the bracket if necessary to provide clearances.
