VOL. 13 No. 22

NOVEMBER 15, 1939

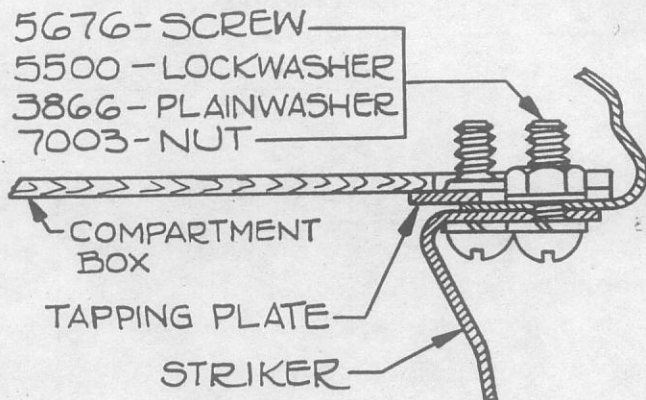
INSTRUMENT BOARD COMPARTMENT DOOR

We have recently made a change in production and are now using a knob type lock and a stiffer striker plate on the instrument board compartment door. On cars fitted with the flush-type lock where you are troubled with the door popping open, rattling, or failing to spring open when the catch is released, installation of the new striker only will usually correct the trouble. The installation can be made in a few minutes.

The new striker is assembled to the under side of the instrument panel flange with three screws. The center screw goes through the flange and is fastened with a nut, lock and plain washer. The two outside screws do not go through the flange and are threaded into the tapping plate which is inserted between the box and the upper side of the flange.

The six screws holding the compartment box can be removed and the box pushed forward to provide room to place and hold the center nut.
