WHEEL FIGHT—1801

CARBURETION—1803-8

TRANSMISSION JAZZ—1801

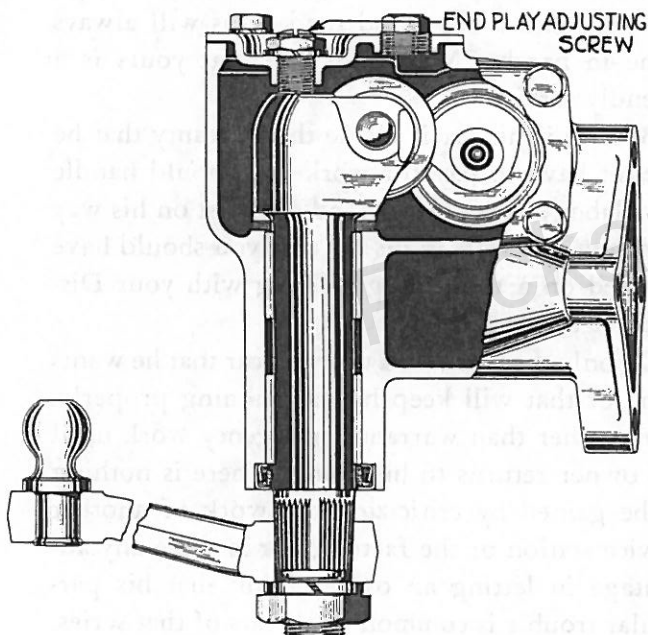
The first step in correcting Wheel Fight should be to carefully adjust the steering gear for "Up-and-Down Play," "Cross Shaft End Play" and "Roller Mesh" as described in the Shop Manual. If excessive "Cross Shaft End Play" is found in the eighteenth series cars it will probably be due to the cross shaft adjusting screw having worn a groove or recess in the end of the cross shaft.

On the early eighteenth series cars a steel cross shaft adjusting screw was used. Later in production the material in the screw was changed to brass to reduce the wear on the cross shaft. When adjusting for "Cross Shaft End Play" the adjusting screw should be inspected and steel screws replaced with the new brass screw. The new screws are carried in service stock under original piece number 213315. When installing the new screw the outside corner of the contact surface should be rounded slightly with a file to insure its fitting into the recess in the cross shaft.

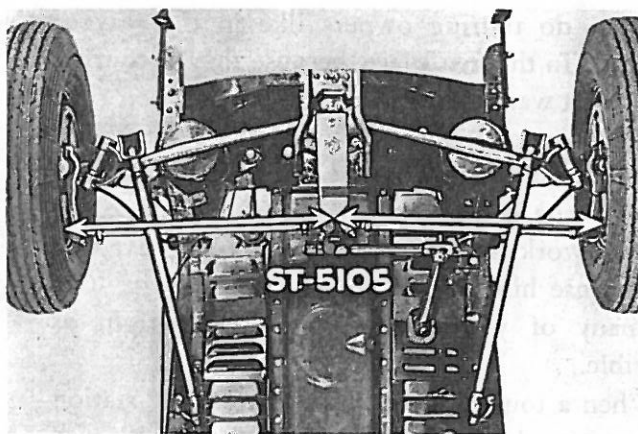
Moving the steering crank in this manner will throw the wheels off the straight-ahead position

and they must be relocated and the toe-in checked and reset. Install the Steering Crank Aligning Gauge ST 5105 in the frame cross channel under the steering crank. The point of the gauge indicates the center line of the car. Adjust the cross tube until the distance from the center of the

gauge to the brake backing plate is the same on each side.

When this is done it will then be necessary to readjust the toe-in. Use Toe-In Gauge ST 128 and adjust by turning each cross tube an equal amount so that the total toe-in will be as equally divided as possible between the two wheels.

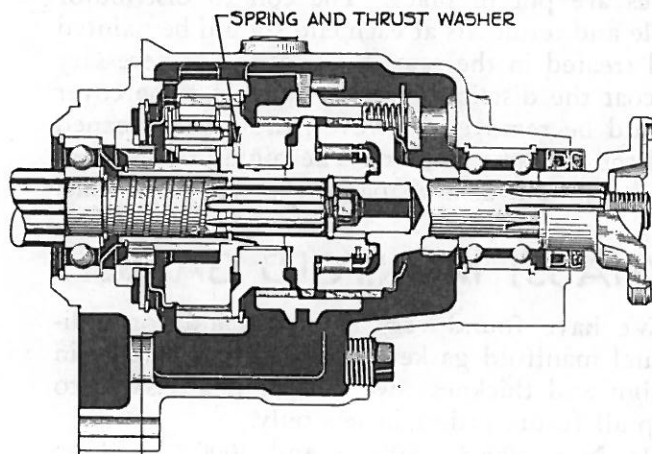
You may have had some complaint, particularly on the 1801, of a rattle or buzz that is heard on pickup at about 20 to 30 m.p.h. Although this noise is a low pitched rattle and sounds much like a loose muffler, it actually is in the transmission and Econo-Drive. It is caused by a natural engine period which sets the transmission and Econo-Drive gears to rattling.

Third: Install spring-loaded Econo-Drive clutch thrust washer. This washer is used to replace the solid bronze thrust washer between the planetary pinion cage and the ring gear hub.

To install it, disassemble the Econo-Drive and replace the original thrust washer with the new

thinner washer and spring. Coat both thoroughly with transmission oil and install the spring first with the cupped surface toward the rear of the car and the machined face of the thrust washer away from the spring. When assembling the ring gear and over-running clutch cam, be careful not to jar the spring and washer off the shoulder on the pinion cage. Pull the screw up slowly and turn the assembly occasionally to make sure the spring and washer remain in place. 362821 Over-drive clutch thrust washer, front. 362822 Over-drive clutch thrust washer front spring. These will be available about the second week of June.
