1. Description of Issue & Service Letter guidance
2. Parts List observations
3. Rebuild notes and photos
4. Additional Assembly Information

1: Description of Issue

Packard acknowledged an issue of a driveline vibration that occurred in 1940 R9 overdrive equipped vehicles, observed only when the overdrive system is active. The excerpt from the letter, below, offers four options to address the vibration, each of which focuses on causes from within the overdrive unit itself. While Packard designed and built its own transmissions, the overdrive unit was designed and manufactured by Borg Warner, as were the prior R6 overdrive for 1939, the R11 overdrive from mid 1948 on and versions used by many of the other car manufactures. Although Packard's first assumption of cause of the issue was directed at the overdrive unit, ultimately Packard identified the cause to be within its own transmission as the explanations below will show.

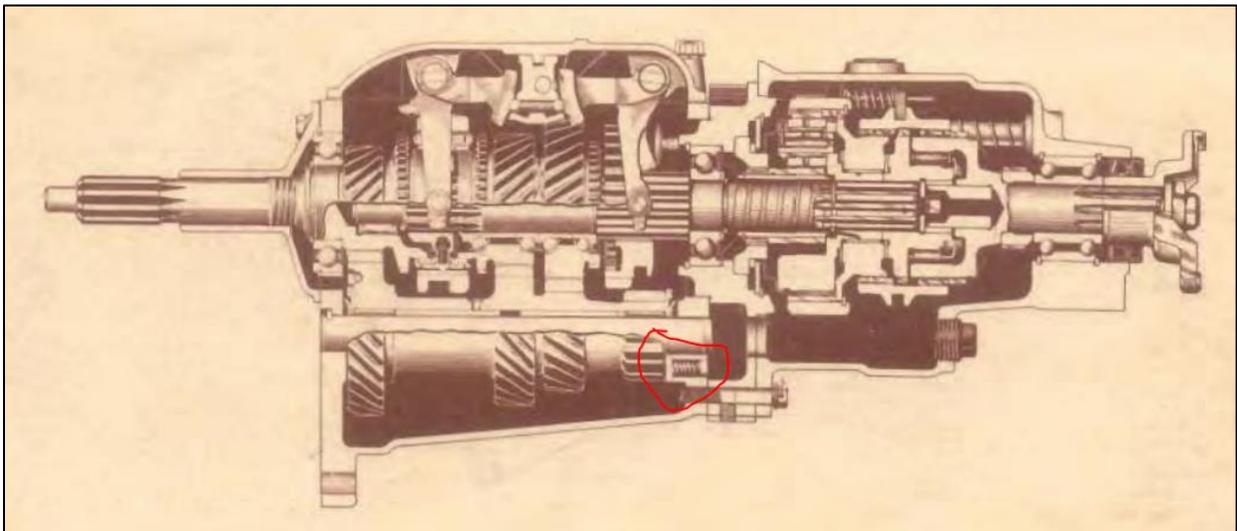
Figure 3: 1941 - mid 1948 Trans & OD with thrust springs

What is not listed in the Service Letters beyond the one above, as far I can tell, is that Packard addressed the issue in future model years by changing the transmission itself, not the overdrive. Specifically, Packard implemented a design change to address vibration coming from the cluster gear, which when the transmission is in direct drive (aka "3rd" or "high" gear) is spinning but not carrying any torque to drive the car. In mechanical engineering, this is a perfect kinematic situation to allow for vibration. So, for the 41-47 (and through mid-48), the function of the transmission countershaft thrust bearings was supplemented by the addition of two small coil springs acting on the backside of the rear thrust bearings, held in place by pressed plugs, as shown in Figure 3 and Figure 4 below. Note that some diagrams of the non overdrive transmission show a cross section of the cap screw that holds the reverse idler gear shaft in place; this can be visually confused as the thrust spring and plug.

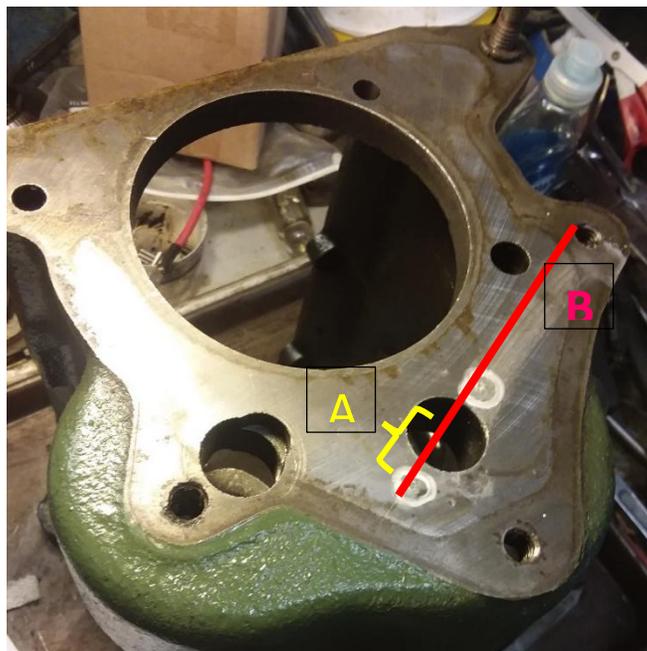
Figure 10: 1940 333463 case, marked for modification

The information from the 35-41 and 41-47 Packard Parts Lists leads to the conclusion that the superseded case 333463 can be modified to accommodate the thrust springs 330087 and plugs 367794, becoming equivalent to 367590 case having the factory design change. Figure 10 shows the 1940 333463 case, marked for drill locations. The centerline of each hole is $13/16$ th" (0.8125 in) from the centerline of the countershaft as shown by the dimension A. The two holes are in line with the countershaft hole as shown by line B, but there is no direct reference feature on the original casting 367590 from which to establish line B other than the edge of the mounting hole at the top of line B. There is a margin for error regarding the location of the holes about the shaft, which can be assessed by judging the thrust surface inside the transmission. The two holes were drilled progressively until the final drill size W, equivalent to 0.386". This size will allow for a press fit of the plug. The two holes were also beveled on both the outside and inside to allow for easy insertion of the plugs and to prevent sharp edges contacting the thrust bearings.

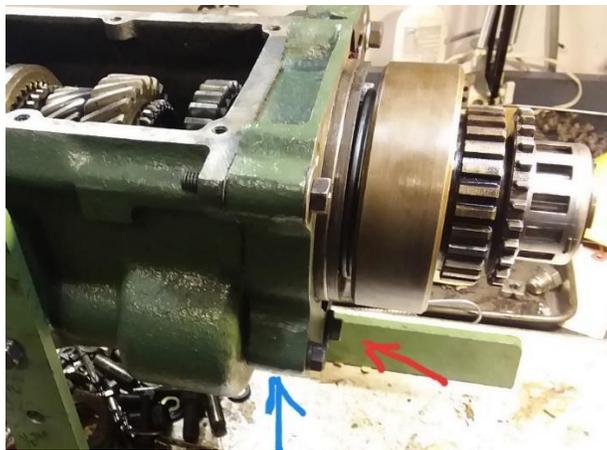
Figure 12: Transmission with Adapter Plate prior to Spring and Plug insertion and Overdrive Housing attachment

Figure 12 shows the transmission case with overdrive adapter plate (blue arrow) attached and the access location through the adapter plate for installation of the thrust springs and plugs (red arrow) and Figure 13. The reason for this, as the transmission assembly procedure explains, is that the cluster gear and its thrust washers and bearings must be placed into the bottom of the transmission case, below the shaft centerline, to allow a clear path for the front clutch shaft and rear main shaft gears to be moved into position. Once these two are in place, the cluster gear is lifted into its final place and its drive shaft driven into place. After this step is confirmed and adapter plate attached, the springs and plugs are installed through the rear.

Although the existing transmission and overdrive assembly procedures are readily available and very good, it is worth noting here that the thrust springs and plugs are not to be assembled into the holes until after the counter gear, thrust washers and shaft are in their final installed positions. An attempt to install them prior will prevent the counter gear and thrust bearings to move into their proper positions. Further, the input clutch shaft and rear transmission main shaft with adapter plate must be in place prior to the springs and plugs.

Drive the countershaft into position in the case while holding and guiding the aligning bar out through the hole in the rear of the case. Install the countershaft thrust springs and drive in the thrust spring plugs deep enough so they will not protrude.
