VOL. 14 No. 2

JANUARY 15, 1940

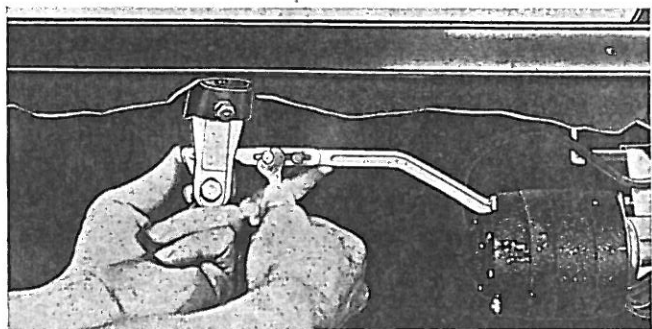
WINDSHIELD WIPERS

1800-1-3-6

Some owners may wish to have the arc cleaned by the windshield wipers raised to provide greater vision at the top and sides. This may be done by installing 10" wiper blades and reversing the parking cam in the wiper mechanism so that the blades will park in the outside position.

In order to reverse the cam, the motor and wiper mechanism must be removed from the car. File off the riveted over end of the cam drive shaft and pry the cam off the end of the shaft. Lift the cam as squarely as possible, being careful not to damage the serrations on the end of the shaft.

Having removed the cam and motor links, file off the riveted over end of the motor link pin and drive it out of the cam. Reassemble the motor links and washers on the pin in exactly their original position and install the pin again on the opposite side of the cam. Secure the pin in place by staking the end securely with a center punch.

When replacing the cam on the shaft, the links should be on the outside, away from the motor as before. Be careful that the links are in their proper position with the long link on the motor side. Place the cam on the serrations on the shaft in a position so that the corner of the cam diagonally opposite the pin has just closed the switch in the dynamic breaker. In this position, press the cam down to a solid seat on the shaft. Now rest the die cast gear housing squarely on a solid support and stake the end of the shaft to hold the cam in place.
