LOCKING IN GEAR

ALL 18th and 19th SERIES

SUGGESTIONS OR QUESTIONS ARE ALWAYS WELCOME. ADDRESS—EDITOR PACKARD SERVICE LETTER

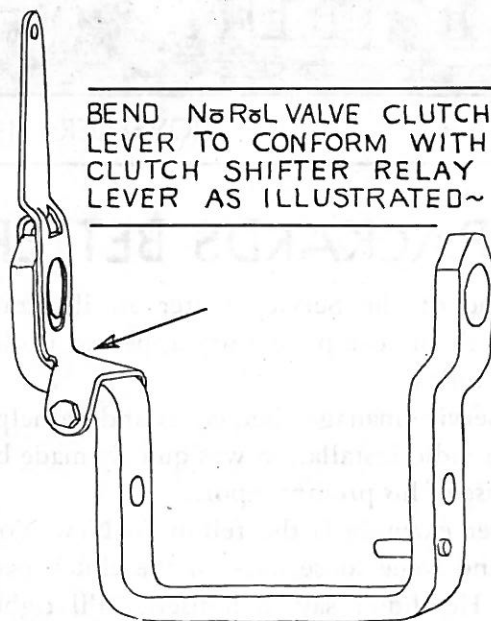
When installing the PA-338013 NoRoI on a 1900-1 model car, it is necessary to bend the "control valve" clutch lever. This is a simple operation and can be done by following the attached drawing. We suggest that this work be done on the bench before the unit is installed.

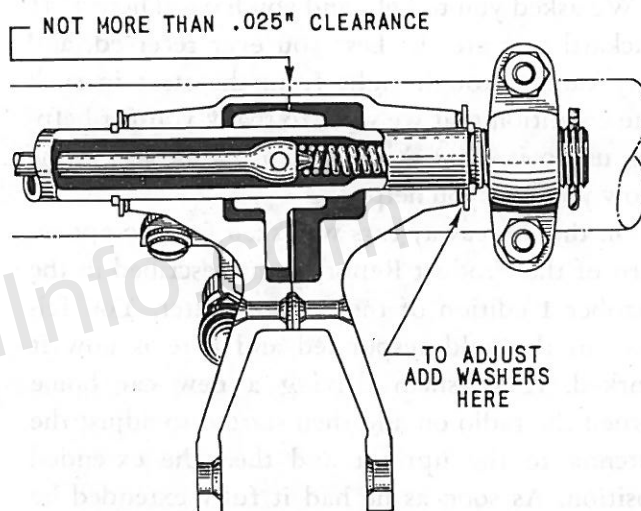
Some cases have been reported in both Eighteenth and Nineteenth Series cars of the transmission gears remaining in low after the gear-shifter lever has been moved to the neutral position. This condition is caused by excessive slack in the gear-shifter linkage and failure to disengage the clutch fully before shifting. Under this combination of conditions the finger in the steering column gear shifter levers reaches the neutral position before the transmission gears are entirely out of mesh and the drive on the gears due to the clutch not

being fully disengaged, pulls the gears back into mesh.

Check the clearance between the steering column gear-shifter levers at "A" by prying them apart with a screw driver. There should not be more than .025" clearance. If more is found, it should be taken up by installing an additional washer at "B" between the spring and horseshoe retaining washer next to the first and reverse lever.

A number of steering column gear-shifter levers are being returned to the factory with the notation "excessive wear." In only a very few of the levers returned is there sufficient wear to justify these returns. The only two places that wear can occur are in the selector finger slot and on the flat surface where the levers bear against each other.

When this happens it is necessary to raise the bonnet and move the first and reverse shifter lever to the neutral position by hand before the gears can be shifted. This is only a temporary repair, however, and the condition should be corrected by adjustment of the shifter linkage.

Excessive clutch pedal free travel makes it necessary to depress the pedal farther before the clutch is fully released. The first step then would be to check the clutch pedal and adjust it to not more than $1\frac{1}{2}$ inches free travel.

Take up all slack in the linkage by adjusting the turnbuckles in the usual way except that the rods should be adjusted $\frac{1}{16}$ " to $\frac{1}{8}$ " short so that when connected there will be a slight tension on the linkage.

There must be some clearance in the selector finger slot. A considerable amount of wear can be compensated for in the adjustment of the steering column lever to bellcrank rods. Wear on the flat faces of the levers results in excess clearance between the levers which can be corrected by installing washers as previously described.

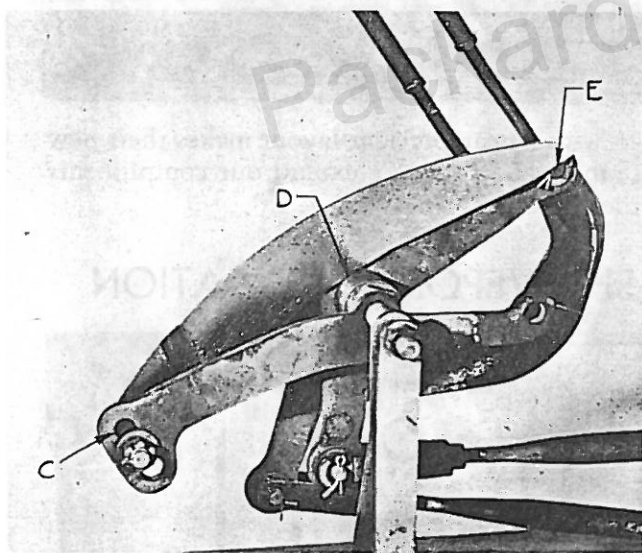
The second and high gear assist spring is linked to the second and high idler lever in such a way that when shifting into either second or high the spring is thrown off center and pulls in the direction of the shift.

In order for the spring to give equal assistance in both second and high gear the spring must be so adjusted that in the neutral position the center of the assist spring anchor "C" is in line with the center of the idler lever bearing "D" and the hole "E" in the end of the lever.

The use of Steering Aligning Gauge ST5105 will greatly simplify this operation. When making the adjustment first take all slack out of the link-

age by adjusting the turnbuckles in the steering column to idler lever rods. Then place the gauge ST5105 so that it rests on the second and high idler lever at "D" and "E" and adjust the anchor pin in the slot until it contacts the gauge at "C."

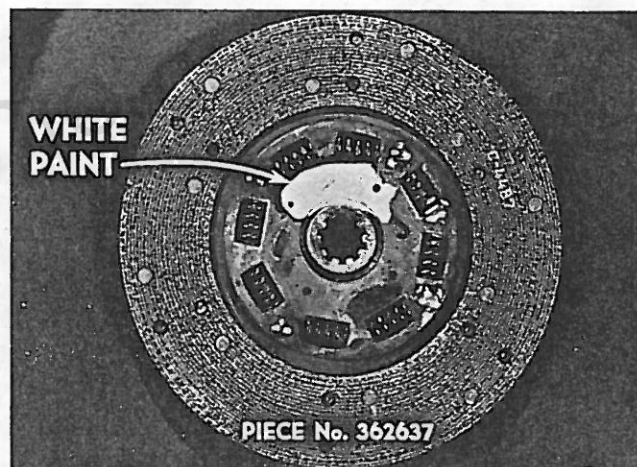
For 1801-1901 Aero-Drive equipped cars only.

Starting with the Eighteenth Series One-Ten and One-Twenty we have specified a higher clutch plate friction lag for Aero-Drive equipped cars than for standard cars. The high and low friction lag plates are carried under different piece numbers and are identified by paint marks on the hub.

Due to some confusion here in the factory and in the field we have recently changed the color of the identifying markings of the plates for the non-Aero-Drive equipped cars from yellow to blue. The white marking of the Aero-Drive plates remains unchanged.

There was some error in the original marking of clutch plates and now with this change in marking we suggest that in order to avoid confusion, all clutch plates in distributor and dealer stocks be checked against the piece number and re-marked according to the above table.

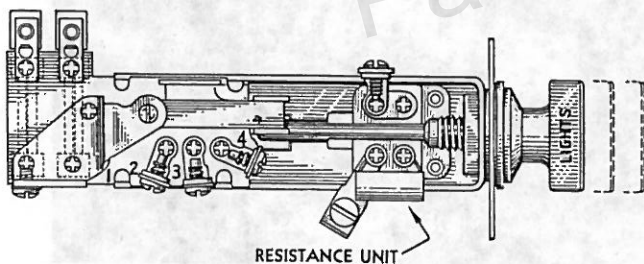
If you find cars in which the Aero-Drive indicator light in the speedometer dial burns all the time, the trouble will usually be found in the headlight switch.

On Aero-Drive equipped cars there is a resistance unit and switch set in the frame of the light switch near where it is attached to the instrument board. Pulling the switch knob out to the "On" position operates the resistance switch cutting in the resistance, thus dimming the signal light whenever the headlights are on.

When the Aero-Drive signal light burns all the time it will usually be found that the resistance unit has been bent out of place and one of the bare wires at the end touches the frame of the switch or some other ground, completing the circuit and causing the light to burn.

The correction, of course, is to line up the resistor so the wires no longer make contact with a ground.
