VOL. 14 No. 23

DECEMBER 1, 1940

IGNITION CUT-OUT

18th and 19th SERIES

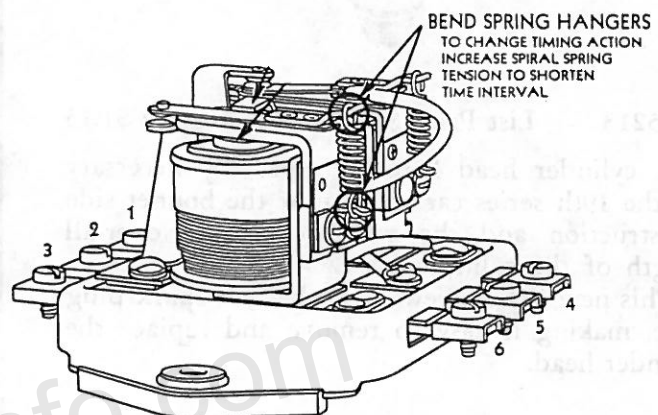
Some servicemen are having trouble locating the cause of an ignition cut-out when decelerating in Aero-Drive.

This condition which was covered in the February 1, 1940, Service Letter, is due to improperly adjusted Aero-Drive relay point and is experienced when decelerating through the cut-out speed.

A check for this condition can be very quickly made by removing the Aero-Drive relay cover and operating the relay points by hand.

When the upper points are closed and then released, the lower points should open a split second later. During the split second between the opening of the upper and lower points, the ignition is grounded to permit withdrawal of the pawl when the solenoid is de-energized by opening of the lower set of relay points.

If the lower points fail to open, the ignition will remain grounded until the car is brought to a stop or the clutch is disengaged which releases the pawl re-establishing the ignition.

If the lower points fail to open, the spring pressure should be increased by bending the lower spring hanger down slightly. It is very important that the spring pressure is not increased too much and that there is a noticeable time delay between the opening of the upper and lower points to provide the momentary grounding of the ignition necessary for the operation of the kick-down feature.

Bend the spring hanger only a little at a time and repeat the check after each adjustment. If the lower points fail to open, it will kill the engine. If the upper and lower points open at the same time, it will be impossible to operate the kick-down feature.
