VOL. 14 No. 3

FEBRUARY 1, 1940

## IGNITION CUT-OUT

## — IMPORTANT — IGNITION BREAKER POINTS 1800

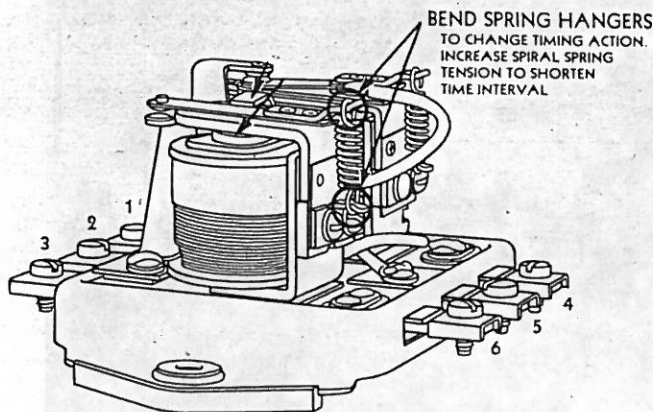
You may have some Econo-Drive equipped cars in which the ignition cuts out and the engine stops when decelerating in Econo-Drive.

This condition may be caused by improper adjustment of the Econo-Drive relay, which is mounted on the front of the dash.

A quick check of the relay may be made by holding the points on the upper coil closed with your finger. This will cause the lower points to close.

When the upper points are released, the lower points should open a split second later. If the lower points fail to open, the spring pressure should be increased by bending the lower spring hanger.

Repeat the above check each time after adjusting the spring hanger. It is important that there be a noticeable time delay between the opening of the upper and lower sets of points. If the points open together it will be impossible to operate the kickdown feature of the Econo-Drive.
