ARE PACKARD SERVICE COSTS HIGH?

January 31, 1940, Vol. 6, No. 12. Take the flat hours of each item shown for each car and multiply it by the hourly rate charge prevailing in your city. To this figure add the material price shown.

WEATHER CONDITIONED CARS

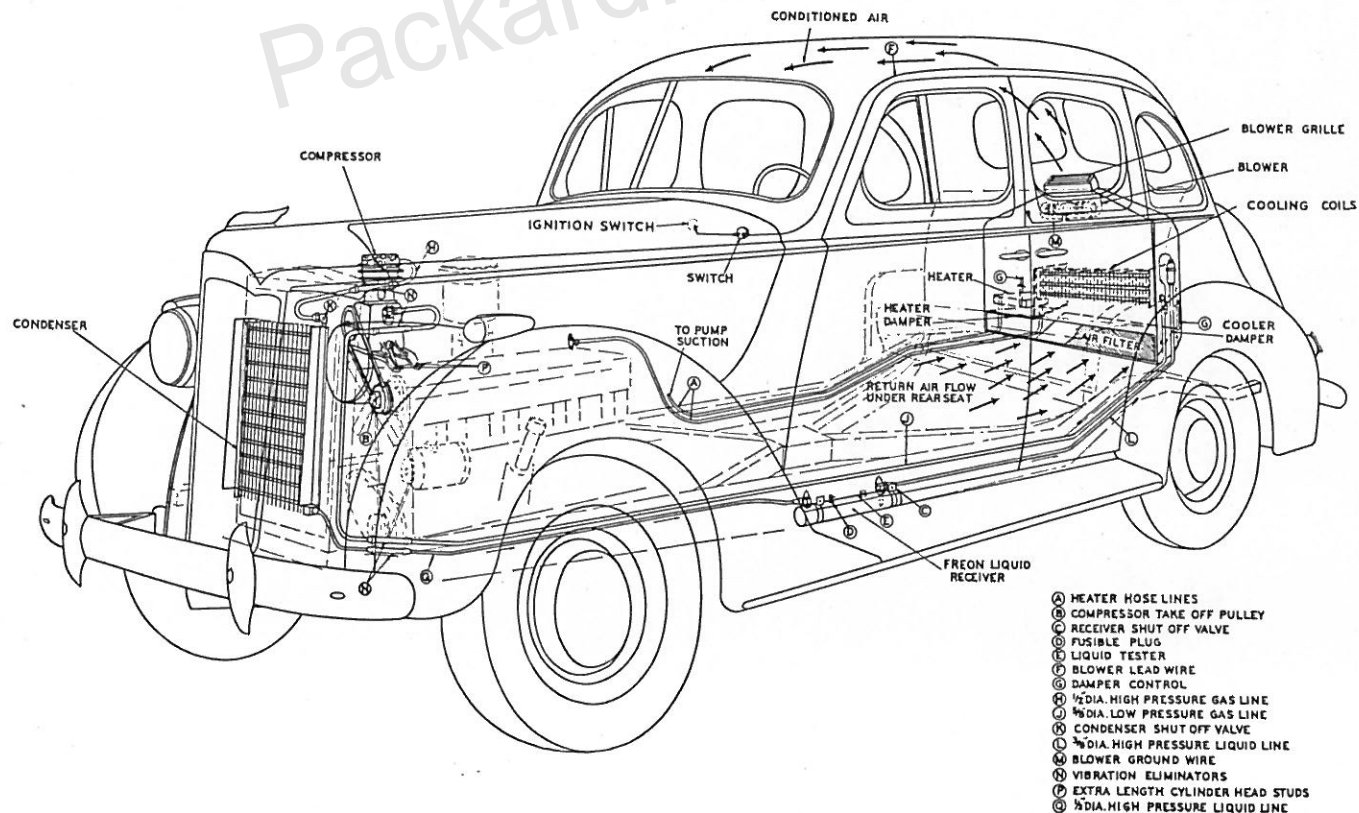
Unless you have had special instruction and training, no attempt should be made to service the Weather Conditioner. The cooling system operates on the same principle as the ordinary electric household refrigerator. If service is required, a good refrigeration man should be called in. He will have the necessary gauges and equipment to enable him to quickly make any necessary adjustments. The service manual placed in the glove compartment of each Weather Conditioned car or the illustration of the installation, will enable him to locate the various parts and points of adjustment.

The refrigerant which provides the cooling effect circulates in the cooling system under high pressure. When working on a car equipped with the Packard Weather Conditioner, do not disconnect any of the piping or open or close any of the valves. To do so may permit the gas to escape and the cooling system will fail to operate.

If it should be necessary to remove the cylinder head of a Weather Conditioned car, *do not disconnect the compressor tubing*. The compressor should be unbolted from the base, a rope tied around the body of the cylinder and the compressor swung around out of the way and hung from the radiator tie rod. Be careful not to twist or strain the flexible connections. This might cause a leak which will permit the refrigerant to escape.

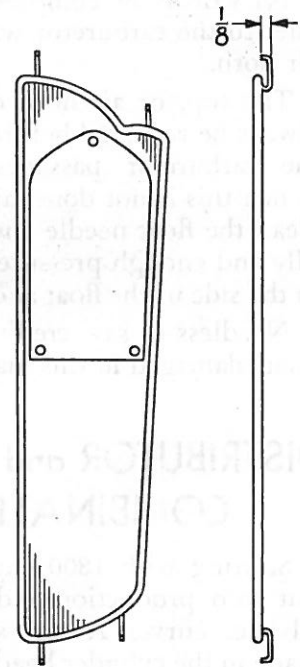
WINTERFRONT—INSTALLATION IMPROVEMENT—18th SERIES

It has been found that the Fabric Winterfronts, PA 351294, may be attached to the radiator grille more securely if the ends of the attaching bars are bent back to form a hook. Installation is made by bowing the winterfront as formerly, but when installed the hooks catch on the edge of the grille frame, holding the winterfront securely in place.

The ends of the eight attaching bars should be bent, with a pair of pliers, to form a right hook of approximately $\frac{1}{8}$ " as shown.

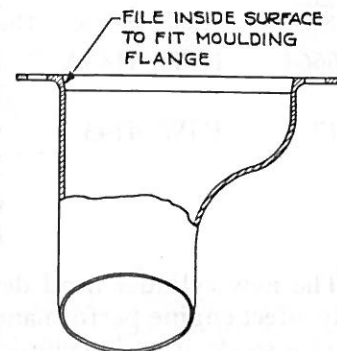
DEFROSTER NOZZLE FIT

We recently changed the defroster nozzle to a die casting instead of a stamping. We now find that, due to the variation in the windshield moulding, in some cases the nozzle will not fit over the flange of this moulding. To secure a satisfactory fit, you may find it necessary to file out the casting slightly. Unless this casting fits up over the windshield flange, it will cut down the efficiency of the defroster considerably. Therefore, it is important that the casting be made to fit properly.
