VOL. 15 No. 5

MARCH 1, 1941

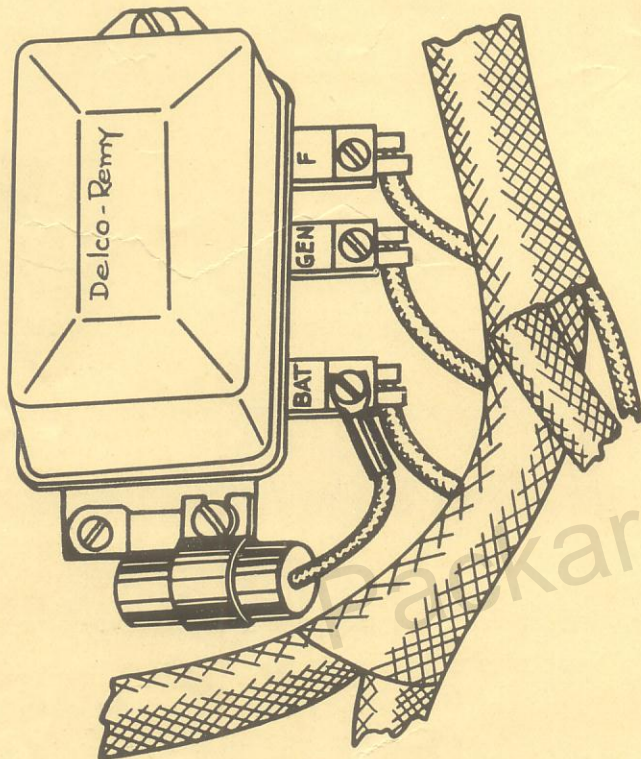
Some cars are equipped with Delco-Remy voltage regulators. In this case attach and connect the condenser as shown in the illustration.

On cars equipped with Short Wave Tuning Unit PA-371926 with Auto Lite voltage regulators, attach and connect the condenser as shown in Figure 6 on the instruction sheet included with each Tuning Unit.

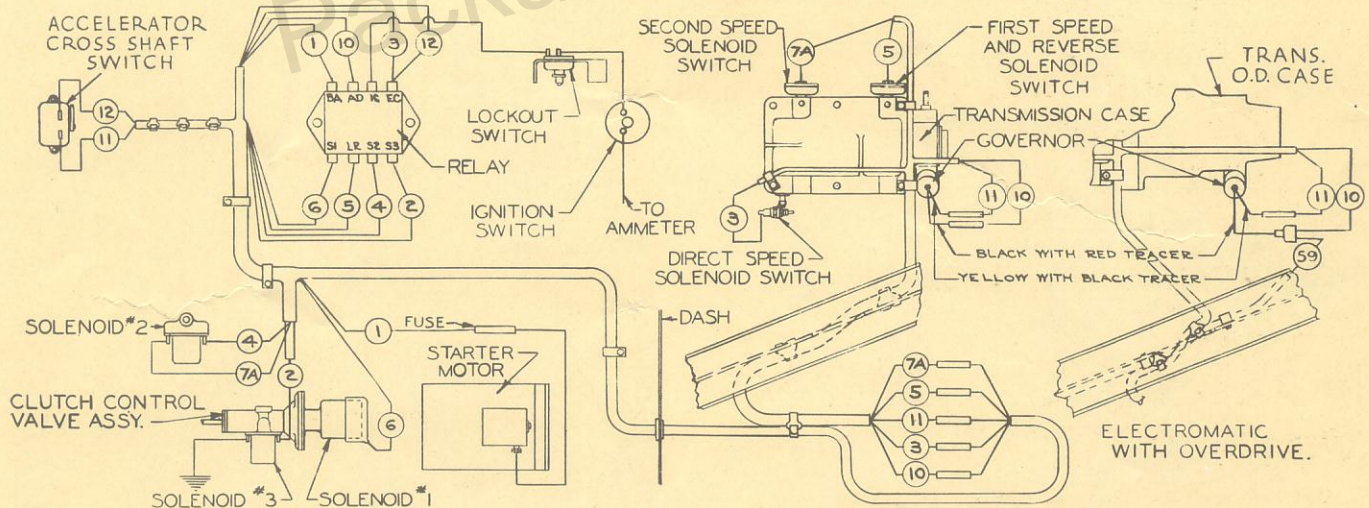
It has just come to our attention that some cars have been shipped with the Electromatic Clutch incorrectly wired, so there is a constant drain on the battery.

When the black (No. 10) and green (No. 11) wires are reversed, it will allow enough current to pass through the Electromatic relay to discharge the battery when the car is placed in storage or is not operated for several days.

The red wire from the Electromatic relay IG terminal to the ignition switch should be connected to the cold side of the switch. If it is connected to the hot side, the direct speed solenoid will be energized, even with the ignition switch off. This will, of course, discharge the battery.

The green wire (No. 11) should be connected to the yellow with black tracer wire. The black wire (No. 10) should be connected to the black with red tracer wire. On Aero-Drive cars, the black with red tracer wire (No. 59) from the kickdown switch to the governor is also connected to black with red tracer wire from the governor through a three-way connector.

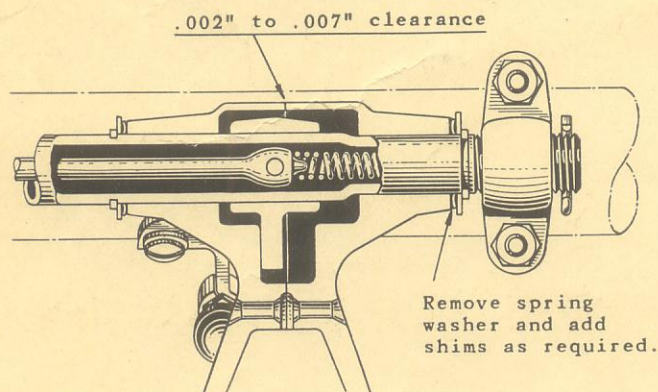
In the November 1, 1940, Service Letter, we described the conditions causing the transmission gears to remain in low after the gear shifter lever has been moved to the neutral position.

We recently made a change in production, removing the spring washer at the lower end of the steering column gear shift lever assembly and installing shims to control the clearance. We recommend this change be made in addition to the adjustments outlined previously when correcting a condition of locking in gear. The shims should be selected to give a clearance of .002" to .007" between the levers.
