GAS LINE INTERFERENCE

SERVICING FIFTH SHOCK

HANDISHIFT LINKAGE

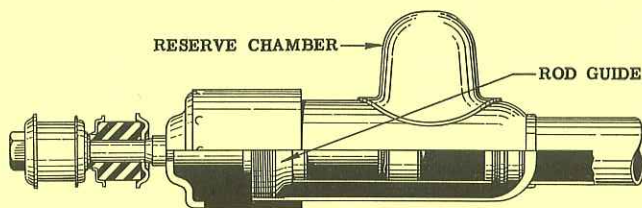
Mount Fifth Shock in vise horizontally with reserve dome pointing up. Compress and extend the shock absorber, noting particularly any lag or free play which might be present. If functioning properly there will be no free play and considerable resistance, more on the extension stroke than the compression stroke.

If any lag or free play is present, check position of rod guide. Wrench slots in rod guide should be located at 45° to reserve chamber dome so as to place an air vent groove at uppermost point of pressure chamber.

If free play continues, after locating rod guide properly, replace rod guide and seal assembly and refill shock absorber with 3¾ ounces, plus ¼ ounce, minus nothing. Note: Fluid capacity of 3¼ ounces given in film, "Servicing the Packard Clipper," has been increased. 3¾ ounces, plus ¼, minus nothing applies to all direct-acting fifth shock absorbers.

Reassemble using regular direct-acting shock absorber procedure, taking care, however, that rod guide wrench slots are at 45° to reserve chamber dome after tightening the rod guide.

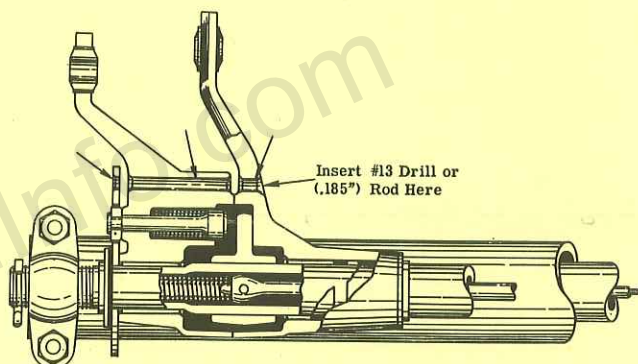
In some of the early Clippers you may find that when shifting out of first gear, the Handishift lever will drop into neutral before the low gear is out of mesh. This is similar to the sticking in gear experienced in other cars with Handishift when wear develops in the linkage. It is less serious in one respect, however, as in the Clipper the Handishift lever can be put back in first speed to pick up the gear and make the shift without lifting the bonnet and centering the levers.

This condition can be corrected by accurately aligning the Handishift linkage. On the 1951 there is a stamped plate directly below the lower of the two steering column gear shift levers. The hole in this plate must line up with the hole through the levers when the levers are in the neutral position.

When adjusting the linkage, disconnect the rods from the levers and insert a No. 13 drill or a piece of .185-inch rod through the levers and the stamped plate to hold all three in line. Put the transmission gears in neutral and, with the pin still in place through the levers, adjust the turnbuckles so that the ends of the rods will slip into the holes in the ends of the steering column gear shift levers freely.

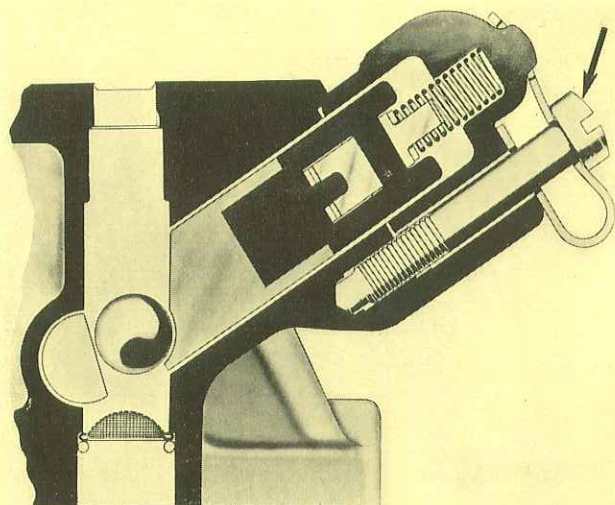
If you should find a case in which the starter does not turn the engine over when the accelerator is depressed, check the car-starter switch located on the side of the carburetor.

The car-starter switch is held in position by a screw which holds a clamp against the terminal cap. If this screw is loose, when the accelerator is opened the ball will lift the entire switch assembly and fail to close the contact points.

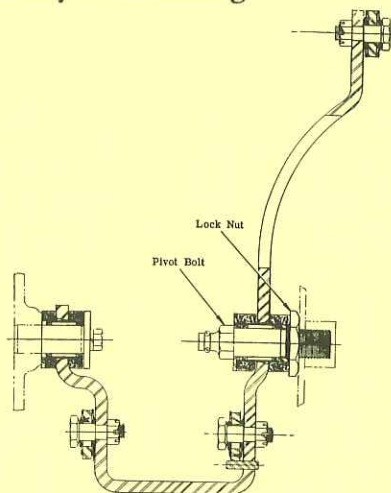
A squeak in the clutch relay lever, which may be thought to come from the control valve, or slow sticky operation of the clutch throwout mechanism may be due to incorrect adjustment of the clutch relay lever bearings.

On Model 1900 and 1901 cars equipped with Electromatic, the clutch relay lever is carried on roller bearings. At the frame side the bearing is carried on a bolt threaded into a boss on the frame

and locked with a lock nut. If the bolt is threaded too far into the frame boss, the roller bearing will be locked between the bolt head and nut so the relay lever will turn on the bearing rather than with the bearing on the bolt.

When a misadjustment of the bearing is suspected all connecting linkage should be disconnected from the relay lever and the action tried by hand. If the action is too stiff, loosen the lock nut and back out the bolt approximately $\frac{1}{4}$ turn and retighten lock nut. Try action of lever again. Continue repositioning lock nut until free action is secured.
