### WINTER LETTER

## ELECTROMATIC CLUTCH VALVE ADJUSTMENT

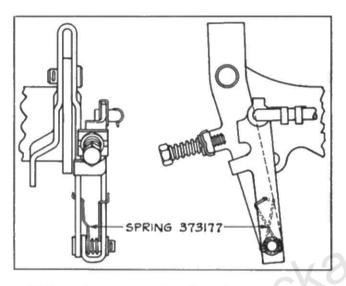
The illustration shows the levers at the forward end of the control valve. It also shows the small wire spring which surrounds the pin and bears against the two levers. The purpose of this spring is to push the spool rod linkage back toward the valve unit so as to remove the slack from the spool rod operation.

This spring was omitted on the control valve assembly of a number of the Clipper models which were electromatic equipped. It is not necessary to the operation of the electromatic but we believe that it is helpful in cases where the car has been in operation long enough to develop lost motion in the linkage.

We suggest, therefore, that if you find an electromatic which is not easy to adjust or one which loses its adjustment, you see whether the spring is in place. If not, it can easily be installed by pulling the cotter pin and slipping the control lever off the clevis pin. The spring is:

#### 373177—Electromatic valve linkage spring.
