VOL. 4 No. 8

APRIL 15, 1930

Servicing Values

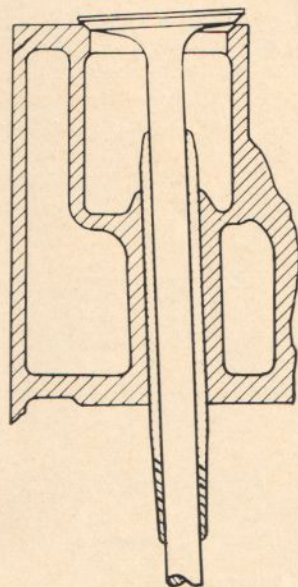
Figure One

We grind valves in an attempt, in too many cases a futile one, to restore the alignment that the valves had when first assembled. The attempt fails because the valve seat is no longer concentric or at right angles to the guide and the valve cannot find a perfect seat.

This sometimes causes the valve stem guide to warp or shift position slightly so that it is no longer in proper alignment with the valve seat. (Fig. 1.)

The blame is not confined alone to the guide, although with its long area exposed to the great heat of the exhaust it is more subject to warpage than the valve seat which is cooled by the water in the water jacket.

If left, however, the raised edge of the valve (Fig. 1) is exposed to the direct heat of

the explosion which will burn both the seat and the valve—the hot flames beating directly on the exposed valve stem will warp it causing worn guides and stuck valves. (Fig. 2.)

A badly burned valve seat cannot always be repaired without bringing the seat too low in the block for efficient operation. Blocks with the seats in this condition will be refused for credit by the factory when returned for credit on the reground basis.

Showing, in an exaggerated condition, the valve resting on the edges of the seat, due to warpage of the valve guide and block by the seasoning process.

After the first 1000 or 1500 miles this seasoning process is completed and if the seat is then recut so that it is again concentric and at right angles to the guide regardless of the top face of the block, it will remain so during the life of the car and will require very little attention.

To correct these evils, the valves should be resealed and refaced. By reseating with the proper method, the seats are made concentric and at right angles to the new position of the guide and the valve is trued up so that it will find a full seat at all motor speeds without having to take the second movement just described, with the resultant noise.

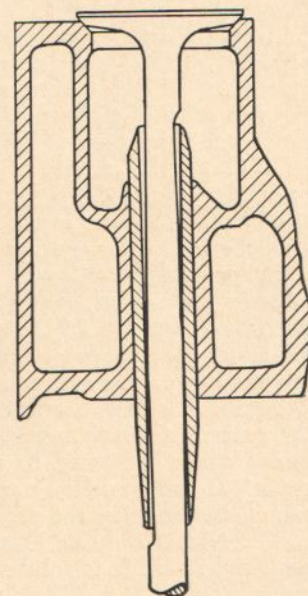
Figure Two

Valve seats not concentric with the guides are also responsible for noisy tappets. In those cases where the tappets are noisy and adjusting them even closer than the prescribed .004" does not correct the fault can almost invariably be traced to this cause. When operating at low speeds, the spring brings the valve to its seat where one side strikes first, (Fig. 1.) During the moment that the valve is on its seat, the tension of the spring causes the valve to make a second movement on the seat which closes the valve, slapping the face against the seat and the stem against the sides of the guide. (Fig. 2.)

It is this second movement that causes the noise which defies adjustment.

In addition to the tappet noise, so-called, it also has a tendency to pound out the seat, wear the valve stem on alternate sides at the top and bottom part of the travel and wear the valve guide egg-shaped.

Showing an exaggerated condition of valve stem and guide wear, the result of the valve spring cocking the valve stem with a second motion after it has found its seat.

that there is not time for the valve to take the second movement and it remains open on one side burning the valve and valve seat.

After 1000 to 1500 miles of operation, the seasoning process is completed and the valves may now be resealed with the assurance that they will remain in line. After having once been resealed the valves need not be disturbed again for many miles more than was previously thought necessary. It may be necessary to clean the carbon more often, but the valves should not be disturbed as long as compression is maintained.

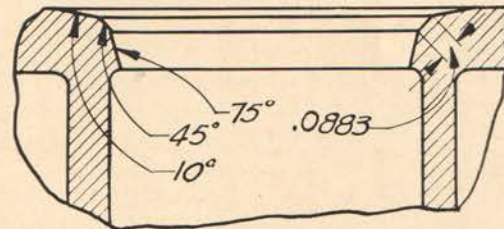
Figure Four
Typical valve seat showing two narrowing cuts
and the proper width of valve seat .0883 in.

The best procedure is to first use the 45 degree notched tooth cutter "F" taking one very light cut to break the scale. Follow up with the 75 degree throat cutter "G" cutting just enough to show a thin mark around the entire line of the seat. The seat should next be narrowed to .0883" using the 10 degree top face cutter "H". Finish up with one very light cut with the 45 degree smooth cutter "I" to put a finished surface on the valve seat.

The valves should now be refaced and reinstalled without grinding. To grind the valve now would be to undo all the good that has been done. Grinding a valve even with a screw driver and using a light pressure will shift the valve in the seat and put it out of line.
