VOL. 5 NO. 5

MARCH 1, 1931

Oil Consumption

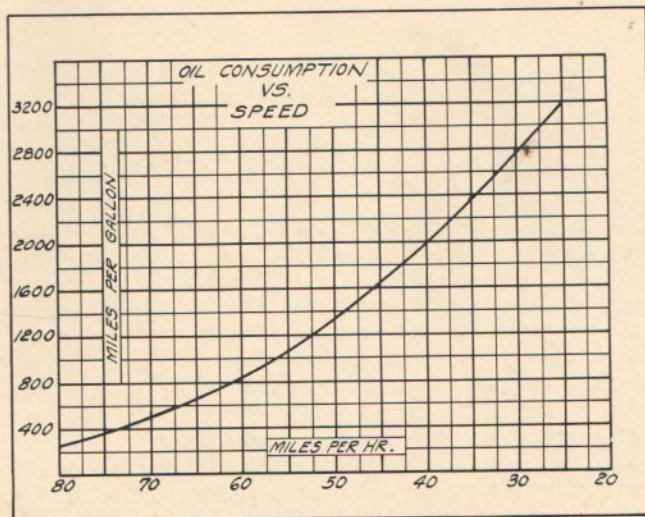
NUMBER 1

Few people realize the manner in which oil consumption is affected by motor speed. Figure 1 shows a typical curve illustrating this variation. The actual oil consumption will vary somewhat with different motors, but the character of the curve remains the same, and in every case the oil consumption will increase very rapidly as the motor speed increases. The curve represents a comparatively new motor with standard fits and clearances, and the consumption will naturally increase as the clearances increase.

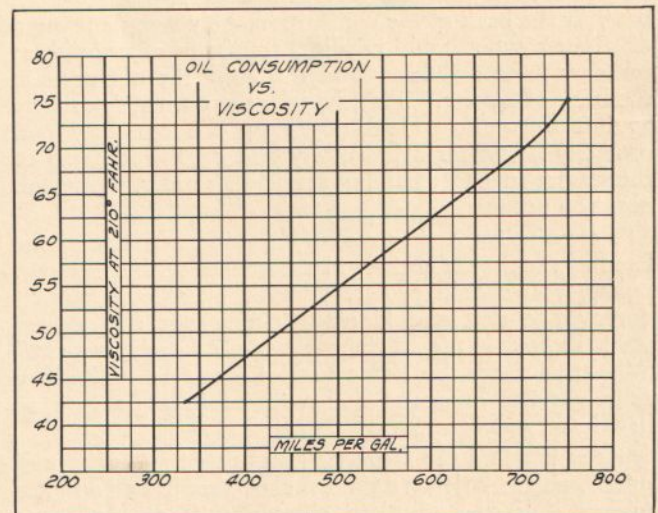
NUMBER 2

The viscosity of the oil also affects oil consumption very materially. This is illustrated in figure 2. During the winter months it is customary to use light oil to assist in cold weather starting, and if a car is driven hard with an oil of this character the oil consumption will be greatly in excess of that which would be obtained if oil of a summer viscosity were used. This, of course, is something which cannot be avoided.

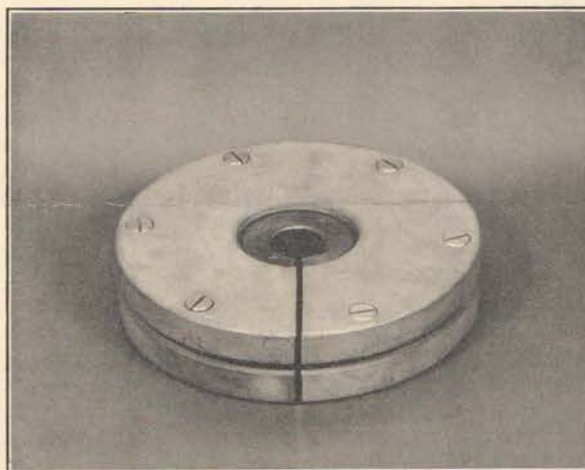
In dis-assembling the Eighth Series Vibration Damper, make sure to mark the three major parts before dis-

assembling as shown in the illustration, as this damper has been balanced and unless it is re-assembled in the same position, you will throw it out of balance.

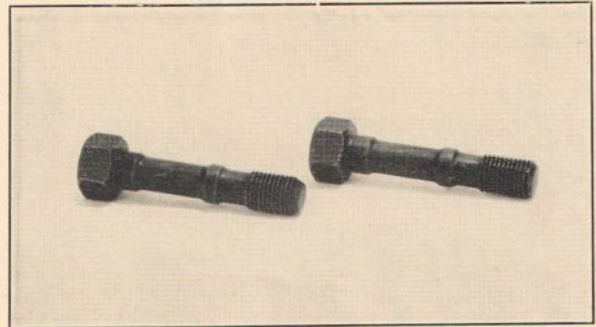
The motor connecting rod screw now used in 826-33 motors is shown in the accompanying illustration.

The new screw is made of a special Alloy steel and is so designed as to prevent the load on the screw from localizing at the base of the thread as was formerly the case. The new screw is covered by piece No. 184578

All service orders are being filled with the new screw and it should be used for all replacements in 626, 726 and 826 motors.

If certain cars are known to be driven at extremely high speeds it may be found advisable to see that the new screws are installed at a convenient opportunity. This can be done simply by dropping the crankcase bottom cover without the removal of any other parts.

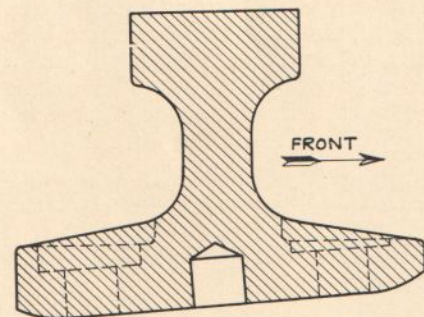
SECTION OF FRONT AXLE SPRING PAD.

At first glance the front axle appears to be absolutely symmetrical, but this is not the case and extreme care should be taken to ascertain which is the front side of the axle before installing.

An axle installed backwards would set up a reverse caster action and cause the car to wander badly and be extremely hard to control on the curves.

To make doubly sure, check the thickness of the I-beam at the spring pad. You will note from the illustration that the forging is nearly twice as thick at the rear as at the front side.

The eighth series axles carry the serial number stamped on the front face between the spring pad and the knuckle.

All replacement front axles furnished through the Service Division will be stamped "Front" in the serial number location.
