VOL. 8 No. 22

NOVEMBER 15, 1934

Ascending the Scale With Packard Connecting Rod Design

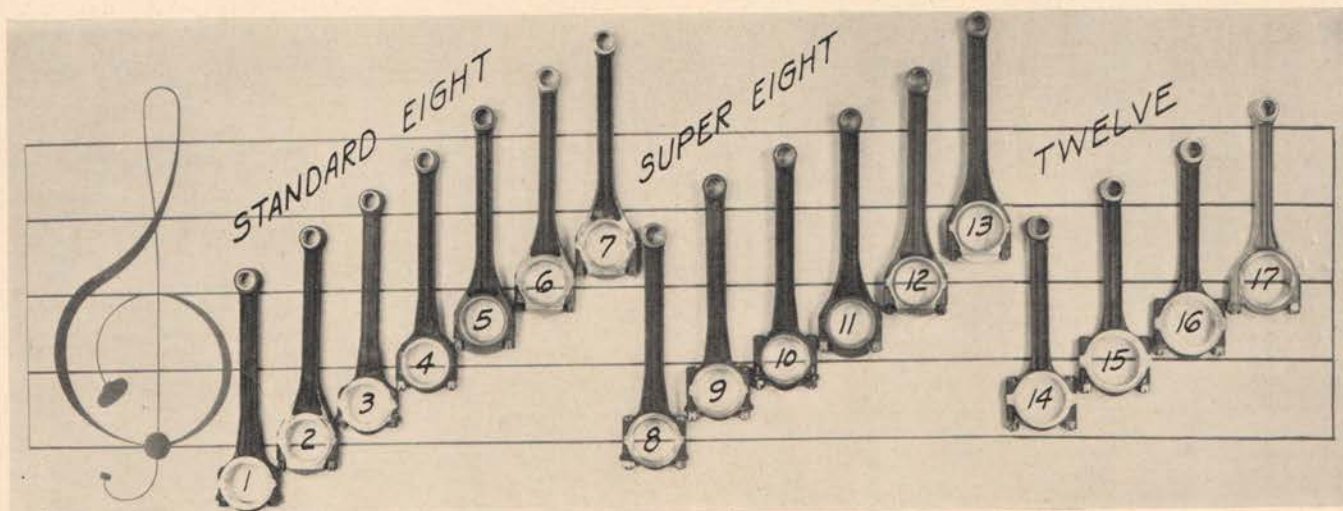
The latest improved connecting rod with the copper lead alloy removable crank pin bearing (illustration Nos. 7 and 13 and Nos. 16 and 17) can be installed in complete sets in the 7th, 8th, 9th, 10th and 11th Series motors.

ILLUSTRATION No. 1 shows the original 626-633 connecting rod, weight $36\frac{3}{4}$ oz. This is still furnished for individual replacements, piece Nos. 158647 and 158648.

ILLUSTRATION No. 2 shows the improved 626-633 connecting rod, bolted type, made from current type heavy forging with a babbit crankpin bearing, weight 42 oz., piece Nos. 98096 and 98097.

ILLUSTRATION No. 3 shows the original 726-733, 826-833 connecting rod, weight $36\frac{3}{4}$ oz., furnished for individual replacements only (piece Nos. 170135 and 170136).

ILLUSTRATION No. 4 shows the original 900-1-2 connecting rod, weight $37\frac{1}{2}$ oz., furnished for individual replacements only (piece Nos. 186647 and 186648).

ILLUSTRATION No. 5 shows the original 1001-2 connecting rod, weight $41\frac{1}{2}$ oz., piece Nos. 210077 and 210078, not furnished. Substitute piece Nos. 225922 and 225923.

ILLUSTRATION No. 6 shows the original 1100-1101-1102 connecting rod, weight $41\frac{1}{2}$ oz., piece Nos. 216216 and 216217, not furnished. Substitute piece Nos. 225922 and 225923.

ILLUSTRATION No. 7 shows the current design connecting rod, weight $41\frac{1}{4}$ oz., shipped in balanced sets for all standard Eight cars, except 626-633 models (piece Nos. 225922 and 225923).

ILLUSTRATION No. 8 shows the original 640-645 connecting rod, weight 46 oz. This is the only rod furnished for these models (piece No. 158388).

ILLUSTRATION No. 9 shows the original 740-45-840-45 connecting rod, weight $44\frac{1}{2}$ oz. Furnished for individual replacements only, piece No. 170124.

ILLUSTRATION No. 10 shows the original 903-4 connecting rod, $44\frac{1}{2}$ oz. Furnished for individual replacements, piece No. 186651.

ILLUSTRATION No. 11 shows the original 1003-4 connecting rod, $46\frac{1}{2}$ oz., piece No. 210101, not furnished. Substitute piece No. 225924.

ILLUSTRATION No. 12 shows the original 1103-4-5 connecting rod, weight $47\frac{1}{2}$ oz., piece No. 216181, not furnished. Substitute piece No. 225924.

ILLUSTRATION No. 13 shows the current design connecting rod, weight $47\frac{1}{2}$ oz., shipped in balanced sets for all custom and Super-Eight cars, except 640 and 645, piece No. 225924.

ILLUSTRATION No. 14 shows the original 905-6 connecting rod, weight $40\frac{5}{8}$ oz., piece Nos. 203676-203677. Substitute piece Nos. 98278 and 98279 for replacements.

ILLUSTRATION No. 15 shows the original 1005-6 and 1107-8 connecting rod, weight $40\frac{5}{8}$ oz., piece Nos. 207811 and 207812. Substitute for all replacements on 1005-6 and 1107-8 models, piece Nos. 98278 and 98279.

ILLUSTRATION No. 16 shows the latest design rod with removable bearing made in service for models 905-6, 1005-6, 1107-8, weight $40\frac{5}{8}$ oz., piece Nos. 98278 and 98279.

ILLUSTRATION No. 17 shows the 1207-8 connecting rod. Use for the above models only. Weight $40\frac{5}{8}$ oz. (This rod is $\frac{1}{8}$ " shorter than 905-6 and 1005-6, 1107-8). Piece Nos. 225925 and 225926.

When installing late type rods in early motors, care must be taken that the bleed hole in the lower end of the rod faces in the right direction. On all motors prior to the 9th Series this hole should be on the same side as the oil filler; on all 9th Series and later motors the bleed hole should be on the camshaft side facing the valves.

In refitting the early motors the bleed hole should be drilled out to the same size as the hole in the old rods removed from the engine (i.e., No. 30 drill size). Unless this is done the cylinder bores may suffer from under-lubrication.

When fitting the new type connecting rods, care should be taken that the radial clearance is the same as used in the factory, i.e., .001" to .0015".

Do not file the cap on this design connecting rod. The bearing projects from .0009" to .003" beyond the cap in order to seat the bearing properly in the rod and cap when the pressure is applied in tightening up the connecting rod bolt nuts.

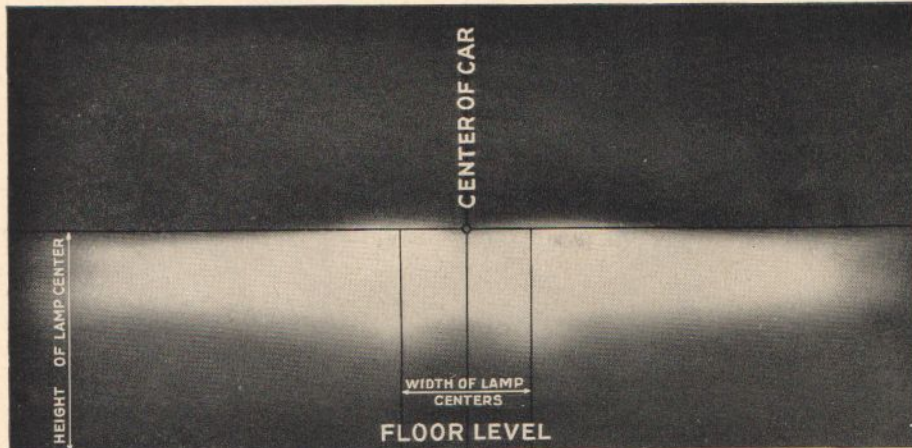
Upper beam of both headlamps correctly aimed

Cover the right lamp, place switch on "country drive" position, then aim the spot of high intensity from the left lamp so that it centers on the corresponding lamp center marker with its upper cut-off falling at the horizontal marker. Tighten mounting nut securely while lamp is in this position.

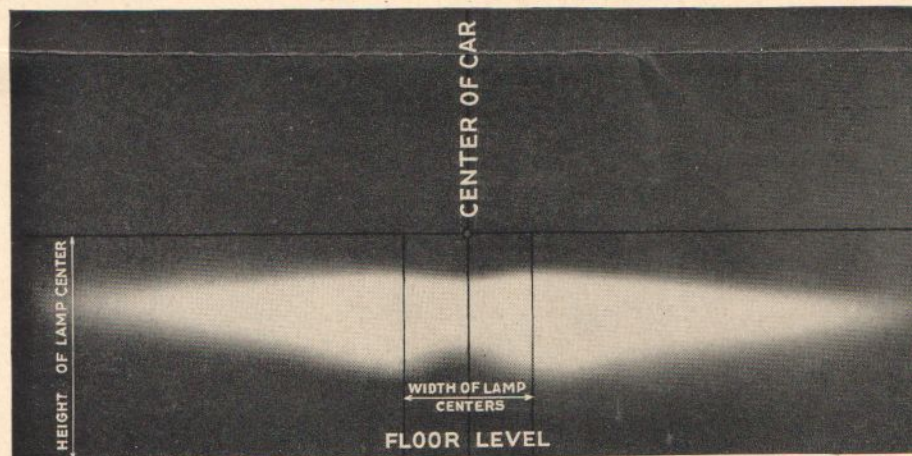
Lower beam of both headlamps correctly aimed

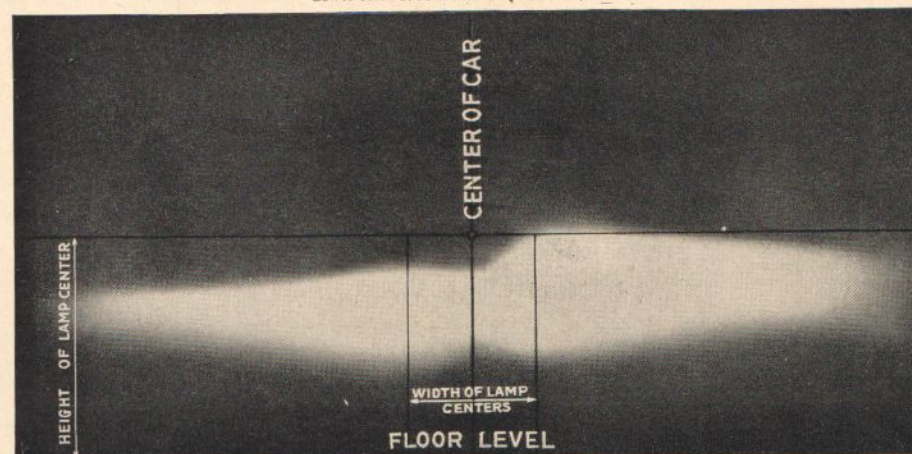
Lower beam of left headlamp—Upper beam of right headlamp correctly aimed

Having covered the left headlamp, proceed to aim the right lamp. In this case the upper cut-off falls at the horizontal ribbon but the spot of high intensity is moved so that its left margin falls on the right center marker as shown in illustration (Fig. 1). With headlamps tightened in these positions, the 'city driving' and 'country passing' beams will fall in their proper places. If the lighting in 'country passing' position appears to be too blinding for oncoming traffic, loosen anchor bolt nut on right hand lamp, turn front end slightly towards curb.

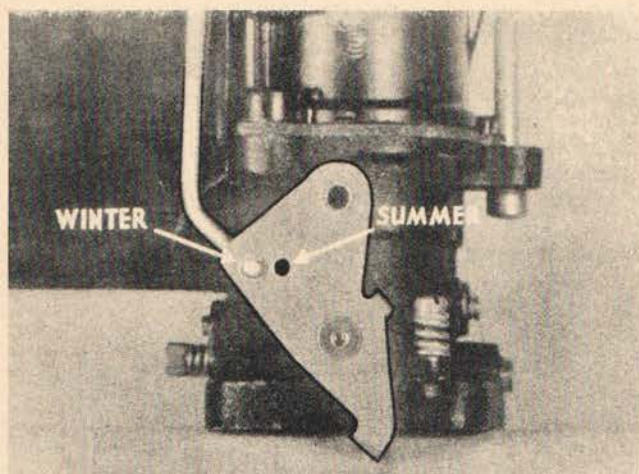
Carburetor Pump Adjustment

There have been a few complaints about a hesitation in the 12th Series motor after coasting the car to a low speed and suddenly picking up in high gear.

This is caused by the sudden action of the accelerator pump when the throttle is opened, putting through an extra load of gasoline for faster acceleration.

However, in cars where it shows this hesitation noticeably, it indicates that the pump is putting through a little too much gasoline. This condition can be greatly improved and in many cases entirely stopped by moving the pump operating rod into the rear hole in the pump lever, which is connected to the throttle valve shaft directly behind the carburetor looking from the right side of the bonnet. This, of course, shortens the stroke on the pump and doesn't allow as much gasoline to be pumped in on rapid acceleration. The rod may have to be moved back to the forward hole in extremely cold weather. This condition, of course, only exists when the motor is hot.
