VOL. 9 No. 8

APRIL 15, 1935

## INTELLIGENT SERVICE

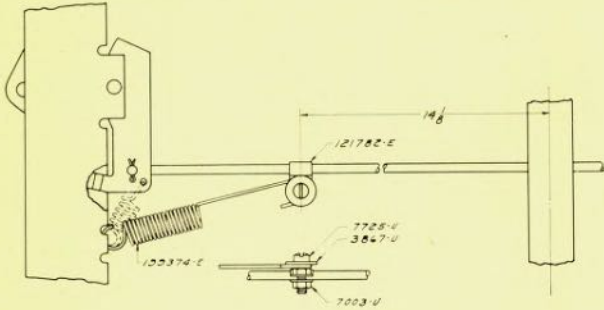
The front seat locking mechanism on the 120 is held in position by a short spring on each side which pulls the locking fingers into the notches in the side plates.

In some cases these short springs have been overstressed by an excessive movement of the mechanism, and the illustration shows a simple method by which a new spring may be attached. The piece numbers of the parts required are shown.

It will probably be sufficient to install the new spring on one side only because this will supply enough pull to engage the locks.

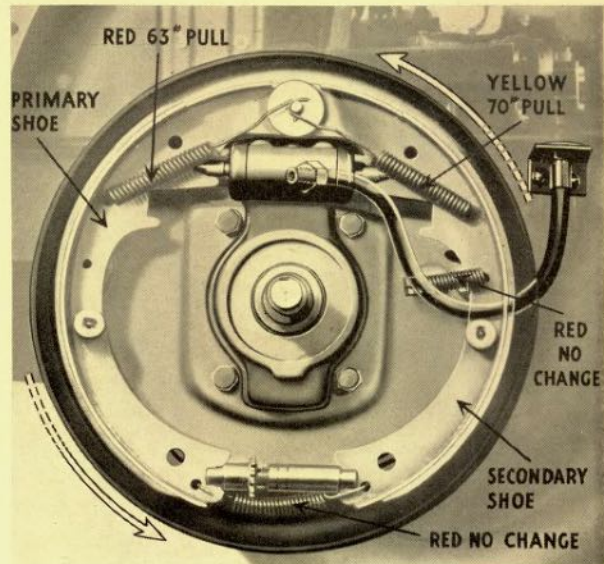
On some of the early 120's there was a back up brake snap such as we experienced in the 900.

This was caused by the brake shoe return springs being too light. The majority were changed here at the factory. However, some cars got out in which this change was not made.

The original return springs were both alike, having a fifty-pound pull. The present primary shoe return

spring has a pull of sixty-three pounds and is painted red. The secondary shoe return spring has a pull of seventy pounds and is painted yellow. It is not necessary to change the springs unless the back-up noise exists. Piece No. 303837 primary shoe return spring. Piece No. 303836 secondary shoe return spring.

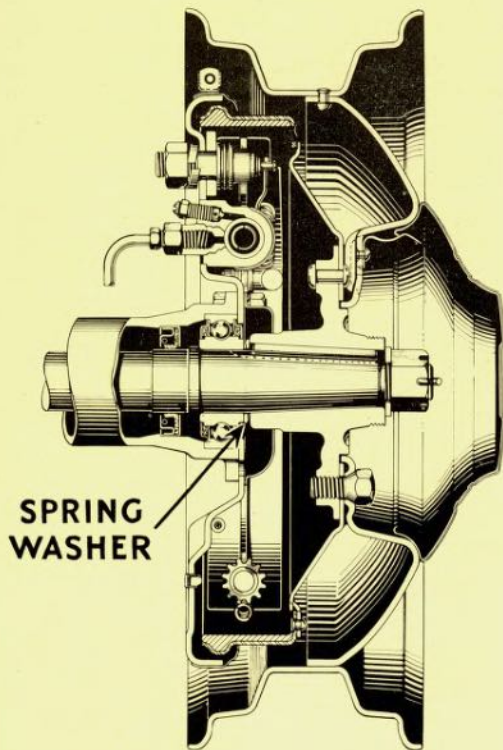
The rear axle shaft bearing is of the ball type, sealed on both sides to keep the lubricant in and the dirt out. The bearing before assembly may give you the impression of being loose, but when pressed on the axle shaft from the taper end, the inner race expands reducing the ball clearance to the required limits.

As a safety measure a spring washer has been provided, fitting between the wheel hub and the bearing. When the hub is tight on the taper, this washer is compressed, providing a pressure of about 2000 lbs., which helps to keep the bearing in its proper position against the shoulder on the axle shaft.

In service when the wheel hub is removed care should be taken not to lose the spring washer. When removing the wheel hub use a puller. If an attempt is made to loosen the hub by a heavy blow on the end of the axle shaft, you will probably drive the shaft through the bearing. When re-assembled you will then experience interference between the drum and brake.

Axle shaft bearing end float can be removed by installing the required thickness shim between the bearing outer race and axle housing.

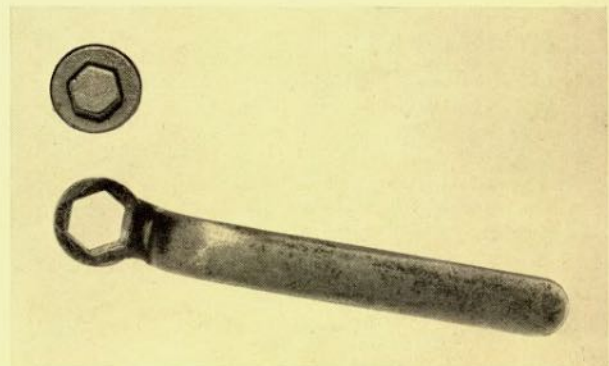
From a service standpoint the standard stock drain plug of a steel stamping is not very satisfactory. The head is square and tapered which makes it difficult to use an ordinary monkey wrench, and there is no standard socket wrench to fit. A special service plug has been designed and is carried in stock. It has a hex head which the standard spark plug socket wrench fits. It can easily be removed without damage.

The plug is carried under piece No. 98378. The wrench under No. 190617. This wrench is standard equipment on Ninth, Tenth, Eleventh and Twelfth Series eight-cylinder cars. The list price of the new plug is 25c.

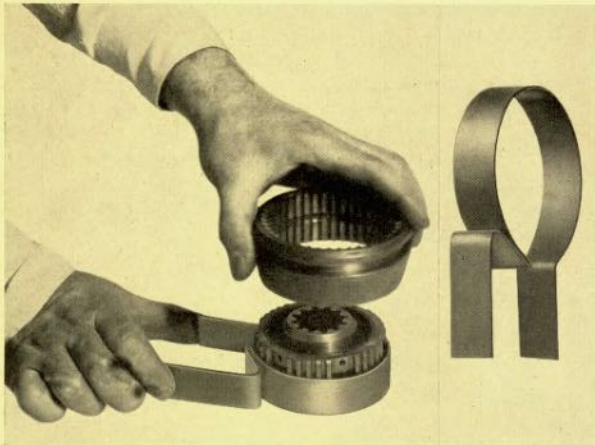
After removing the change speed lever and cover from the transmission, it is very important that the direct drive and second speed clutch ring is not moved from its position.

This ring can be very easily slid off the gear, allowing the springs and balls to fall into the transmission case.

We have designed a clamp, known as S. T. 5014 Transmission Direct Drive and Second Speed Ring Clamp, to hold the springs, balls, and synchro-mesh gear in position while setting the clutch ring in place.

This tool has a spring tension so that when it is sprung over the gear it will stay in this position. It is a very simple matter to turn the gear and insert the balls and springs in their proper place. The clamp will hold them there until the collar is placed over the gear as in the picture.
