Packard

SERVICE TECHNICAL BULLETIN

September 10, 1947

Subject: MARINE ENGINE THERMOSTAT CHANGE 1M245 - 1M356 ENGINES

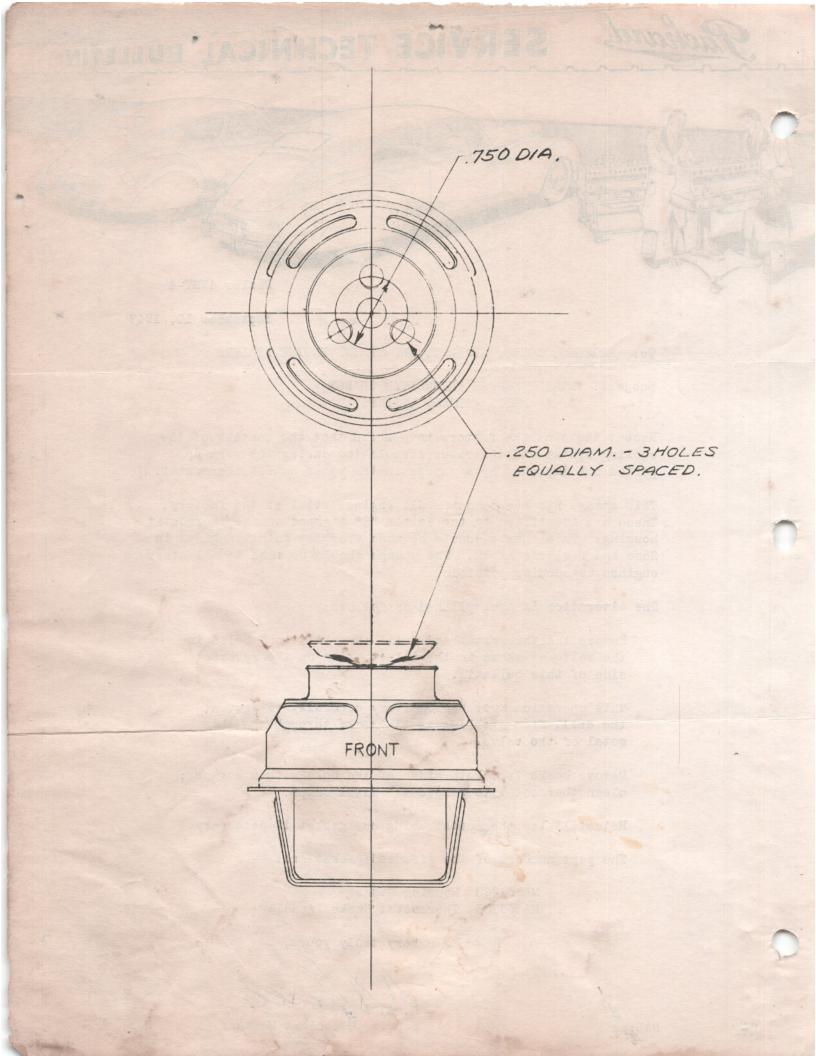
Recent tests at the factory have shown that the venting of the cooling system and the water circulation during the warm-up period are improved by a change in the water outlet thermostat.

Remove the thermostat and drill three 1/4-inch holes in the valve as shown in the illustration on the reverse side of this bulletin.

This operation must be done very carefully to prevent the drill from grabbing as it breaks through the thin metal of the valve.

Remove burrs from both sides of the hole with a scraper; clean thermostat to remove all metal chips.

Reinstall the thermostat using new gasket if necessary.
