Dealer 47T-24
October 16, 1947

Subject: CONVERTIBLE TOP CAMPAIGN, MODELS 2259-2279

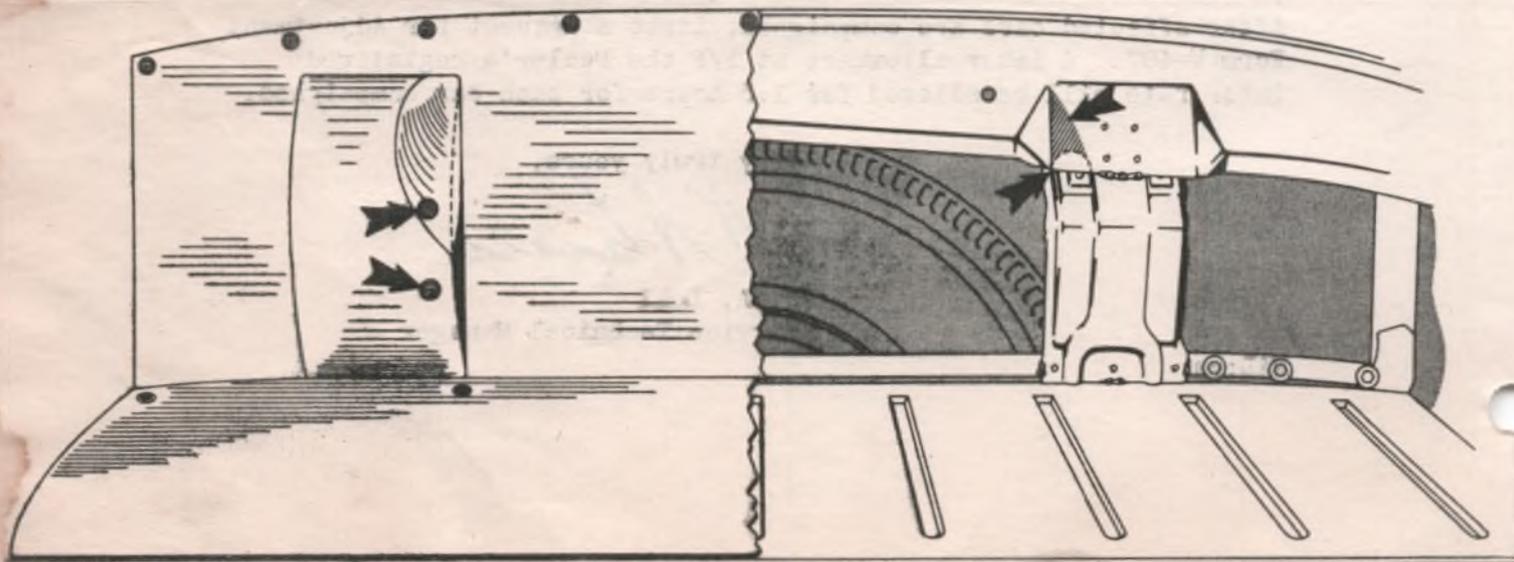
All Convertibles in Zone and Dealer stock and also those delivered to Owners may be subject to a rubbing action between the outer edges of the top curtain glass frame and the No. 2 top bow when lowering and raising the top.

When this condition exists, the chafing of the fabrics at these points may be enough to wear holes in the fabric, resulting in a major repair operation involving the replacement of the top cover, the top curtain, or both.

Cut a small section out of each trunk hinge support recess above the hinge inner retaining nut as shown in the accompanying illustration. This may be accomplished by drilling a series of small holes in a semi-circle as shown by the dotted line in the illustration and breaking the metal away.

Bend the inner corner of each hinge support recess downward against the hinge support. This section is indicated by the shaded area in the illustration.

Using hand pressure, collapse and push the inner corners of the box sections of the trim panel inward against the hinge supports.

Drill two 1/8-inch holes through each box section and hinge support and install No. 6 Parker-Kalon screws, part number 7017, and washers, part number 374850, as shown in the illustration.
