Packard **SERVICE TECHNICAL** **Bulletin**

Dealer 48T-22
August 30, 1948

Subject: INCORRECT TRUNK LID LOCK CYLINDER ASSEMBLIES - 22ND SERIES MODELS

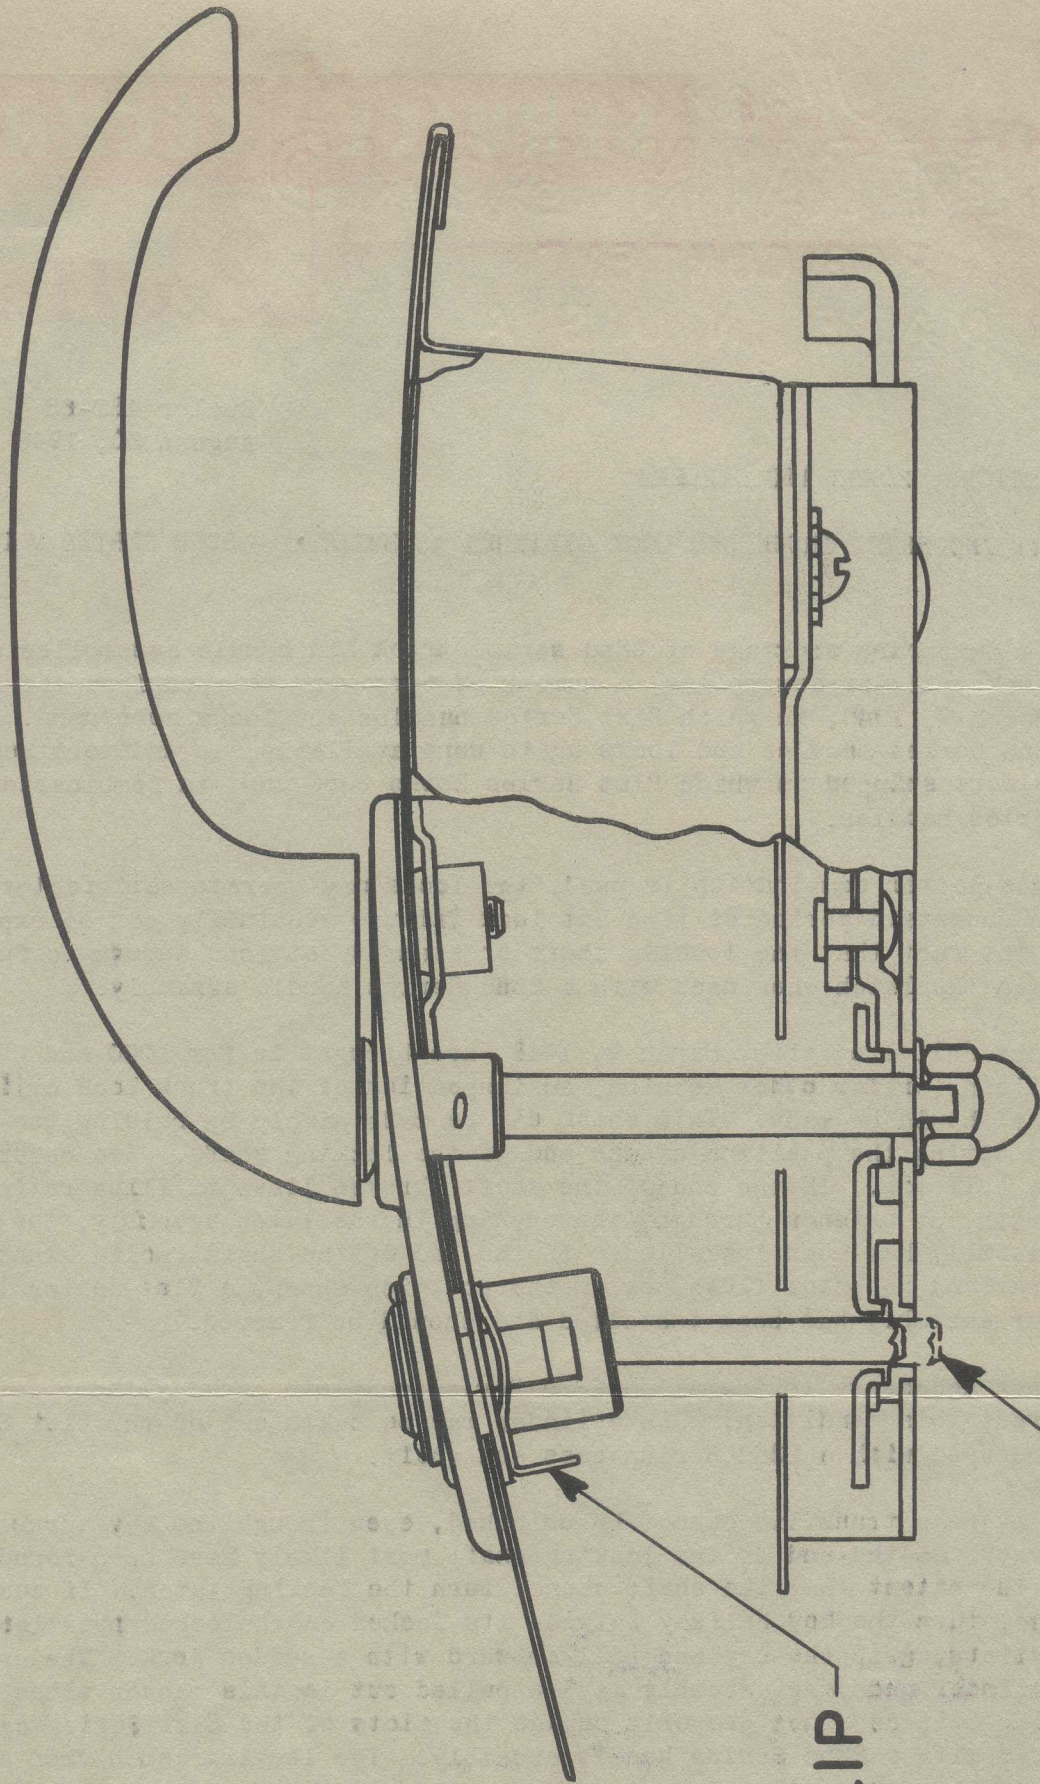
When this latter combination is used, the locks may operate satisfactorily over an uncertain period of time but lock failure eventually can be expected due to the fact that the locking shaft or stem is not long enough to fully engage in the latch when used with a 22nd Series handle assembly.

When cars delivered after March 9, 1948, are brought in for 1000 and 3000 mile inspections, or for other service, an inspection of the trunk lock cylinder assembly should be made. This check can be made simply by raising the trunk lid and noting the position of the end of the locking shaft. See reverse side of this bulletin. If the end of the shaft (broken lines in illustration) is flush with, or extends through, the opening in the latch assembly, the proper lock assembly has been installed. If the end of the shaft (solid lines in illustration) is below flush, or in the position shown, a 21st Series lock cylinder assembly has been installed and should be removed.

It is not necessary to install a 22nd Series complete lock cylinder assembly to correct this condition. The cylinder may be taken out of the 21st Series case and used with a 22nd Series case and shaft.
