Packard **SERVICE TECHNICAL** **Bulletin**

50T-15, Dealer 12
March 23, 1950

Subject: ULTRAMATIC DRIVE OIL FILLER CAP CAMPAIGN

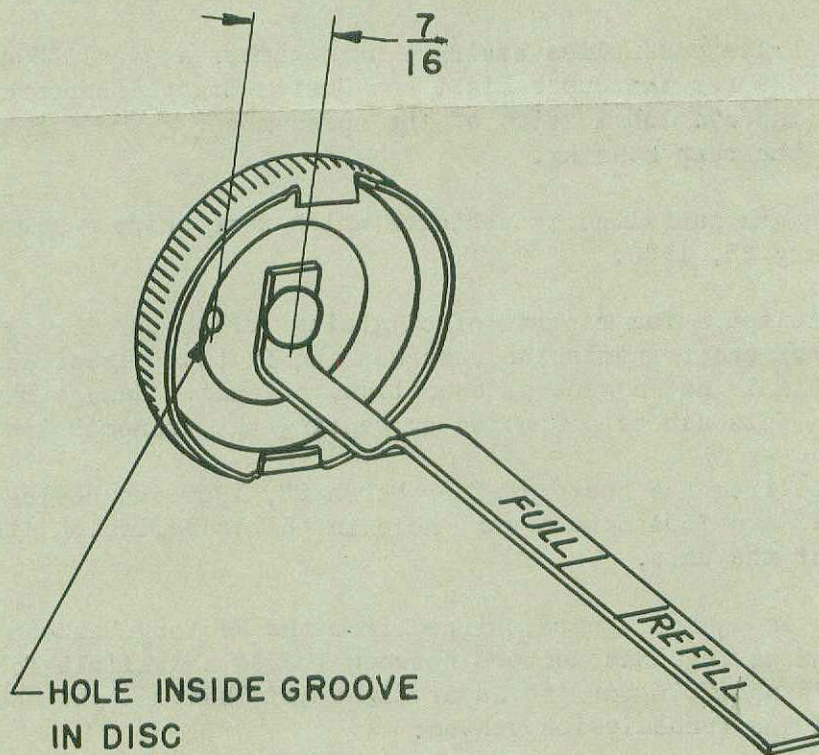
We have received a few reports of oil being forced out through the breather in the top of the transmission rear housing in these later design units. Although this is not a general condition, extensive damage may result when it exists. This can be corrected by venting the transmission case.

Venting is accomplished by drilling a 1/16 inch vent hole in the brass spring disc in the filler cap as shown in the illustration on the reverse side of this bulletin.

The hole should be drilled through the disc only and not through the cap. It also is important that the hole be drilled inside the circular groove in the disc.
