# **Packard** **SERVICE TECHNICAL** **Bulletin**

50T-51, Dealer 38  
November 30, 1950

Subject: BRAKE SHOES AND LININGS - 24TH SERIES AND PREVIOUS MODELS

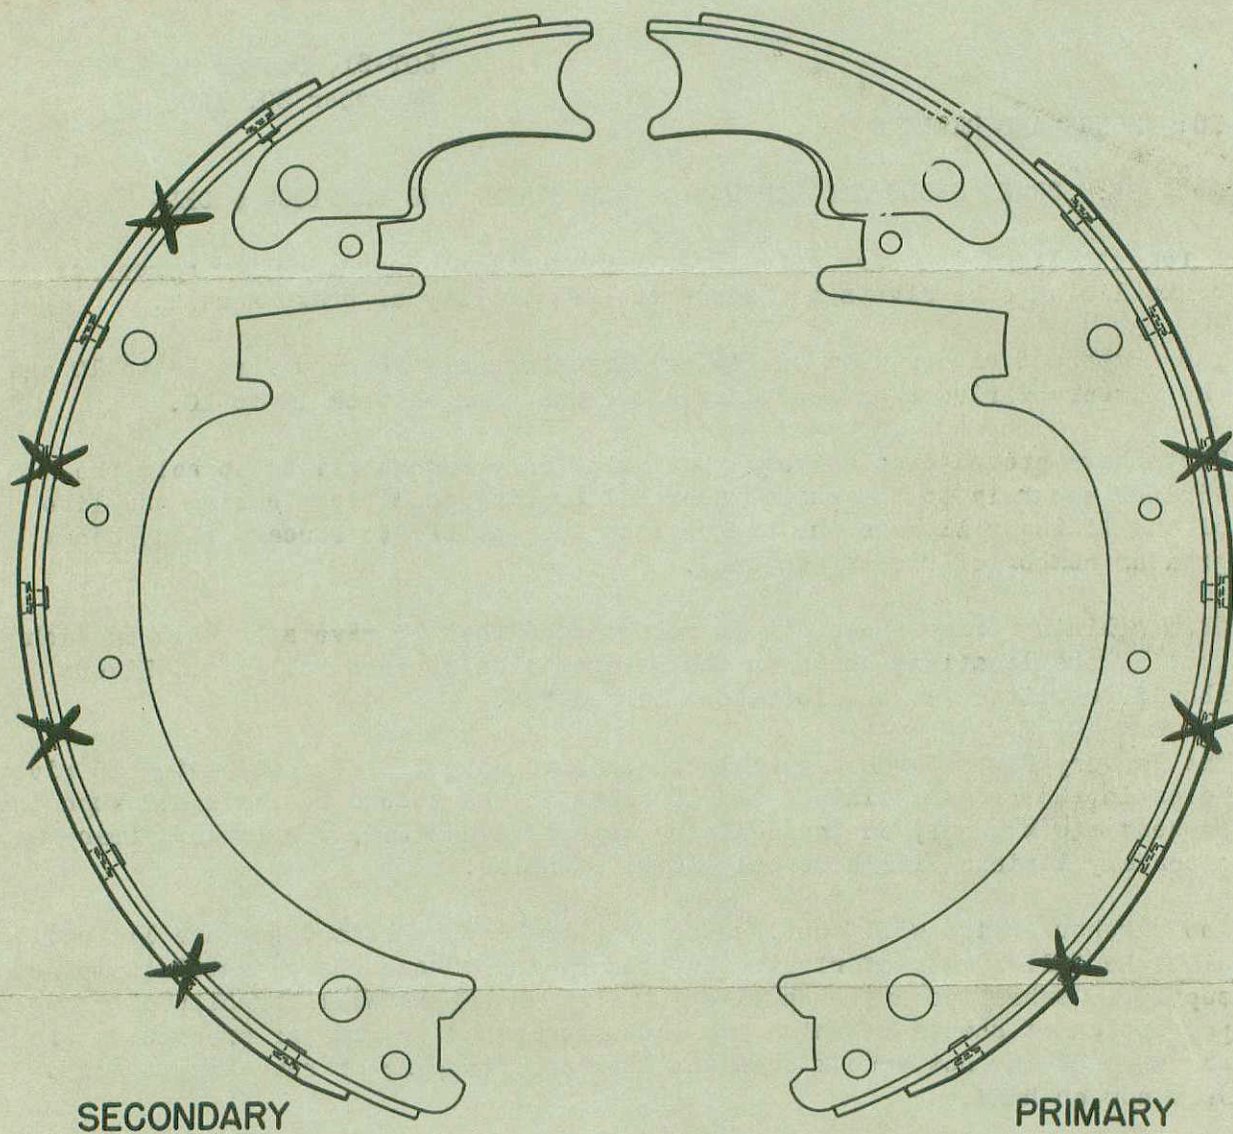
A recent alteration, now effective in production, decreased the number of brake lining shoe rivets to reduce the possibility of brake squeak.

The number of rivets used on the primary shoes was changed from 16 to 10 and the number of rivets on secondary shoes was changed from 18 to 10.

Tests have proved conclusively that using only enough rivets to hold the linings securely to the shoes under all braking conditions during the life of the lining will make the brakes less susceptible to squeaks than when a greater number of rivets are used.

When relining brake shoes, it is recommended that 10 rivets be used in each shoe at the locations shown on the reverse side of this bulletin. Rivets should be omitted at the locations marked "X".
