Packard SERVICE TECHNICAL
Bulletin

50T-54, Dealer 41

Subject: LOOSE REAR ENGINE SUPPORT - 24TH SERIES

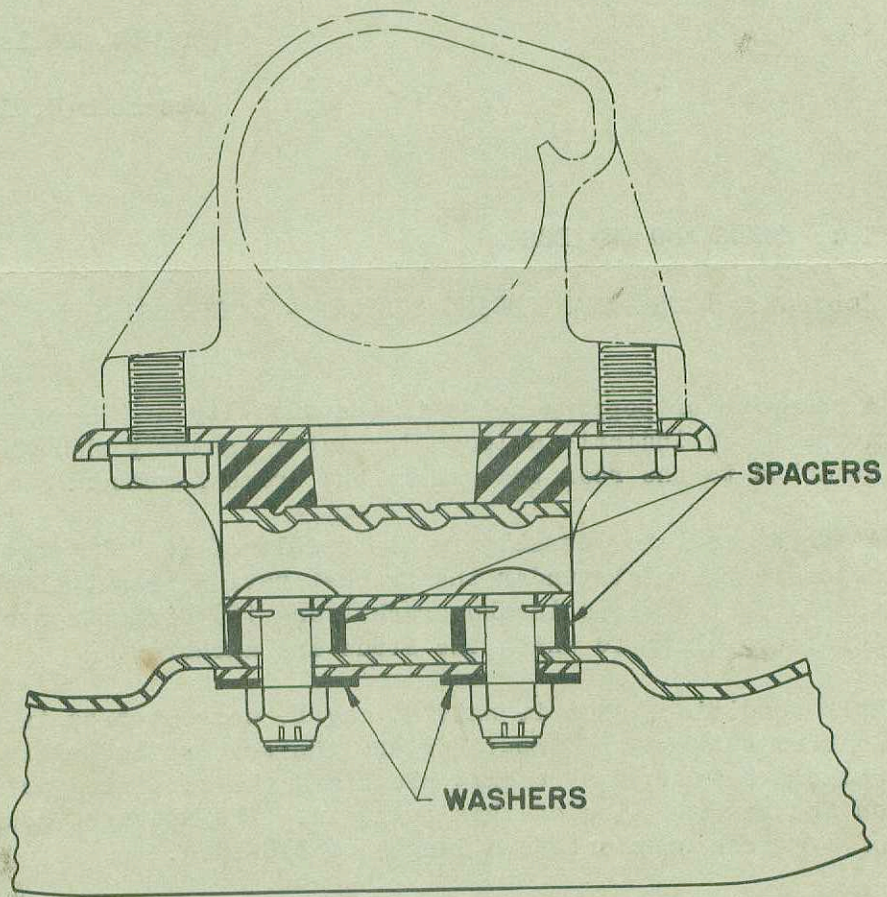
A snapping or popping noise in the vicinity of the engine rear support may indicate a loose insulator assembly where it is attached to the rear bracket in the frame X-member.

A loose insulator usually is the result of (1) the edges of the holes in the plate under the bracket having been pushed up into the elongated slots in the bracket and (2) distortion of the insulator plate to which the studs are anchored.

This condition, when it exists, may be corrected by installing spacers between the insulator and the bracket and plain 7/16-inch washers between the bracket plate and the retaining nuts as shown on the reverse side of this bulletin. The spacers should be made of 3/4-inch pipe cut to a length of 3/8-inch.

If the anchor plate is not distorted or if a new insulator is to be installed, the 3/8-inch spacers are of the correct length. The retaining nuts should be tightened so that the sides of the anchor plate are pulled down against the top of the support. They then should be further tightened to slightly distort the anchor plate so that it is being pulled against the spacers.

If the original insulator assembly is usable but has a distorted anchor plate, the spacers should be ground down to a length governed by the amount of distortion. They are of the correct length when the sides of the anchor plate are pulled against the support just before the plate pulls against the spacers.
