Packard

Bulletin

51T-48

Subject: REGULATOR POINT BURNING AND RUN-DOWN BATTERIES  
ON DELCO-REMY EQUIPPED CARS

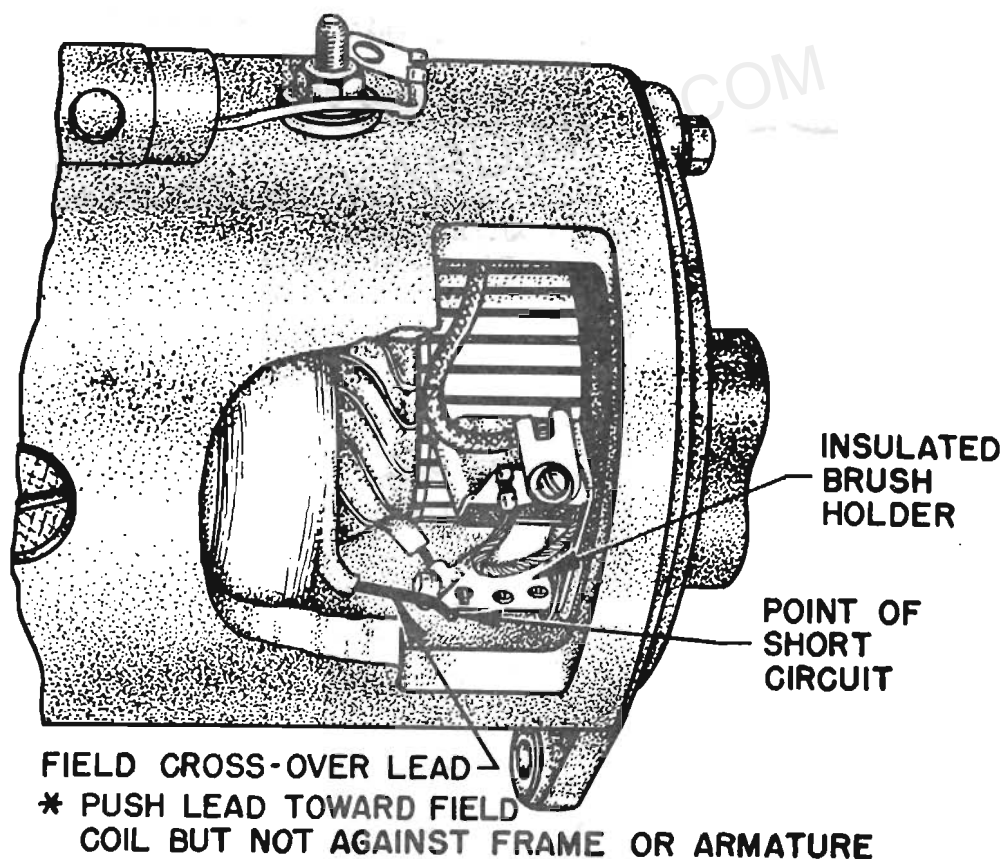
There have been some Delco-Remy generators produced since June, 1951 that may have the field coil cross-over lead touching the insulated brush holder. (See illustration.) This lead, touching the insulated brush holder, causes a short circuit at this point, which allows excessive field current to go through the regulator points, resulting in burned regulator points, high generator cut-in speeds, failure to charge, and run-down batteries.

band removed for inspection of the field cross-over lead. Push the cross-over lead away from the brush holder, toward the field coils, but not against the frame or armature.\* (See illustration.)

Wherever a short circuit has occurred in the generator field cross-over lead, the car should be sent to the local United Motors Service for repairs or replacement of the regulator, which will be taken care of on a warranty basis by United Motors Service.
