Packard **SERVICE** **TECHNICAL** **Bulletin**

51T-8, Dealer 7
March 7, 1951

SUBJECT: CAMPAIGN - HYDRAULIC WINDOW EQUIPPED VEHICLES
MODELS "300" - "400"

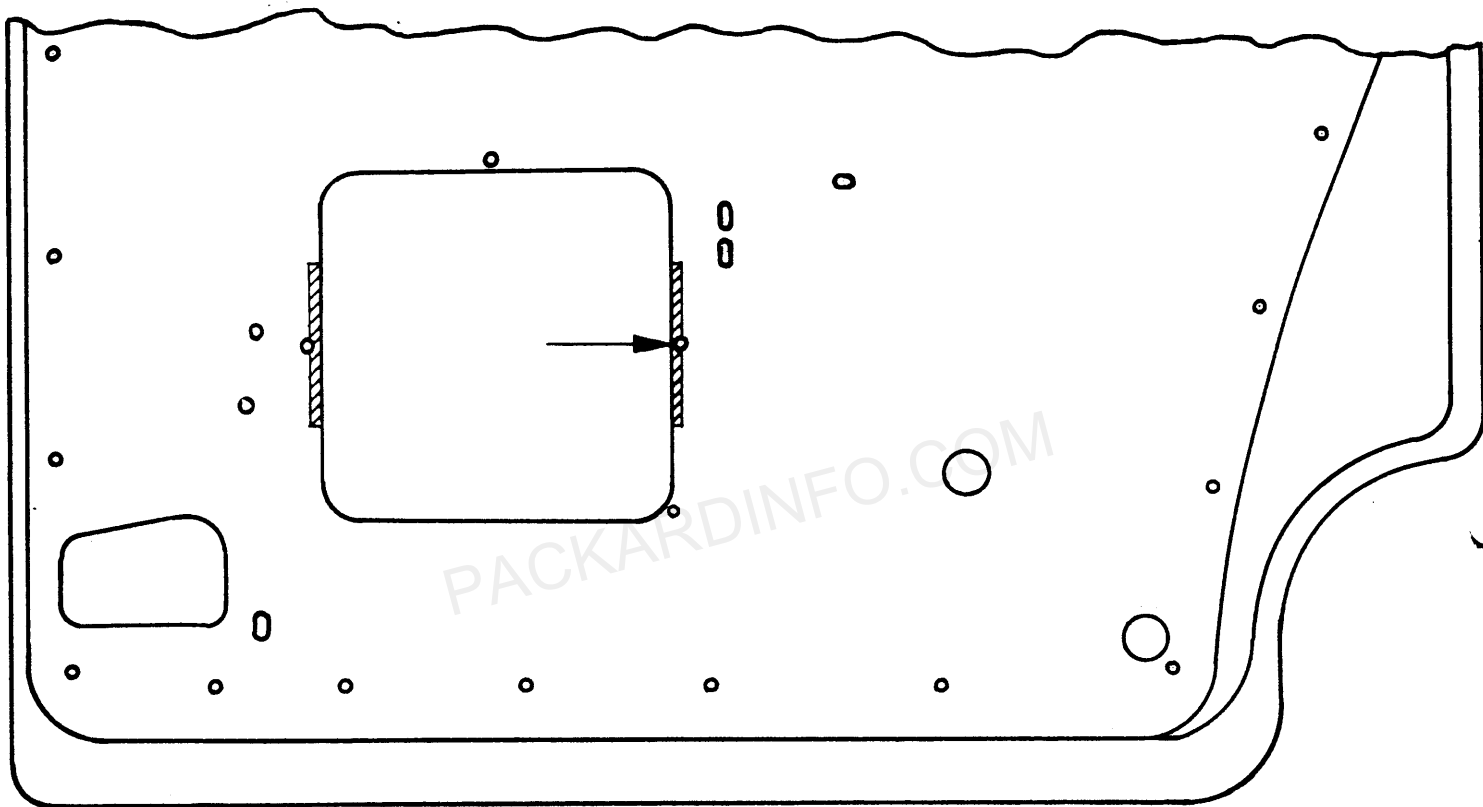
The Factory has shipped approximately 150 hydraulic window equipped cars in which the hoses in the rear doors may be subject to chafing in the support clip.

The clip is tack-welded to the inside of the door inner panel at the location indicated by the arrow in the drawing on the reverse side of this bulletin. After removing the clip, any rough metal at this point should be ground or filed smooth. The edges of the opening, at the shaded areas in the drawing, then should be bent inward slightly so they do not contact the hose. When reinstalling the access opening cover plate, use a retaining screw only at the top of the plate and omit the two screws at the sides.

These cars in Zone and Dealer stock and also those in the hands of owners should be campaigned and the support clip removed.

Hose clip removal on these cars will be handled on an RFA in the usual manner with a labor allowance of 1.8 hours for removing the clips from both rear doors. The removed clips must be returned to Zones with the RFA.
