Packard SERVICE TECHNICAL Bulletin

52T-33
Dealer 24
November 20, 1952

SUBJECT: DISTURBANCE IN REVERSE - ULTRAMATIC 25TH SERIES

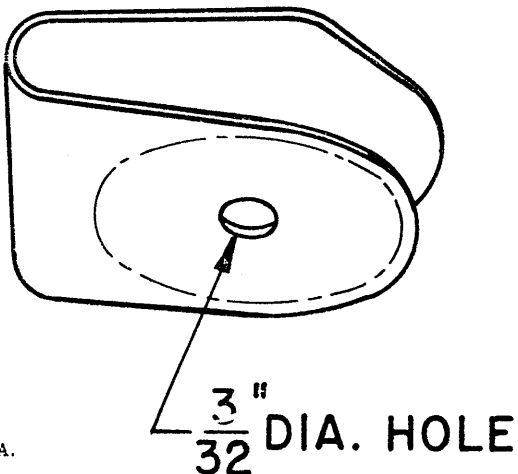
A disturbing noise when driving in reverse has been reported on a few 25th Series Ultramatic equipped cars.

During reverse operation, the rear pump is rotating in reverse direction creating a vacuum on what would be the pressure side of the pump during normal forward operation. This vacuum along with air admitted by the governor vent valve causes an aerated condition of the oil at the rear pump.

To correct this condition it is necessary to supply a greater amount of oil to the rear pump to counteract the vacuum created. This can be accomplished by drilling a $\frac{3}{32}$ " hole in the rear half (flat side) of the rear pump check valve. Insert a piece of wood between the two sides of the valve when drilling so that the shape of the valve will not be distorted. Be sure to drill the hole directly in the center to correspond to the center of the bore opening. "See illustration." Remove all burrs from the edges of the hole.
