**P**ackard **SERVICE TECHNICAL**  
Bulletin

55T-18  
May 18, 1955

Subject: TORSION-LEVEL SUSPENSION REAR LOAD ARM LINKS

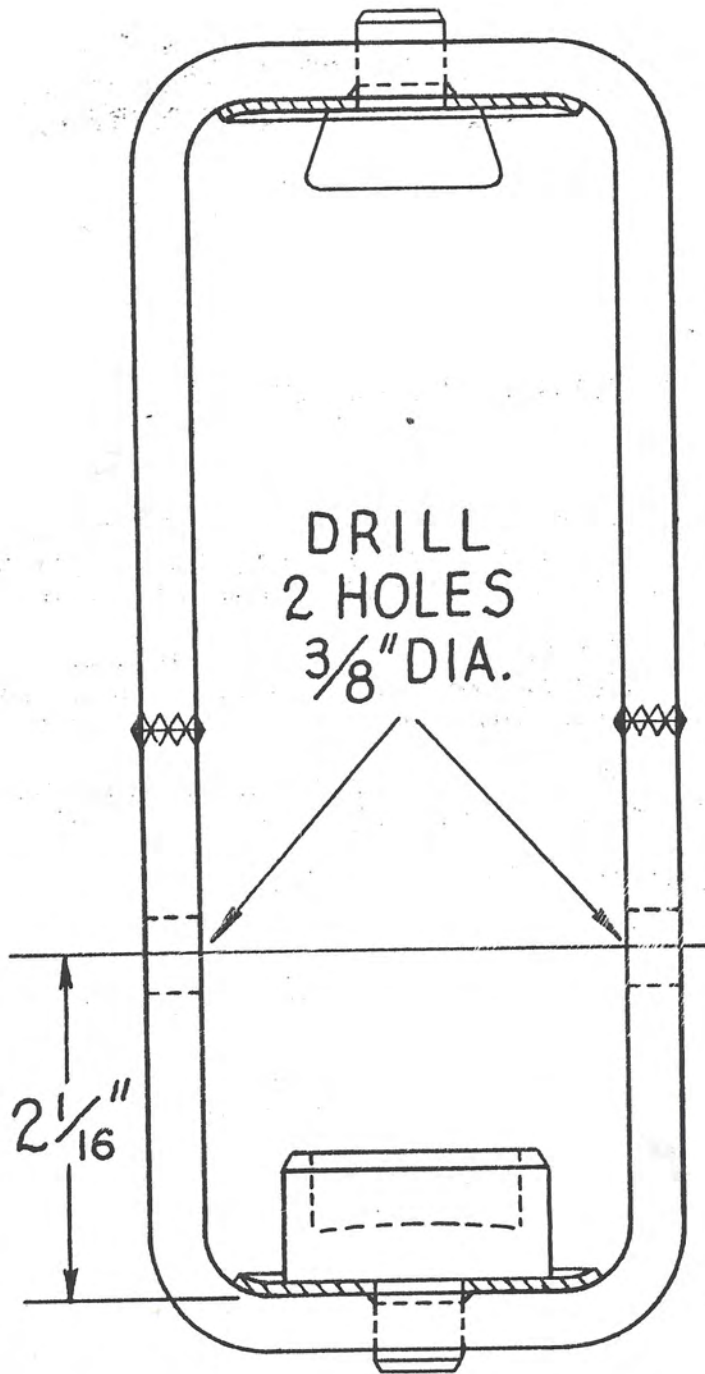
REAR LOAD ARM LINK  
ASSEMBLY

A recent change was made in the rear load arm of Torsion-Level Suspension cars to prevent any possible chance of the load arm becoming unseated from the rear links.

The attached illustration indicates the position of the retaining pin (part number 445393), which can be installed by drilling a 3/8" hole through both sides of the links.

It would be well to install these pins on cars that are known to be extremely abused by owners or dealers.
