# Packard SERVICE TECHNICAL Bulletin

55T-34  
Dealer 25  
July 15, 1955

Subject: WINDSHIELD WEATHERSTRIP RETAINER - 55TH SERIES

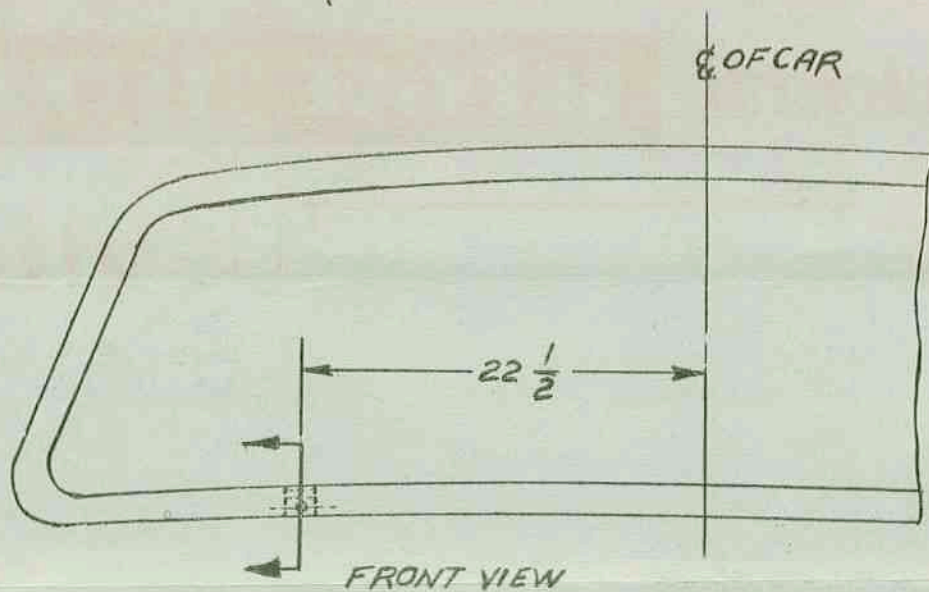
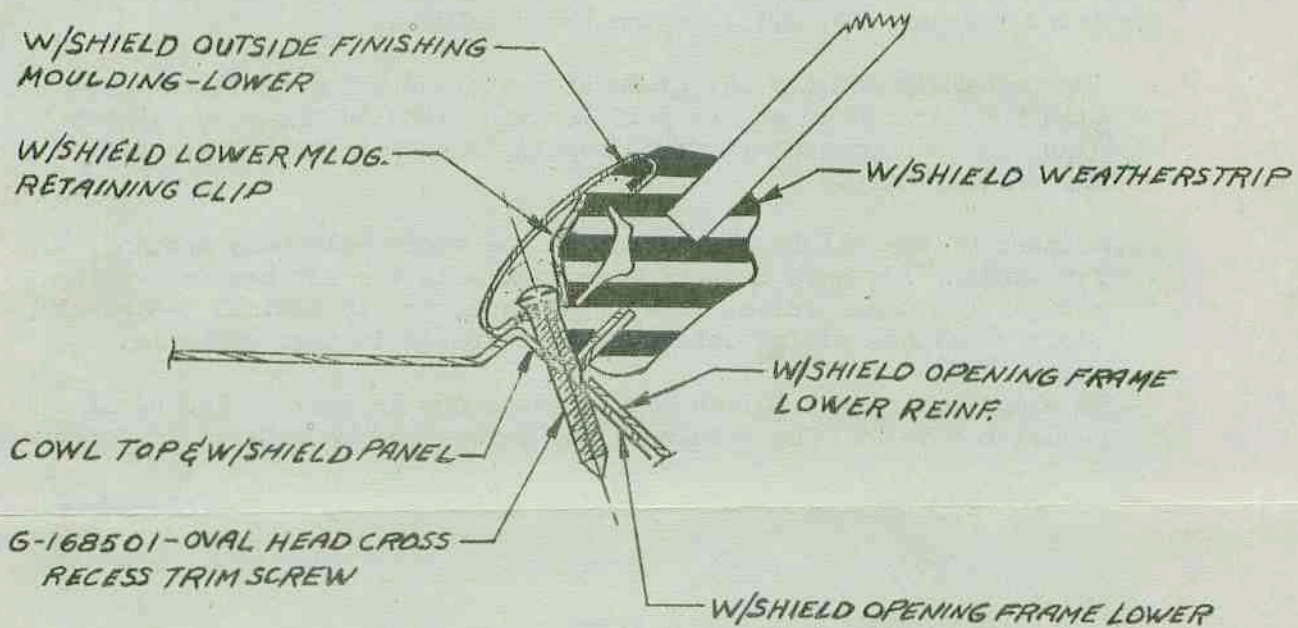
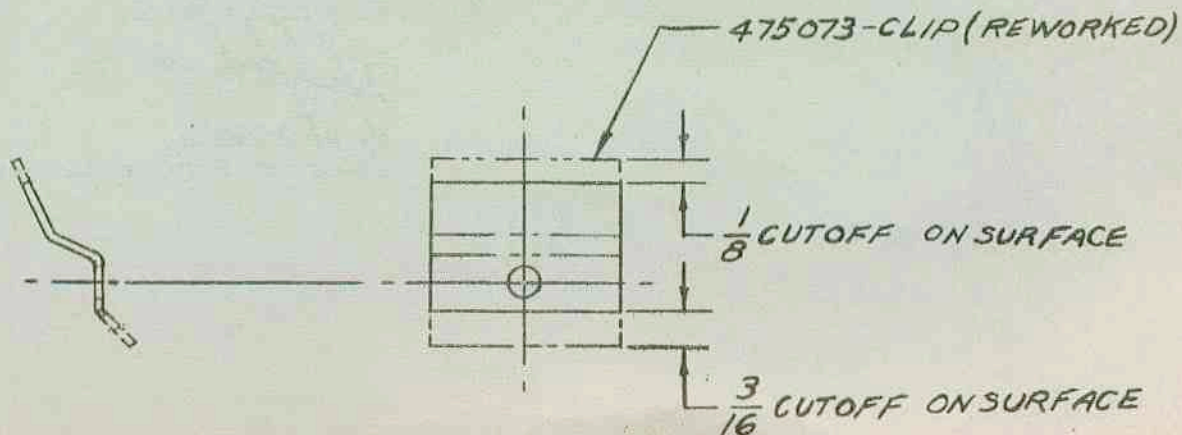
Because of the slight variations in the windshield body opening, a few windshields have dropped down even with the new heavier weatherstrips. In these cases, it will be necessary to install two weatherstrip retainers as indicated and illustrated in this bulletin.

To align the glass, follow the instructions in Service Technical Bulletin 55T-10. The retainers and screws may be ordered as follows:
