# Packard **SERVICE TECHNICAL** Bulletin

55T-5  
January 26, 1955

Subject: CYLINDER HEAD OIL PASSAGE - 55TH SERIES

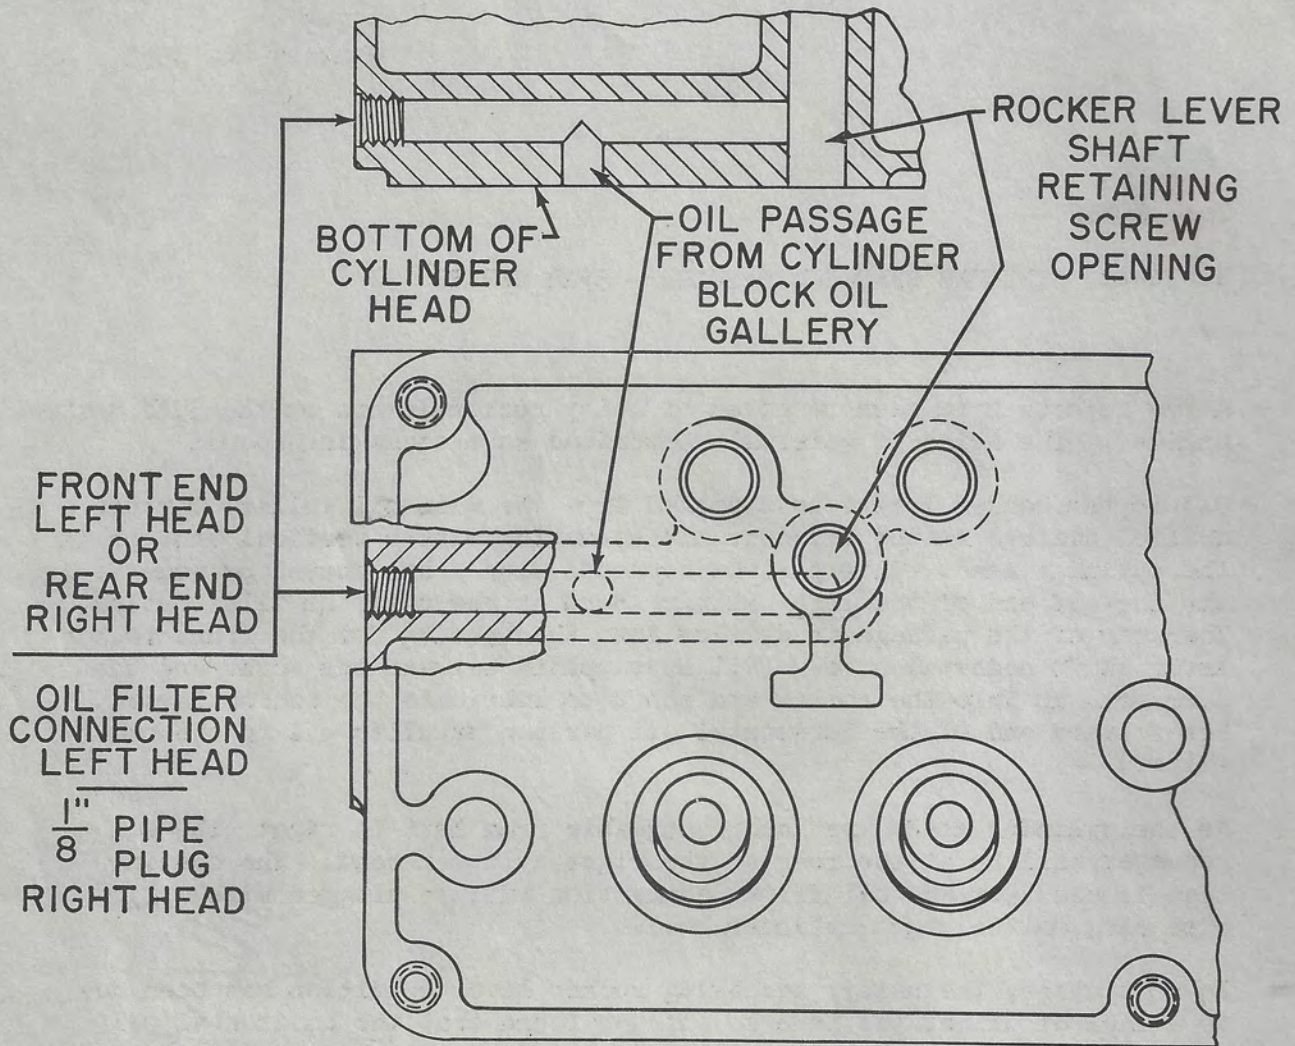
Oil to the rocker levers is supplied from the main oil gallery through a drilled passage in the cylinder block, mating with a vertical passage in the cylinder head. This passage connects with a horizontal passage at the forward end of the left cylinder head as shown in the illustration. The rear of the passage is drilled into the opening for the front rocker lever shaft pedestal screw. Oil is supplied between the screw and the pedestal, up into the rocker arm shaft to lubricate the rocker levers. The forward end of the horizontal oil passage supplies oil to the oil filter.

In most cases, the noisy, squeaking rocker lever condition has been due to a lack of oil at the levers. It was found that the horizontal oil passage in the head was not drilled deep enough to connect with the pedestal screw opening.

When noisy, squeaky rocker levers are encountered, remove the rocker covers and examine the levers for oil supply while the engine is running. If no oil is found, it will be necessary to remove the cylinder head and drill out the passages with a 21/64" drill to the depth shown in the illustration. Blow out the chips with compressed air.
