Packard SERVICE TECHNICAL Bulletin

56T-20
Dealer 17
May 3, 1956

Subject: ENGINE OIL PUMP RELIEF VALVE TUBE KIT FOR CORRECTION OF HYDRAULIC VALVE TAPPET LETDOWN - 55TH-56TH SERIES

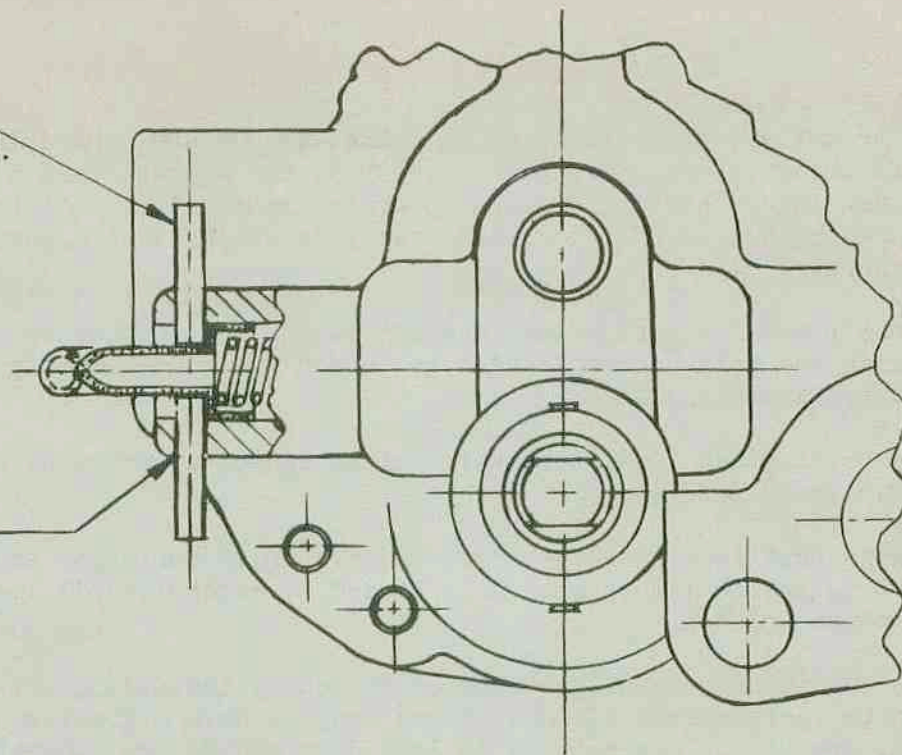
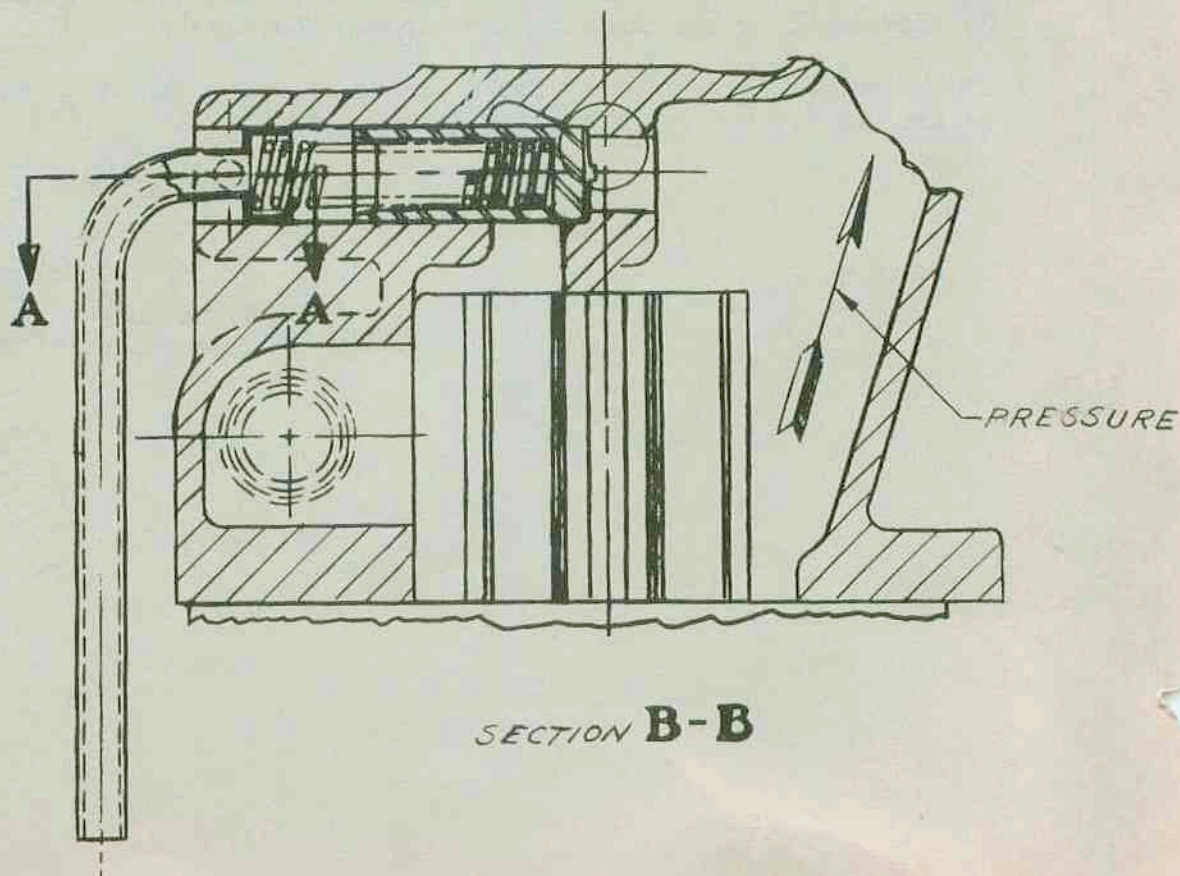
Hydraulic valve tappets that intermittently become noisy at idle speed or at speeds of 40 to 60 M.P.H. after the oil gets hot in most cases has been caused by air getting into the oil pump and gallery thereby interrupting the oil supply to the tappets.

G 455346
ROLL PIN .160^{+0.007}/_{-0.000} DIA.
2 PLACES

DRILL OUT COTTER
PIN HOLE TO $\frac{5}{32}$ "

For Service, we have released an engine oil pump relief valve tube with attaching parts which can easily be installed on the oil pump in place of the relief valve spring retainer. The small end of this tube points downward into the oil in the oil pan thus preventing any air being drawn in past the relief valve. This engine oil pump pressure relief valve tube kit is identified as part number 6484613 and may be procured on order from your parts warehouse. In every case where intermittent hydraulic valve tappet noise is encountered on 55th and 56th Series cars this kit should be installed. Where the car has been in service less than 12 months or 12,000 miles, we will honor your claim, without the necessity of prior approval, for parts and 3.3 hours labor per car for installation.

3. Check relief valve for being free, it should fall back and forth from its own weight. Clean up with crocus cloth if necessary to free up valve.
4. Enlarge the cotter pin hole by drilling through with a 5/32" drill. Be sure to wash the oil pump thoroughly after drilling.
5. Install the relief valve and spring, start the flanged end of the tube in the housing with small end of tube pointing downward (toward bottom of pump). See illustration.

Carefully drive the tube into the housing with the back side of flange just past the cotter pin holes. A tool can be made up locally for driving in the tube by using a small steel sleeve that will fit in the relief valve opening and cutting a slot in the side of the sleeve so it will straddle over the bend of the tube.

Drive a roll pin in each side of the cotter pin hole with their inner ends just touching the tube to hold it in place. See illustration.

6. Due to slight variations in the oil pan and the close fit on the left side at the vacuum unit, interference may be encountered at the lower end of the tube and the rear roll pin.

If the oil pan screw holes do not line up when installing the pan, cut 1/4" off the rear roll pin with a hack saw and bend the lower end of the tube inward and forward slightly.
