PACKARD MOTOR CAR COMPANY

April 8, 1936

Subject DOOR ALIGNMENT - 12th and 14th SERIES CARS

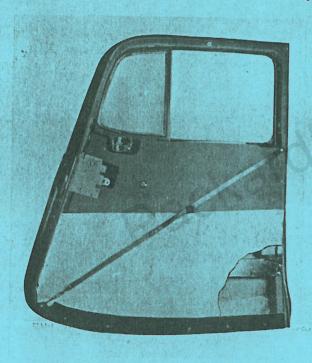
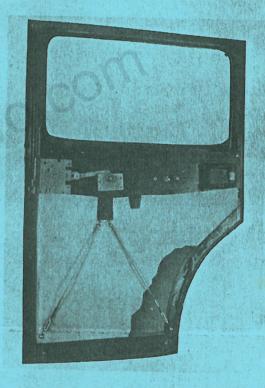
FRONT DOORS

You may encounter cases where doors of the Senior cars originally fitted properly have lost their shape, moving either inward or outward at the bottom.

When this occurs it is due to the presence of moisture which has caused the wood to warp, and the correction consists in eliminating the warping tendency and preventing the condition from developing again.

Remove hardware and trim material.

Remove the bottom trim board and cut out the center leaving 3" at the top to carry the window channel. Leave only enough of the trim board at the bottom to project 1" above the door sill in order to provide a water dam.

If the door has become thoroughly water soaked it will usually be found that the glue holding the trim board to the door frame has loosened so that the board can be easily removed. If the glue is still holding the trim board in position the center portion can be cut out without removing the entire board. The purpose of this operation is to eliminate as much of the trim board as possible because the warping of this board is largely responsible for the distortion of the door.
