PACKARD MOTOR CAR COMPANY
DETROIT · MICHIGAN

April 22, 1919
Reprinted December 15, 1922

TO PACKARD DISTRIBUTERS

REPLACEMENT AND ADJUSTMENT OF CAM SHAFT DRIVING CHAIN

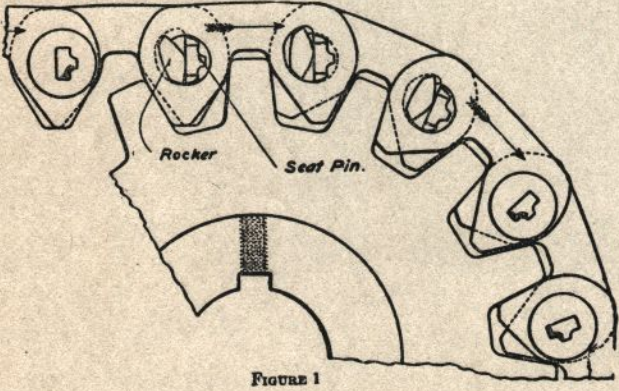
4. If for any reason a chain is removed and replaced, it is essential that it be properly installed. The pins must be inserted as shown in the diagram, as a broken chain may result if their position is altered. The chain must be installed on the sprockets so that the arrows stamped on the links point in the direction of chain travel.
