PACKARD MOTOR CAR COMPANY
DETROIT, MICHIGAN

February 21, 1922

TO PACKARD DISTRIBUTERS

FRONT SPRING FRONT BRACKETS—EC TRUCK

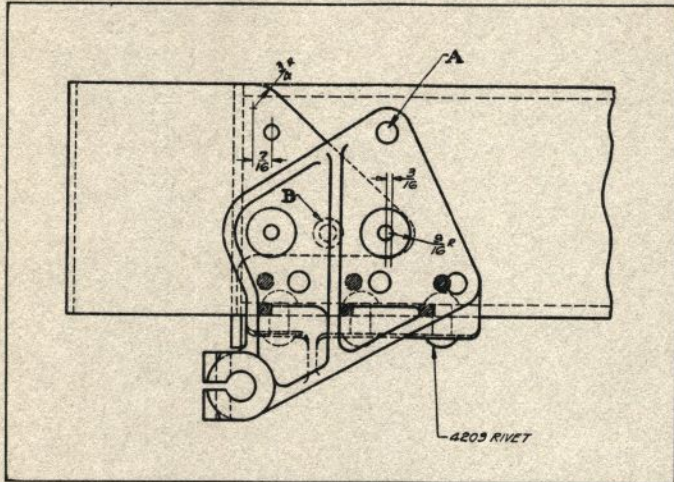
A new design front spring front bracket, which is already available in service stock, has been developed for the size EC truck. The new bracket will go into production shortly. As can be seen from the illustration, the new design has better rivet spacing, and attaches to the frame side member above as well as below the center line of the web.

In making the installation, the old bracket should first be removed, and all of the old rivet holes filled by welding, and the web surface made plane and smooth. The rear upper corner of the bumper bar should then be sawed off diagonally, as shown, in order to expose the rivet hole in the frame marked "A", since this hole is used in mounting the new bracket. The round headed rivet remaining in each end of the bumper bar assembly at "B" must then be removed and the holes countersunk to take Pc. No. 5161 rivet, in order to permit the bumper bar to clear the new spring bracket.

When installing the new unit, the bracket may first be temporarily bolted on at "A", since this is the only one of the old holes used with the new mounting. The remainder of the holes can then be located and drilled. The new bracket, like the old, should be secured to the frame by careful hot riveting. Seven rivets, Pc. No. 4203, are required per bracket.
