PACKARD MOTOR CAR COMPANY
DETROIT, MICHIGAN

June 15, 1922

TO PACKARD DISTRIBUTERS

REAR SEAT BOTTOM PANEL CLEAT — SINGLE-SIX

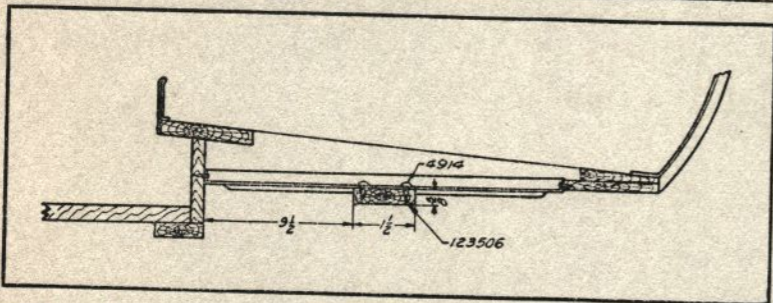
On some of the early 126 and 133 models, you may encounter a complaint developing from a drumming sound in the rear seat bottom panel. This is being remedied in current production by the addition of an ash cleat, which acts as a deadener and stiffener, and which is installed as shown in the illustration. The same method will take care of any vehicles in service. These cleats can be very easily made up in your own shop, and you will find it quicker and more convenient to do this than to order the parts from the Factory. The cleat should be $35\frac{3}{8}$ " long, and is notched only sufficiently to clear the beading in the seat bottom panel.
